**D 6.2 Documentation of each study case
CS1 Public Weigh House, Bolzano (Italy)
Delivered at M42**

**[Compatible solutions for improving the energy efficiency
of historic buildings in urban areas]**

Deliverable D6.2 Documentation of each study case

Project Acronym	3ENCULT
Project Title	Efficient ENergy for EU Cultural Heritage
Project Coordinator	Alexandra Troi EURAC research, Viale Druso 1, 39100 Bolzano/Italy Alexandra.troi@eurac.edu
Project Duration	1 October 2010 – 31 March 2014 (42 Months)

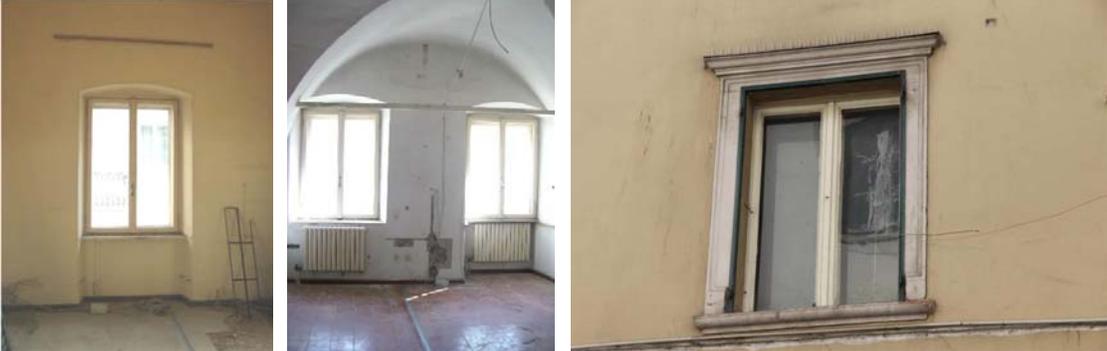
Actual state:	<p>The major part of the original windows was replaced by box-type windows in the 1950s/60s, just a few original windows are from the late baroque era with thin wooden profiles and single glazing (e.g. in the jutting on the north façade). The unified window size dating from the 16th is typical for baroque era, also profiled sandstone frames date from this era. For shading and darkening, wooden window shutters are used. The showcases on ground floor are single or double glazing from the last century with mostly thin metal profile frames, partially integrated in the plaster. The windows in the roof dormers are standard industrial insulation windows from the 1990s.</p>
Assessment of the conservator:	The box-type windows, the showcases and the windows in the roof dormers are not of historic value, while the few original windows should be maintained.

Possible interventions:	<p>Since the box-type windows of the 1950s/60s are not of historic value, they could and should be replaced reproducing the appearance of a historic window, the outer window being placed right behind the existing historic stone frame and positioned and installed in the reveal in a similar way. The late baroque original windows should be preserved and repaired – and possibly be enhanced from energetic point of view. The showcases on ground floor and the windows in the roof dormers could also be replaced.</p>
-------------------------	--

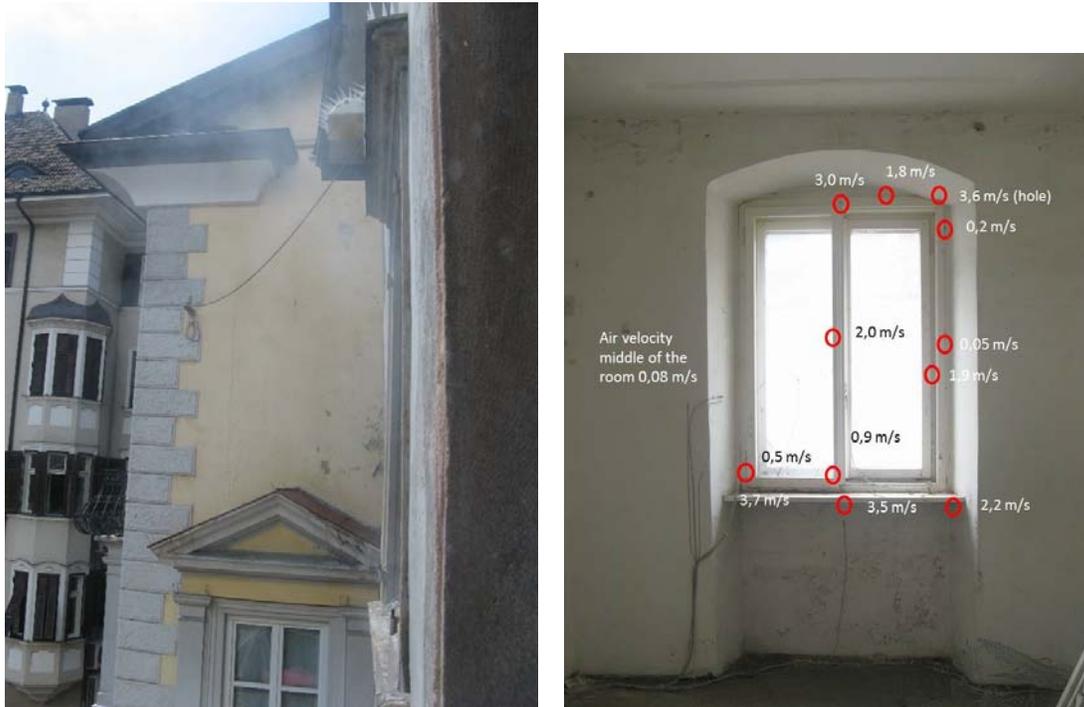
We carried the test on some rooms on the second floor positioned on the south part. As a first step, we used the gas tracer to check where the air infiltrations were localized. We created a pressure difference of 50 Pa with the fan, and we blew the gas inside the room. We saw that the gas overflow mainly through the windows and through some cracks on the interior wall. Therefore, we measured the air velocity inside the room, near the windows and near the cracks to check the differences.

Figure 2 and Figure 1: Gas through the windows, air velocity near the window

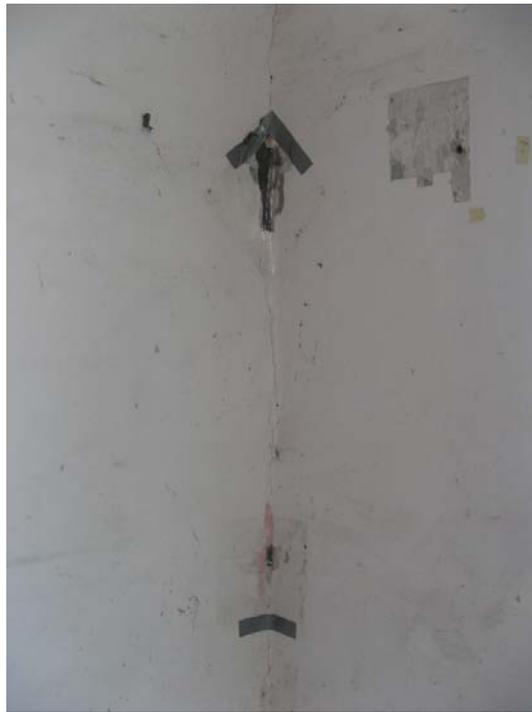
Figure 3: Sealed cracks on the interior wall

After the gas tracing, we sealed the cracks on the interior wall in order to have only the air losses through the windows. At the end, we were able to measure the infiltration rate caused by the windows. The results of the blower door test in the rooms are reported in the following tables.

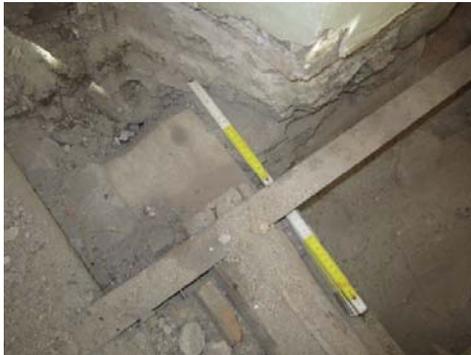
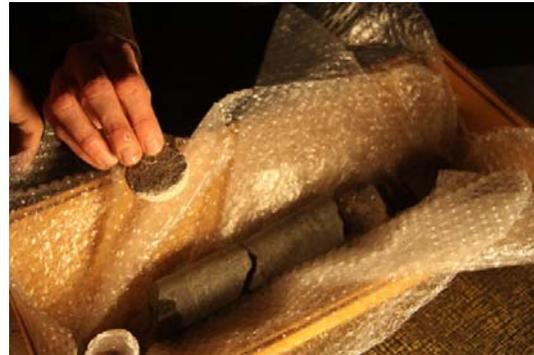
Several wooden beam-ends in the ceiling of first and second floor were opened to be able to do visual diagnosis on their exact position, their bearing in the exterior wall and on their condition (see figure ...). Furthermore, number, position and dimensions of chimneys that could be used for ventilation were identified.

Figure 9: Opening of wooden beam ends

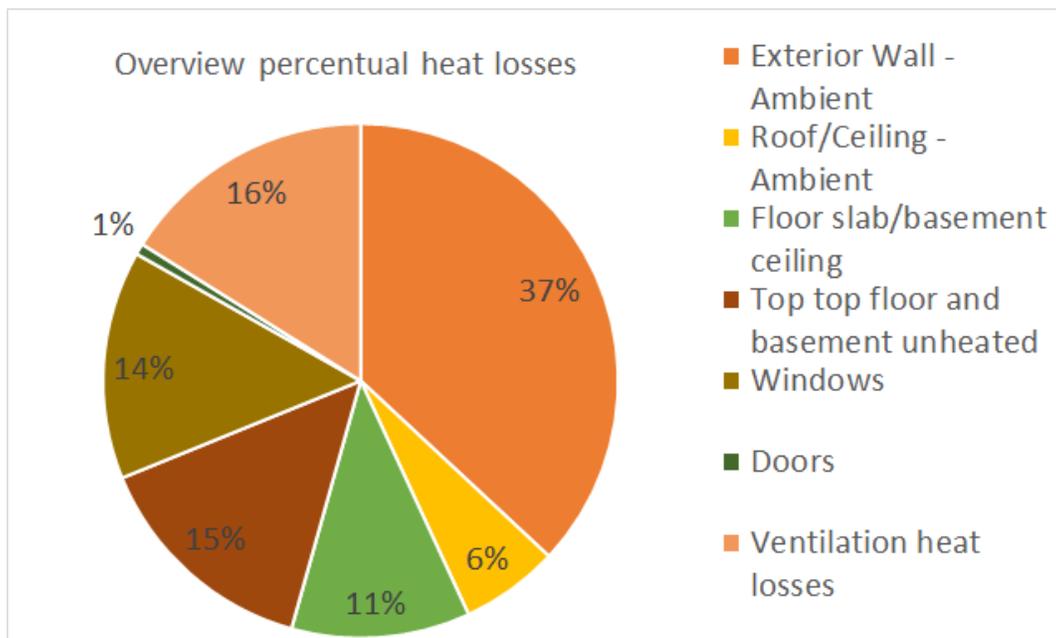
The heating energy demand for the building (as-is-state, including top floor), calculated with the software PHPP (Passive House Planning Package) is **225 kWh/m²h**. Looking at the energy balance of the building and respectively at the distribution of heat losses over the thermal envelope, we can see, that the low thermal resistance of the exterior walls causes with 38% most of the heat losses. Followed by the ventilation heat losses (19%) and the windows (16%). 22% of the transmission heat is lost over the isolated part of the roof, the walls and ceilings towards the unheated part of the roof and the ceiling of the walkway. The rest is caused by the baseplate towards the soil and the unheated cellar as well as the entrance doors (5%).

Figure 28: Energy balance of the building: distribution of heat losses over the thermal envelope

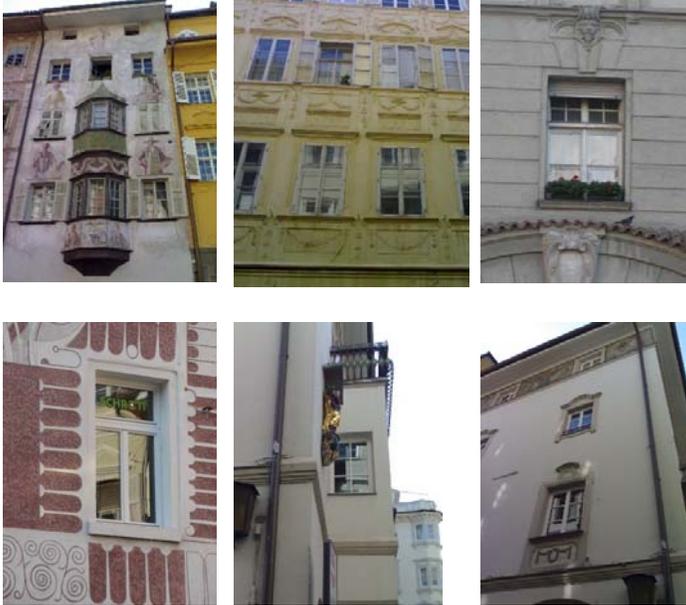
Figure 30-35: Originally, the wooden frames, impost and sash bars were very fragile and thin, possibly moulded (fig. 30-32), while the optic of the typical replacements is much broader (simple application of the IV68 standard, fig.33-35).

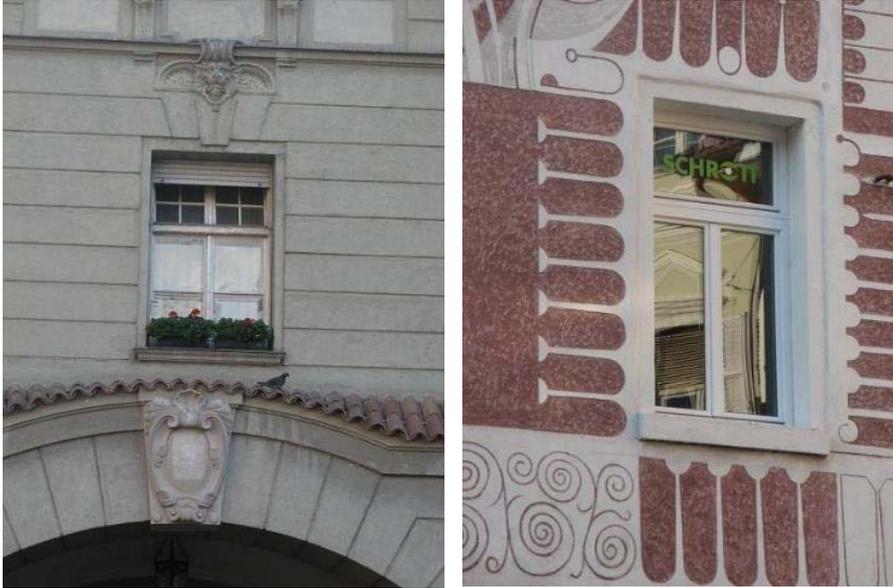
Mrs Kofler-Engl shows the different appearance of a historic window with original glazing (photo above, on the left: Municipality) and of a refurbished window with double glazing (photo above, on the right: building angle Bindergasse/Via dei Bottai – Lauben/Portici). The optic appearance seems to be quite different because of the different mirroring.

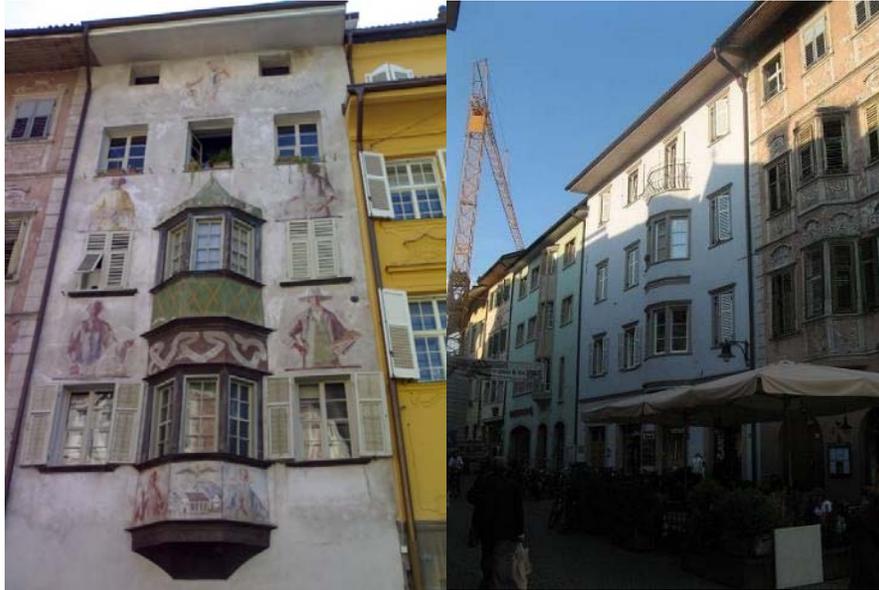
Above you can see another building example with original glazed windows (on the left: building Bindergasse/Via dei Bottai) and of a building with refurbished windows with double glazing (on the right: building Bindergasse/Via dei Bottai).

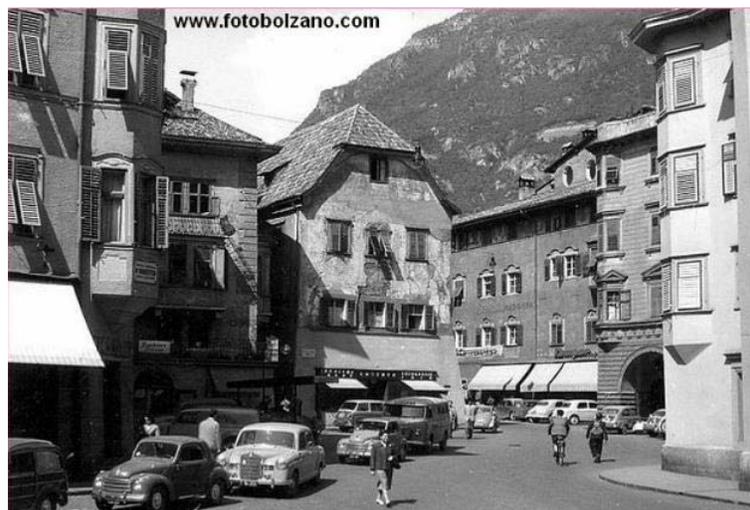
Figure 4.14: Photo from the Weigh House from 1958: On first floor, you can see the original baroque window with the horizontal impost
