INVESTIGATIONS ON FORMER STONE CONSERVATIONS AT THE KAPELLENTURM, ROTTWEIL

F. Grüner¹

ABSTRACT

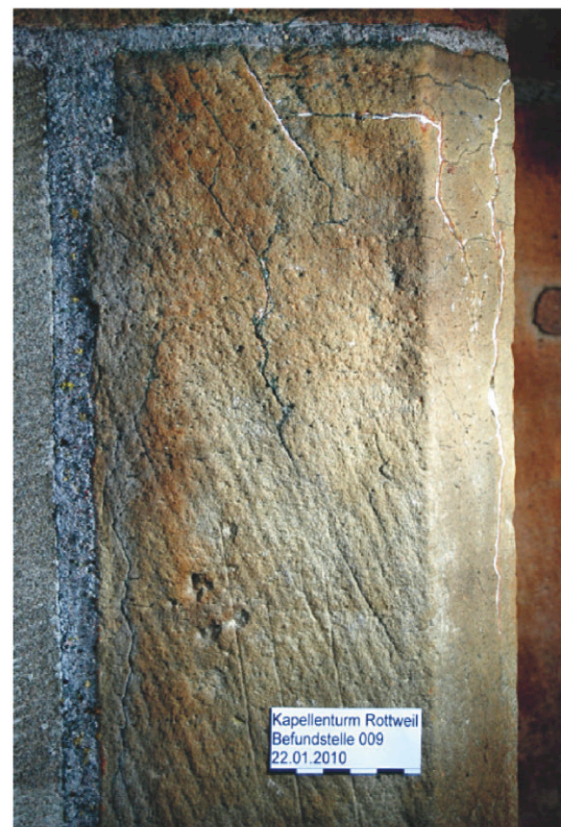
- Contour scaling and flaking
- Brownish and white discoloration of the greenish sandstone surface
- Development of cracks and partly fragmentation
- Staining due to hydrophobic treatment, especially on the Kordeler sandstone

Figure 2 Development of cracks (partly filled with cementitious materials) and discoloration at the stone surface, local green Schilf sandstone (photograph by Frank Eger).

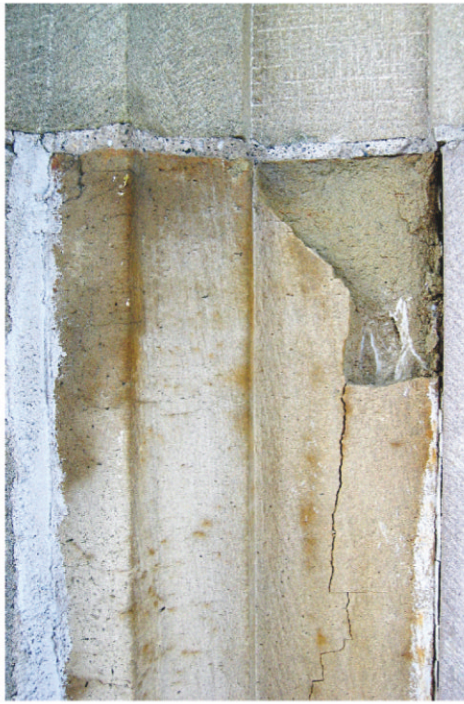
Figure 3 Contour scaling and development of cracks in the Schilf sandstone, white and brownish discoloration, note the original green color of the sandstone.

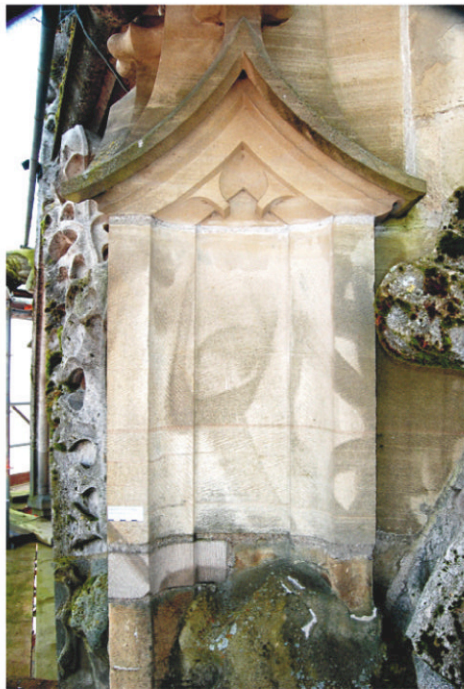
Figure 4 Staining due to hydrophobic treatment, Kordeler sandstone (photograph by Frank Eger).

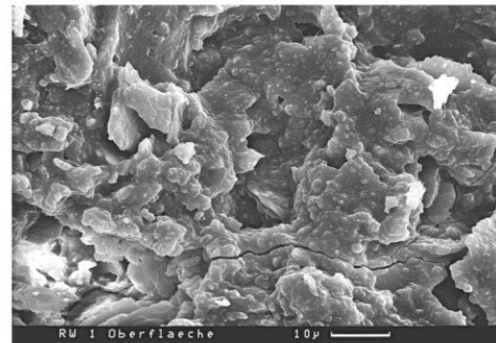
Microscopic investigations show at the surface and some millimeters in depth a coating of the rock forming minerals with Si-rich gels. Most of them do not show any cracks from shrinkage, like gels deposited from modern silicic acid esters do (see Figure 5). As a result the stone surface was condensed and small cracks due to the development of higher tension or stress occurred. Below this dense and hard crust the sandstone shows higher porosity and loss of adhesion of the clay-rich grain structure.

Figure 5 Surface of the Schilf sandstone of sample RW 1, coated with SiO₂ - gels, probably hardened from waterglass. Note the highly compacted surface and the development of cracks (not from shrinkage).

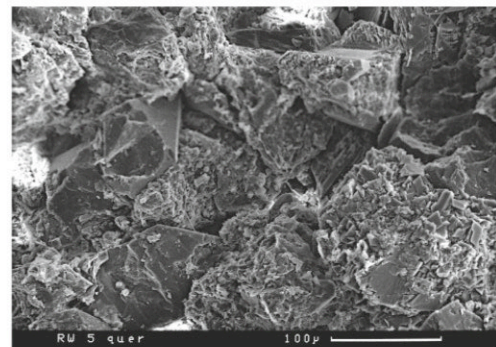
Etched and severely corroded feldspar minerals with small, cubic and octahedral fluorite are the result of the stone conservation treatment of the 1970s using fluates (see Figure 6, 7).

Figure 6 Etched and highly corroded feldspar minerals, influence from the application of fluoric acid for stone cleaning and strengthening.

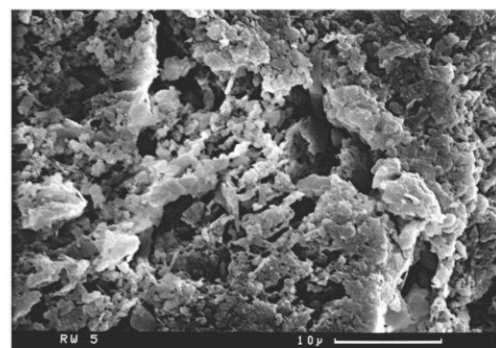
Figure 7 Etched structure of the clay-rich sandstone, increase of porosity due to silicate mineral solution processes.

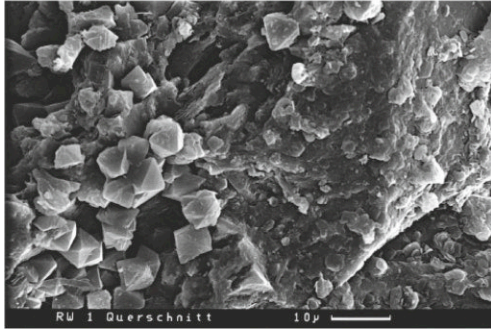
In carbonaceous natural stones the fluates or fluoric acid in aqueous solution are reacting with calcium carbonate to fluorite (CaF_2). The manufacturer of the “Hermetique” products promised a long – lasting reinforcement of any kind of carbonaceous and even siliceous sandstone. In fact, the mineral surface of the clay minerals and of the feldspars have been etched and the rarely formed fluorite rests on the surface in single crystals showing no reinforcement (Figure 8).

Figure 8 Small octahedral fluorite crystals growing on the clay mineral structure of the Schilf sandstone. Etched quartz grain on the right side.

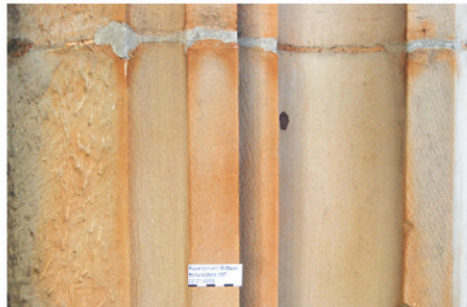
But a strong discoloration of the green sandstone to a grayish colored surface occurred. Additionally Fe^{2+} - ions from iron bearing clay and chlorite minerals were dissolved in the more acidic pore solution and caused a brownish discoloration due to the formation of iron oxides at the stone surface (see Figure 9). Together with the siliceous gels precipitated from waterglass, which was applied in different concentrated solutions a dense and discolored crust with a medium thickness of 1 – 2 cm was formed.

Figure 9 Brown and grayish discoloration of the stone surface, Schilf sandstone.

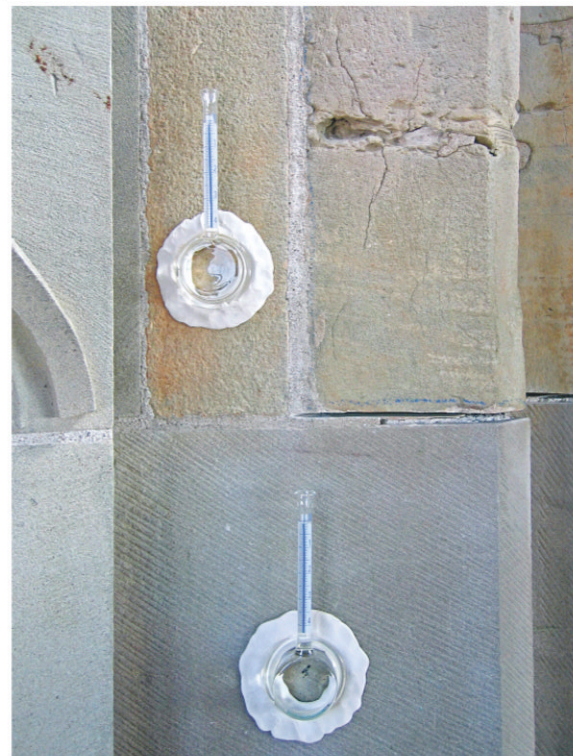
The preliminary assessment by determination of the water absorption coefficient showed an obvious hydrophobic behavior of the stone surface. The non-destructive measurements were done onsite with a graduated glass tube (Karsten tube) as a function of time. For calculation of the absorption coefficient with an Excel spreadsheet Calkarow 3.2 based on the algorithm of Wendler [5] was used (Figure 10).

Figure 10: Determination of capillary water absorption by Karsten tube measurements. Upper part: Schilf sandstone, lower part Kordeler sandstone.

Onsite the depth of the hydrophobing zone was tested by wettability. In average a hydrophobic zone of about 2 mm in depth was detected. The remaining quality of the hydrophobizing (finally applied in 1986, Wacker 290S) was different, dependent on the type of sandstone. The Kordeler sandstone, used for substitution in the 1960s showed still good results. Its water absorption coefficient was in average $0.3 \text{ kg/m}^2\text{h}^{-0.5}$. But the different Schilf sandstones from various restoration phases showed higher values of about $0.5 \text{ kg/m}^2\text{h}^{-0.5}$ on average. The evaluation of the effectivity of the hydrophobizing was carried out according to the assessment of the WTA [7]. In agreement with the WTA scale of 1-5 a retreatment of façades impacted with wind-driven rain is necessary by reaching a critical average value of $w = 0.5 \text{ kg/m}^2\text{h}^{-0.5}$. A highly effective hydrophobizing should have

a w – value $< 0.1 \text{ kg/m}^2\text{h}^{0.5}$ [8]. Clay-rich sandstones like Schilf sandstone are critical respective to the effectiveness, because quartz-rich sandstones show a high amount of free silanol groups at its quartz surfaces. In contrast clay minerals exhibit silanol groups only at their rims, which can react with siloxanes. The polysiloxan films therefore only stretch like canvas from clay particle to clay particle [9].
