# Engineering School Bejar

## Case Study 7 Engineering School of Béjar Salamanca - Spain

Béjar (Salamanca), 30/10/2012

3ENCULT CS7. Engineering School of Béjar

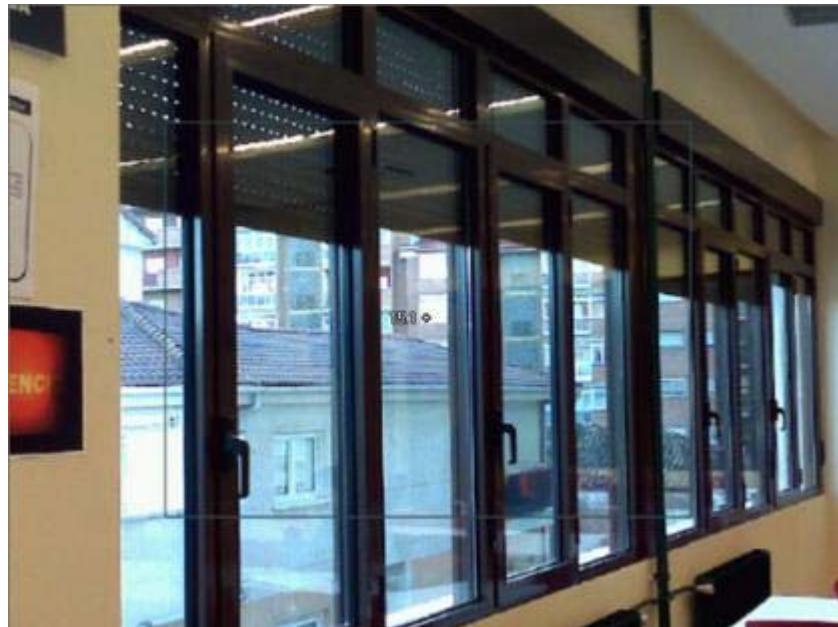
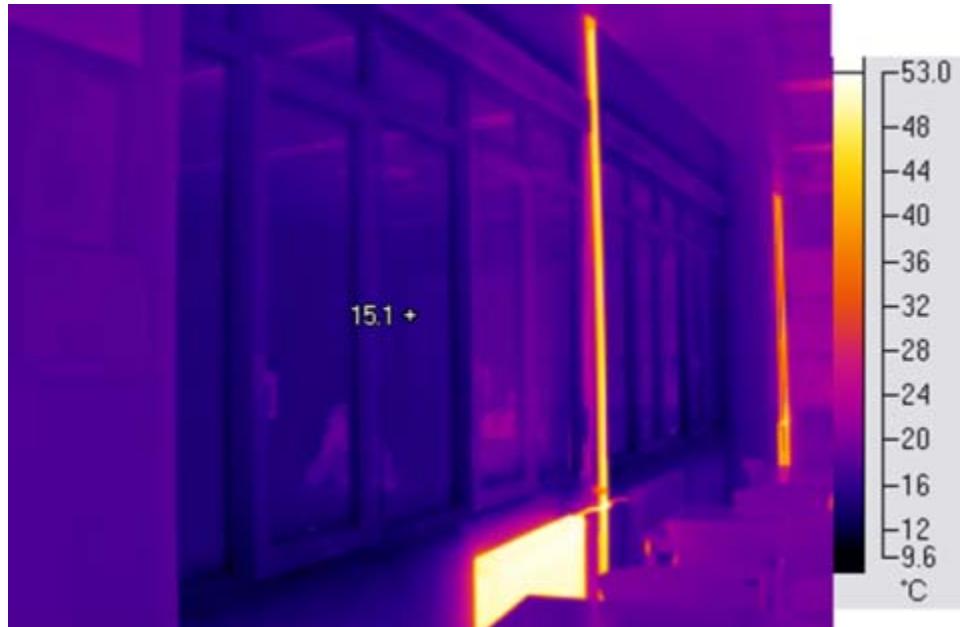
## 1. Infrared thermography

First IR report approach

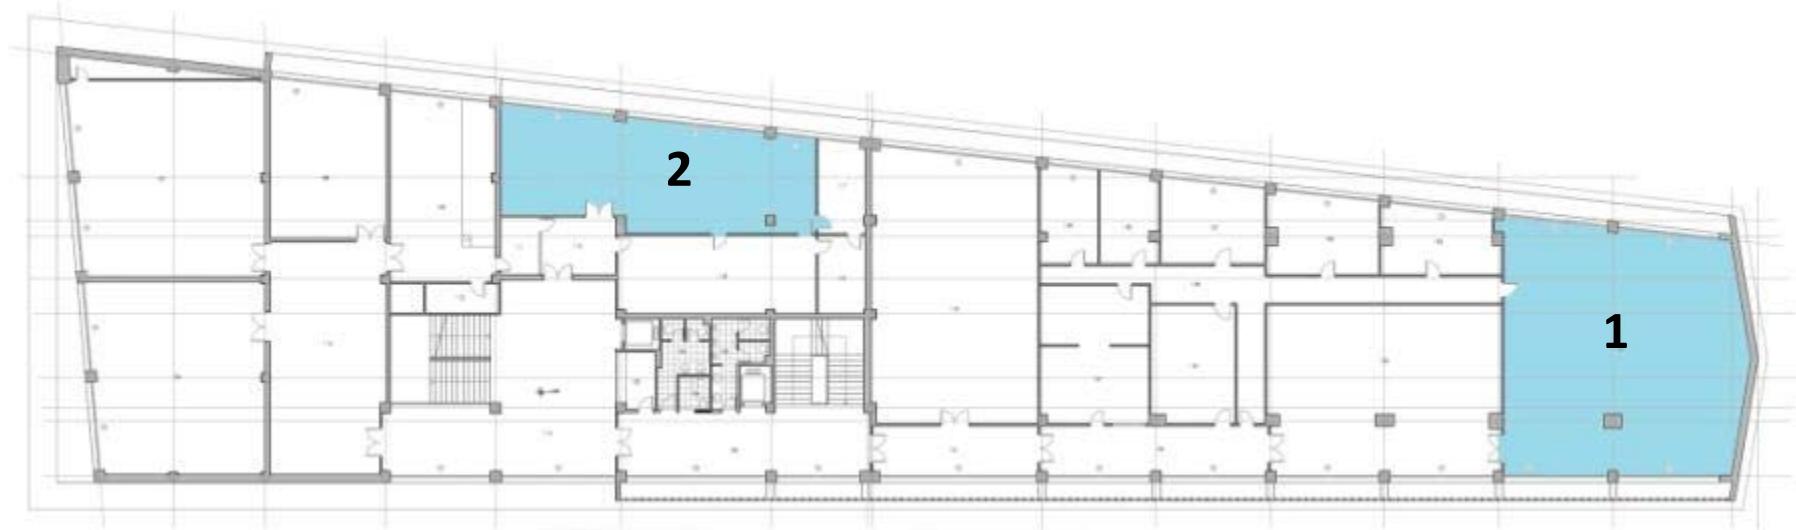
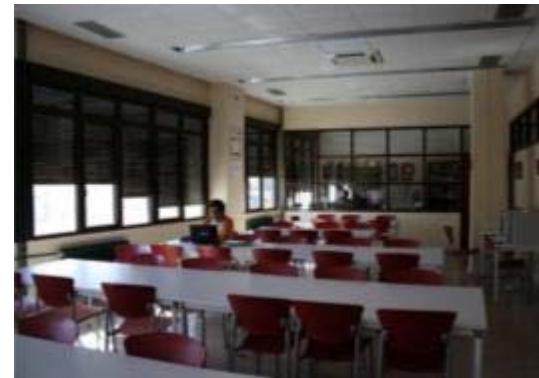
1. Physics laboratory
2. Library

- Physics Laboratory
  - Outdoor temperature = 3°C
  - Indoor temperature = 19,1°C
  - Indoor RH = 34,2%
- Library
  - Outdoor temperature = 5°C
  - Indoor temperature = 20,3°C
  - Indoor RH = 38,4%

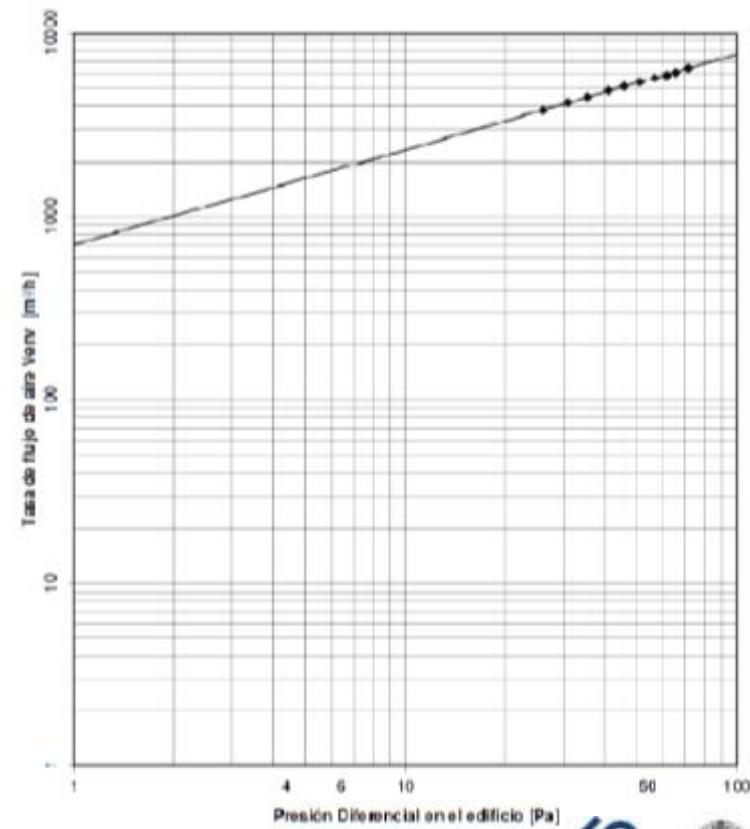
Air flow rate (m<sup>3</sup>/h) resulting from the Blower Door Test

- $V_{50}$  Average flow at 50 Pa (m³/h) = 5191 m³/h
- $n_{50}$  Airchange rate at 50 Pa (1/h) = 9,2 h⁻¹
- $w_{50}$  Air flow at 50 Pa / usable floor area = 30,2 m³/m²·h
- $q_{50}$  Air flow at 50 Pa / envelopment area = 10,0 m³/m²·h
- Annual average airchange rate = 9,2/20 = 0,46 h⁻¹

- $V_{50}$  Average flow at 50 Pa (m³/h) = 4778 m³/h
- $n_{50}$  Airchange rate at 50 Pa (1/h) = 8,4 h⁻¹
- $w_{50}$  Air flow at 50 Pa / usable floor area = 27,8 m³/m²·h
- $q_{50}$  Air flow at 50 Pa / envelopment area = 9,2 m³/m²·h
- Annual average airchange rate = 8,4/20 = 0,42 h⁻¹

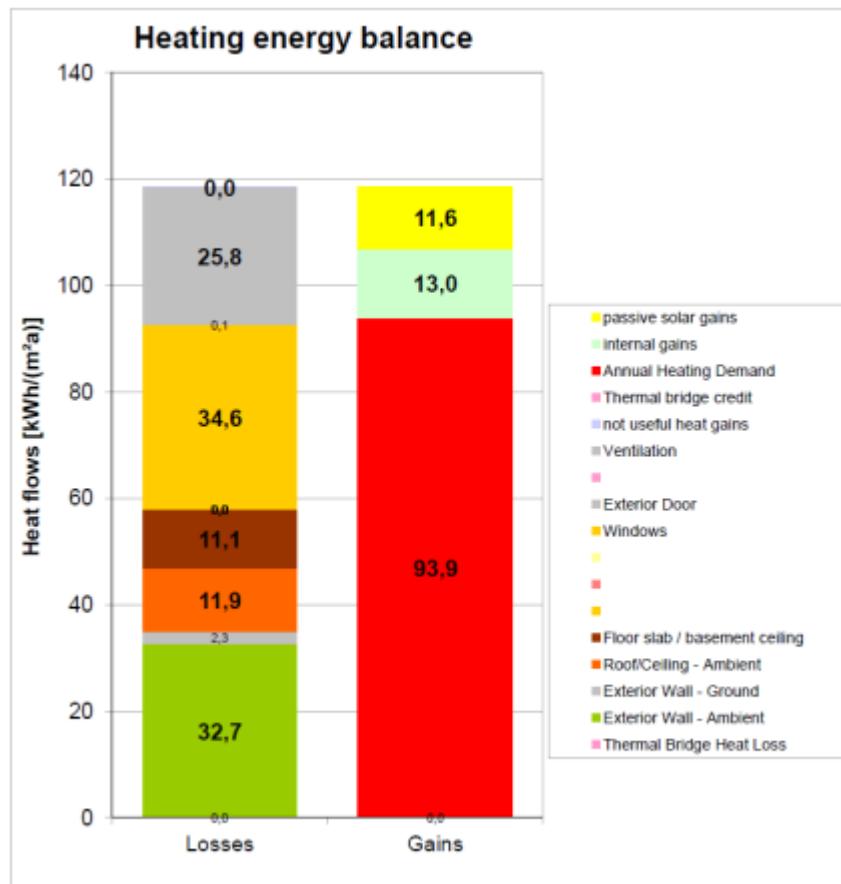
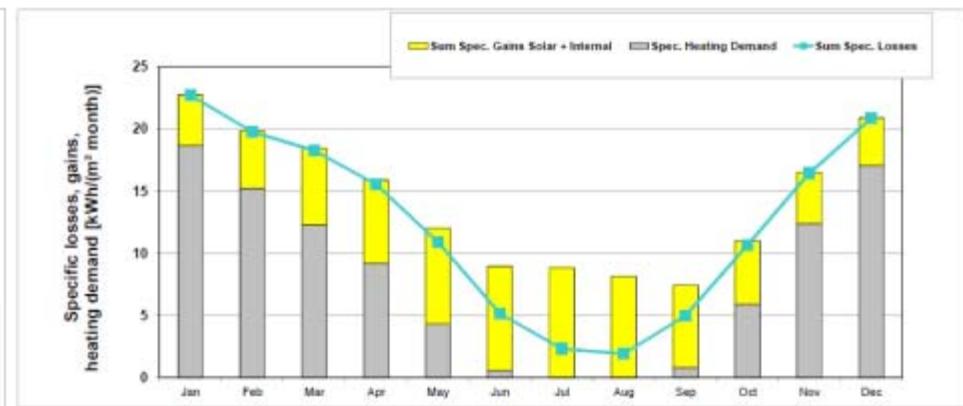
## 4. Building energy performance simulation (PHPP)

Treated floor area 10525,5 m <sup>2</sup>	Requirements	Fulfilled?*
Space heating	Annual heating demand 97 kWh/(m <sup>2</sup> ·a)	15 kWh/(m <sup>2</sup> ·a)	no
	Heating load 39 W/m <sup>2</sup>	10 W/m <sup>2</sup>	no
Space cooling	Overall specific space cooling demand kWh/(m <sup>2</sup> ·a)	-	-
	Cooling load W/m <sup>2</sup>	-	-
Primary Energy	Frequency of overheating (> 25 °C) DHW, space heating and auxiliary electricity Specific primary energy reduction through solar electricity	12.0 %	-
	kWh/(m <sup>2</sup> ·a)	120 kWh/(m <sup>2</sup> ·a)	-
Airtightness	DHW, space heating and auxiliary electricity Pressurization test result n <sub>50</sub>	kWh/(m <sup>2</sup> ·a)	-
	3,0 1/h	kWh/(m <sup>2</sup> ·a)	-
	3,0 1/h	0.6 1/h	no

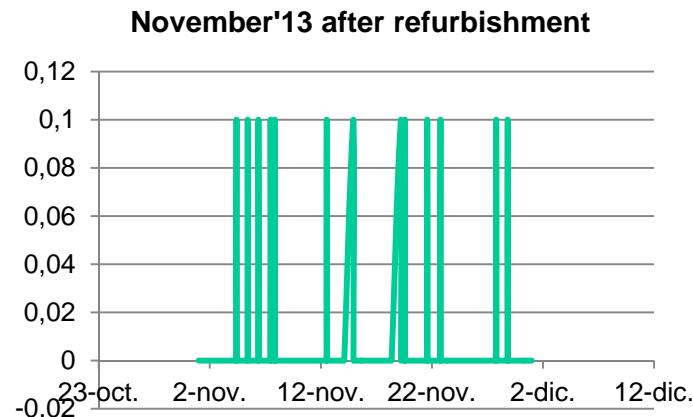
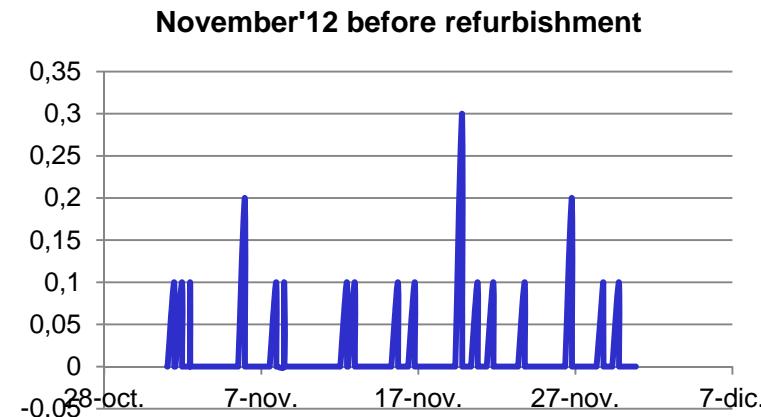
## 2. Energy efficient solutions: Physics laboratory – Results

- **Total consumption reduced**
  - **2.2 kW in November 2012**
  - **1.3 kW in November 2013**
  - **Lighting comfort level**
- **Results could be extrapolated to other rooms**

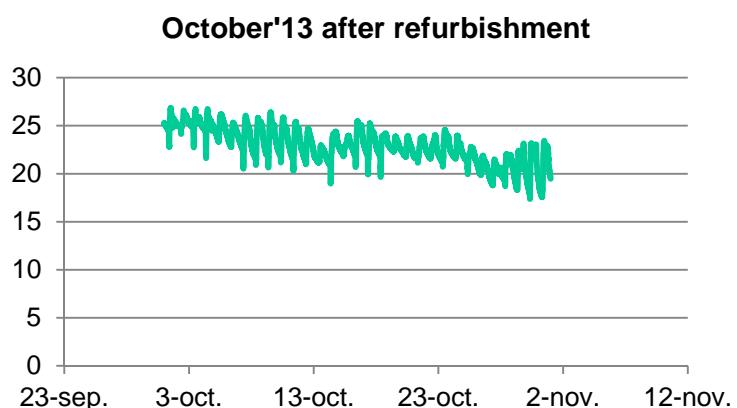
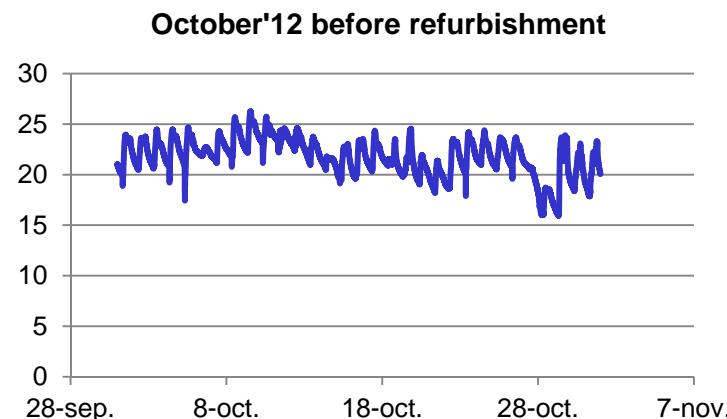
## 2. Energy efficient solutions: Library – Results

- **Average temperature**
  - 21.91°C in October 2012 with a standard deviation 1.86
  - 22.89°C in October 2013 with a standard deviation 1.79
  - Dependency of min and max set-points
- **Comfort level achieved – Reduction of claims**
- **Not significant increment of consumption**
  - In fact, it is sometimes reduced because of automatic control
