D 6.2 Documentation of each study case CS3 Palazzina della Viola, Bologna (Italy) Delivered at M42

Project Acronym	3ENCULT
Project Title	Efficient ENergy for EU Cultural Heritage
Project Coordinator	Alexandra Troi EURAC research, Viale Druso 1, 39100 Bolzano/Italy Alexandra.troi@eurac.edu
Project Duration	1 October 2010 – 31 March 2014 (42 Months)
Deliverable No.	D6.2
Dissemination Level	PU

Local case study team	LCS-Team of CS3 - Palazzina della Viola: UNIBO (scientific guidance), UNIBO (building owner), Soprintendenza per i Beni Architettonici di Bologna & Soprintendenza per i Beni Artistici di Bologna, Architect(s) in charge of the conservation intervention
Name and company of surveyor	Camilla Colla, Elena Gabrielli, Marco Giuliani (UNIBO- DICAM); Giacomo Paci (UNIBO – DEI)
Comments	*At the moment (2013) the building is used as headquarters of the International Relationships Department of the University of Bologna

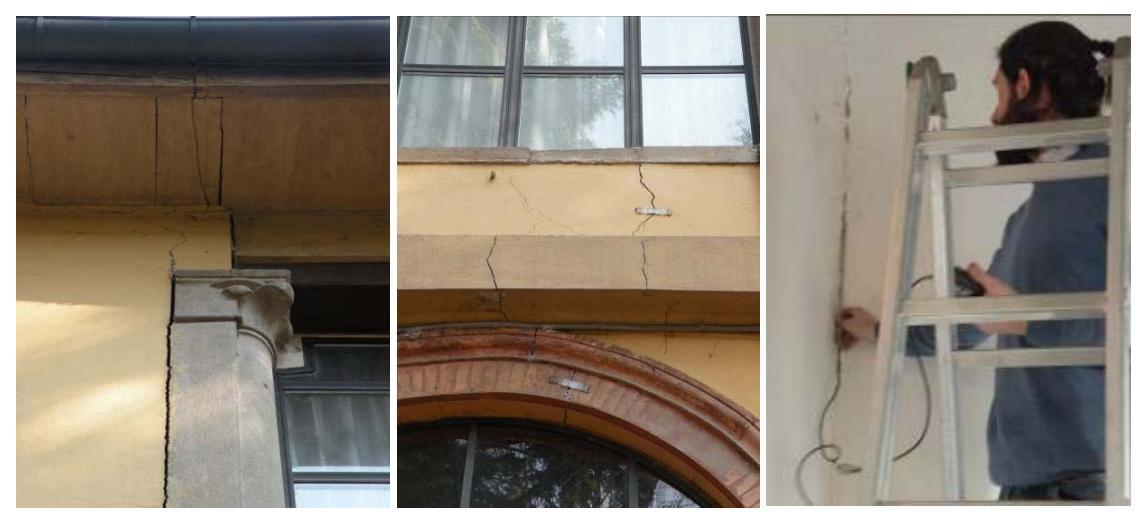
The building presents some structural problems as cracks in walls, ceilings and floor at different levels, especially in the South-West side (Fig. 1.24). In this case the survey and drawing of the crack pattern is very important and it has been conducted in order to better understand the state of damage of the structure and its vulnerable points. An example of a sketch of the crack pattern recorded on-site is given in

Fig. 1.24 – Cracks on the exterior walls in the SW side (left and centre); measurement of the air-flow through cracks from the interior with an anemometer (right)

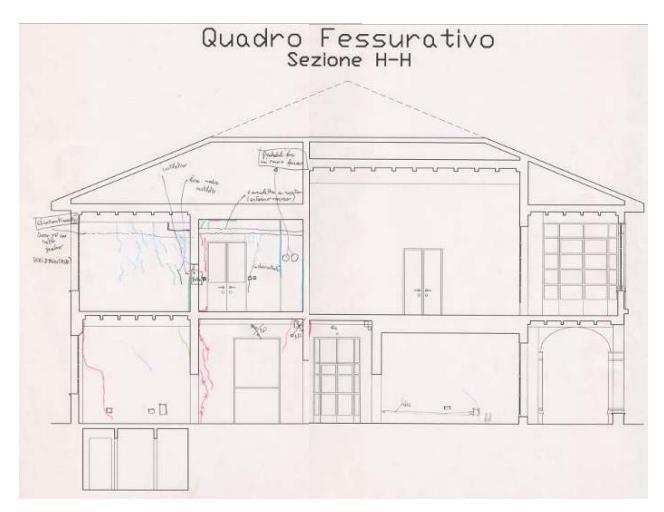
Fig. 1.25 - Crack pattern survey on a vertical section

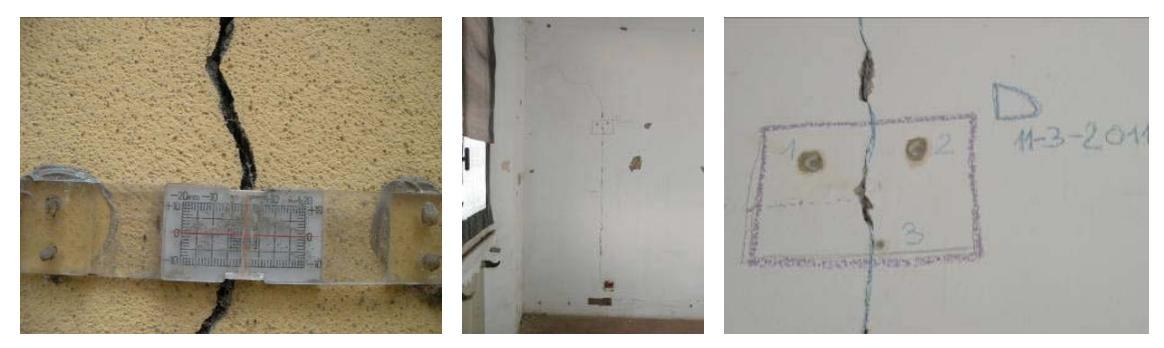
Moreover, some of the opening and movements of cracks are being monitored by using different systems as shown in Fig. 1.26.

Fig. 1.26 - Monitoring of cracks

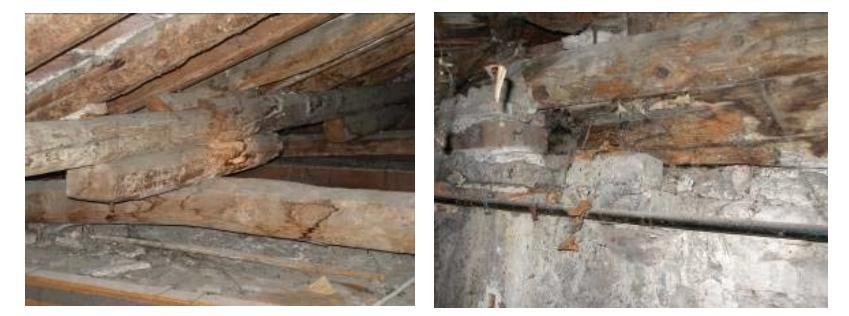
Other structural problems are related to the wooden roof structures, made of ancient, original and new timber elements; the main problems are due to the water leakages as visible in Fig. 1.27.

Fig. 1.27 – Water leakages on the wooden beams of the roof.

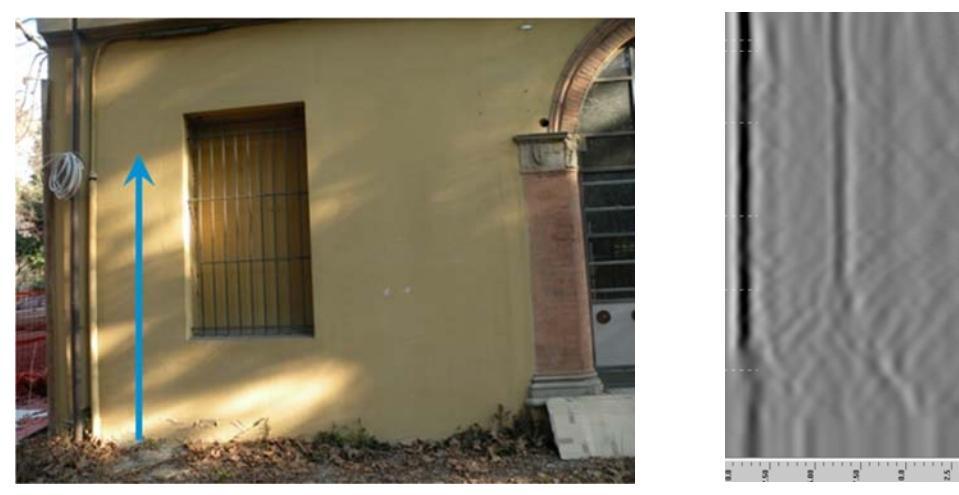
Fig. 1.28 – GPR radar for moisture detection: vertical survey line on a masonry wall (left) and the collected radargram (right)

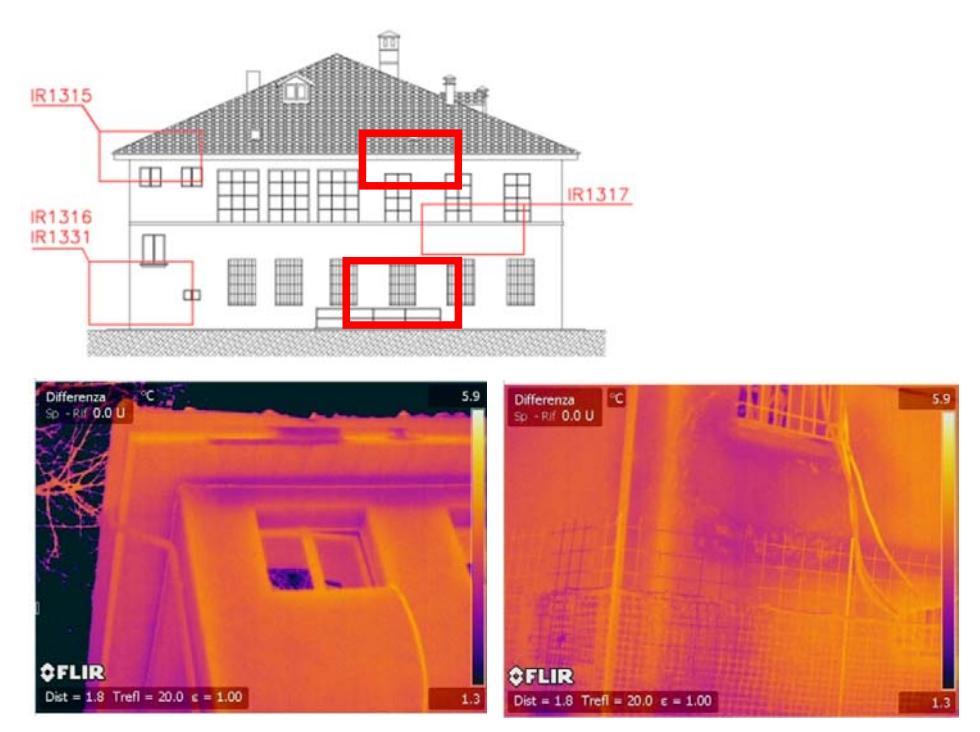
Fig. 1.29 – IR-thermography for moisture detection, exterior wall, rear side of the building

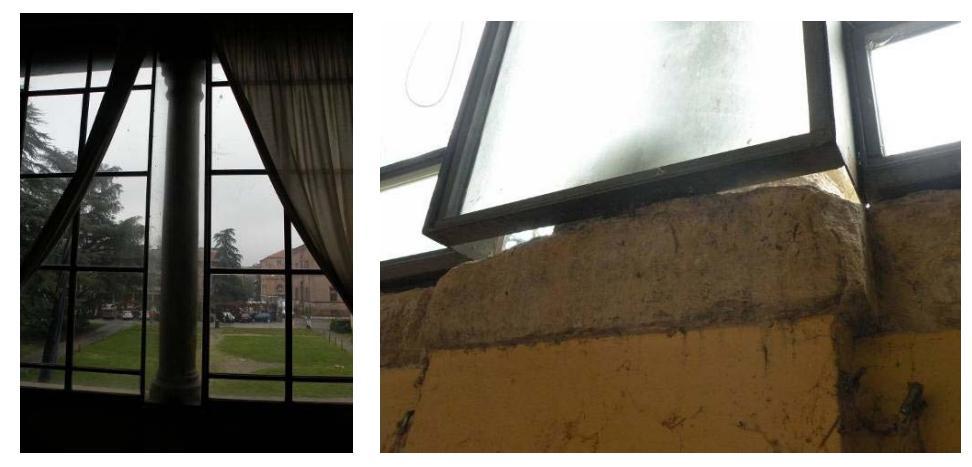
Fig. 1.31 – Window frame around a masonry column (left) and detail of the opening (right), 1st floor, front side of the building.

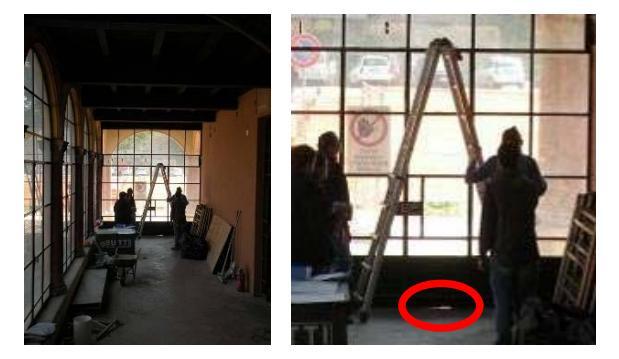
Fig. 1.32 – Main entrance door in low airtight conditions, as visible from the passing light at the bottom

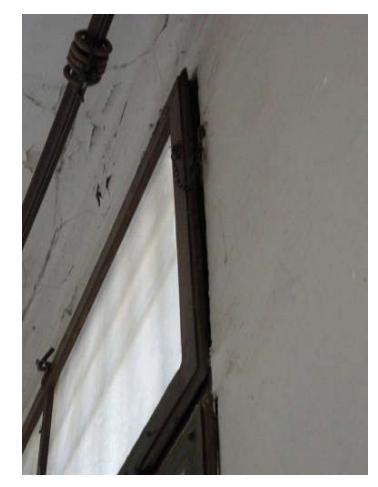
Fig. 1.33 – Detail of a window of the ground floor with a "bad closing"

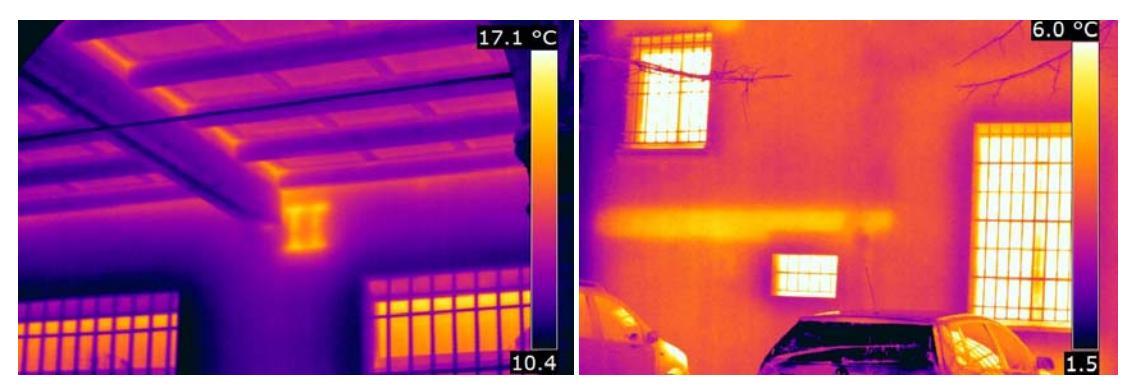
Figure 1.44 - Post-refurbishment NDT of thermal bridges by IR thermography: steel beam-ends (left); concrete stairs landing (right)
