**D 6.2 Documentation of each study case
CS2 Palazzo d'Accursio/Municipal Palace,
Bologna (Italy)
Delivered at M42**

**[Compatible solutions for improving the energy efficiency
of historic buildings in urban areas]**

Project Acronym	3ENCULT
Project Title	Efficient ENergy for EU Cultural Heritage
Project Coordinator	Alexandra Troi EURAC research, Viale Druso 1, 39100 Bolzano/Italy Alexandra.troi@eurac.edu
Project Duration	1 October 2010 – 31 March 2014 (42 Months)

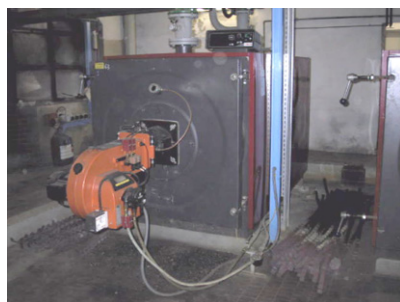
Generator located in the Palace power station
and indicative perimeter of area warmed

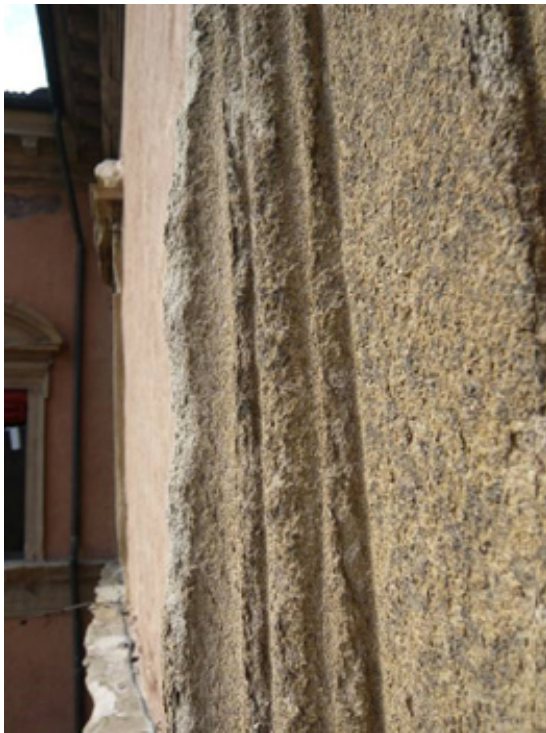
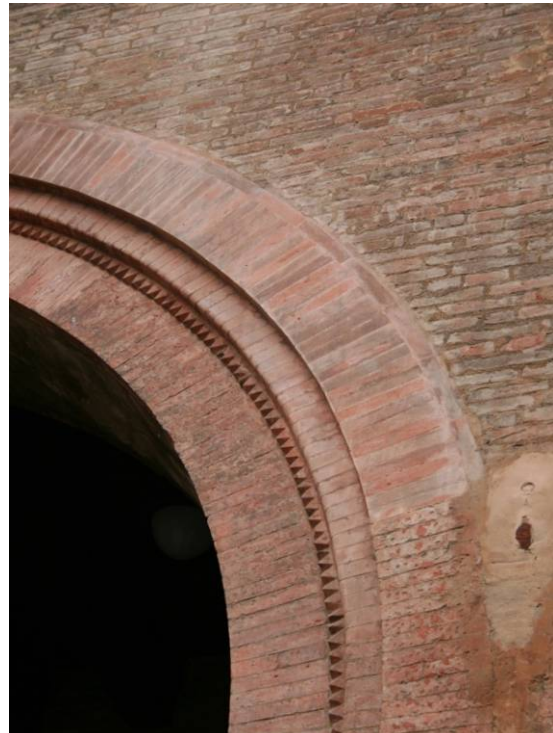
The materials used for building the palace are typical of the area: brick for the bearing structures, with two or three heads; sandstone for the decorative pieces; and with some exception marble to embellish the architecture (present only in the lancet windows of the facade on the Maggiore Square).

The attics of the first and second floor of the Palace that overlooks the East side are mostly made of brick arches, with screeds of lime, sand and fill to the sides made of brick debris or stones. The ceilings on the second floor are made of thin plaster arches or sometimes of a wooden structure on which lays a wooden plank about 3 cm thick.

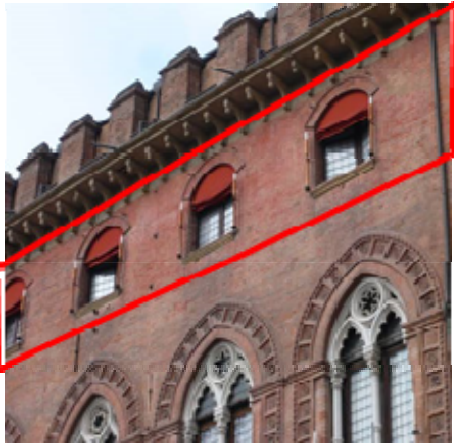
Façade 2: wall M-M-F2-2

Description		Masonry wall, built in the phase around 1580, exposed to South-East.				
		LAYER	CONDUCTIVITY [W/mK]	RESISTANCE [m²K/W]	SPECIFIC HEAT [J/kgK]	DENSITY [kg/m³]
		1 Internal lime plaster	0.800	0.025	1000	1600
		2 Solid brick wall facing	0.810	0.864	840	1800
		3 External plaster	-	-	-	-
		Total thickness	72 cm			
		Transmittance calculated	0.921 W/m²K			
		Transmittance measured on site	0.771 W/m²K			
Type of facade		Not plastered masonry facade.				
Balcony		None				
Eaves		Present				
Conservation state of the façade: humidity or other visible stain/deterioration on walls		There are signs of rising damp in some parts of the building.				
Openings/holes usable for wiring or		From the investigations done in the Museum study

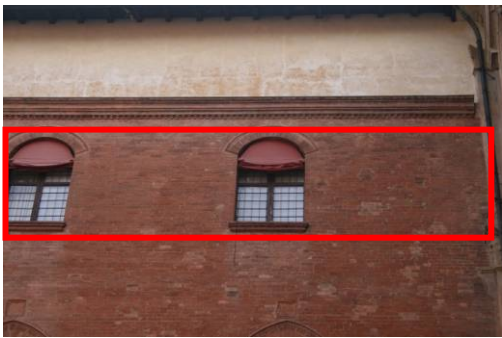
Façade 3: wall M-M-F2-3

<p>Masonry wall, built in the phase around 1560, exposed to North-East.</p>				
Description	LAYER	CONDUCTIVITY [W/mK]	RESISTANCE [m ² K/W]	SPECIFIC HEAT [J/kgK]	DENSITY [kg/m ³]
	1 Internal lime plaster	0.800	0.025	1000	1600
	2 Solid brick wall facing	0.810	0.568	840	1800
	3 External plaster	-	-	-	-
	Total thickness	50 cm			
	Transmittance calculated	1.228 W/m ² K			
	Transmittance	0.869 W/m ² K

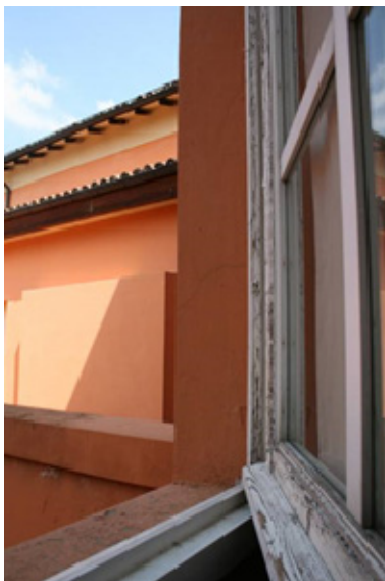
Façade 4: wall M-M-F2-5

Description		Wall built in the phase around 1580, exposed to North-West.				
		LAYER	CONDUCTIVITY [W/mK]	RESISTANCE [m²K/w]	SPECIFIC HEAT [J/kgK]	DENSITY [kg/m³]
		1 Internal lime plaster	0.800	0.025	1000	1600
		2 Solid brick wall facing	0.810	0.481	840	1800
		3 External plaster	1.000	0.020	1000	1800
		Total thickness	43 cm			
		Transmittance calculated	1.378 W/m²K			
		Transmittance measured on site	1.348 W/m²K			
Type of facade		Plastered façade built in masonry.				
Balcony		None				
Eaves		Present				
Conservation state of the façade:		There are signs of rising damp in some parts of the

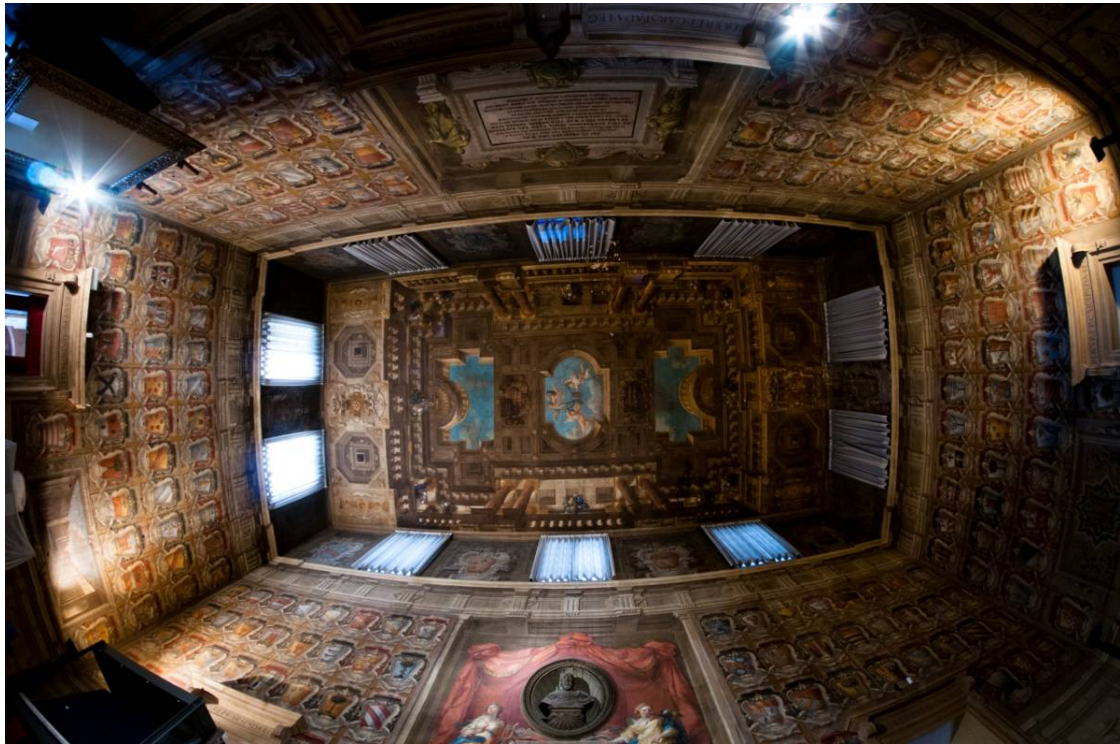
View from below of Sala Urbana's frescoed ceiling

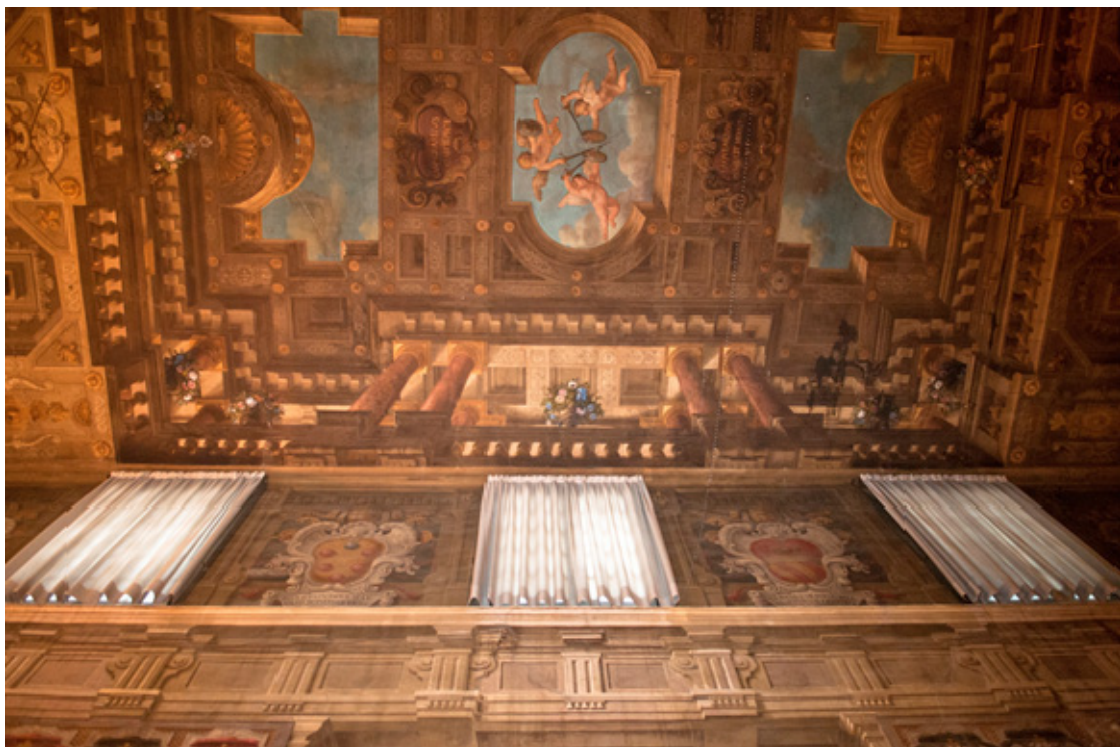
View from below of Sala Urbana's frescoed ceiling and perimeter longitudinal wall.

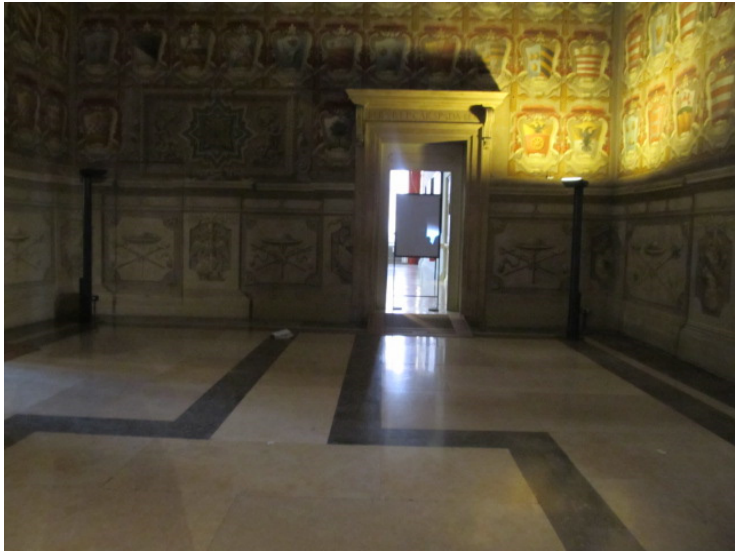
Description	Realized in polychrome marbles by craftsmen expert in the cut and treatment of marble stone.
Technical equipment	
Label	The existing installation consists of alone standing removable luminaires.
Lighting devices/luminaires

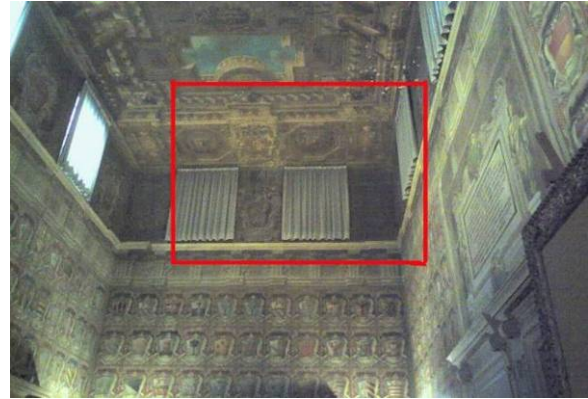
Date & Time: 18/03/2011 12:55:33

Comment: West wall of Sala Urbana is only partially exposed to the external cold air, which is clearly visible in the two areas Ar1 and Ar2. The room ceiling is supported by a wood structure, clearly visible in the thermogram, with large beams crossing the room transversally. Also, two warmer zones are observed that could correspond to a layer of insulation (Ar3 and Ar4), for example a second layer of wood beams. A cold area is indicated by the white arrow and could be due water leaks.

Description	<p>West wall of Sala Urbana is only partially exposed to the external cold air, which is clearly visible in the two areas Ar1 and Ar2. The room ceiling is supported by a wood structure, clearly visible in the thermogram, with large beams crossing the room transversally. Also, two warmer zones are observed that could correspond to a layer of insulation (Ar3 and Ar4), for example a second layer of wood beams. A cold area is indicated by the white arrow and could be due water leaks.</p>

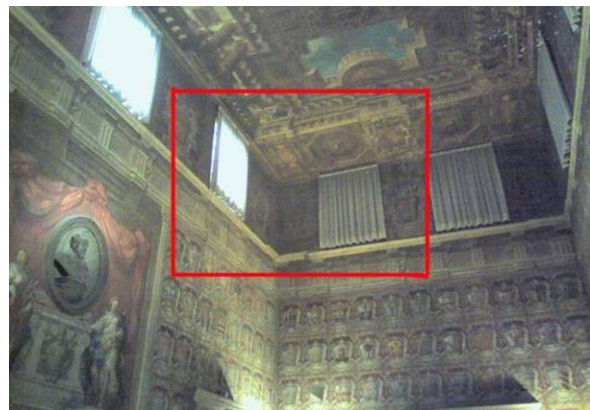
Comment: the white arrow aims at a damp area or otherwise a lack of insulation. The black arrow aims at South wall and identifies a cold area probably due to water leaks, although a similar trace is visible also at the opposite side of the same wall.

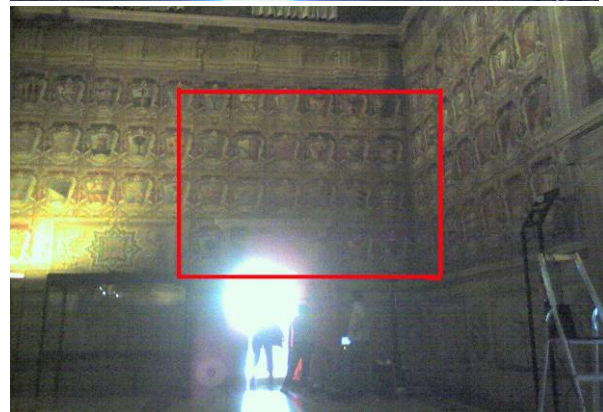
Comment: areas Ar1 are slightly warmer than the rest of the wall and this identifies a large detached portion of the plaster. Also area Ar2 is interesting to observe because it does not show the small colder irregularities of the lower part of the wall; possible explanations are: 1. a different plaster 2. the influence of the different superficial decoration 3 a diffused detachment. We must also consider that Ar2 coincides with a portion of the wall facing into the attic of the building, so that thermal transmission characteristics are completely different from the lower part of the wall.

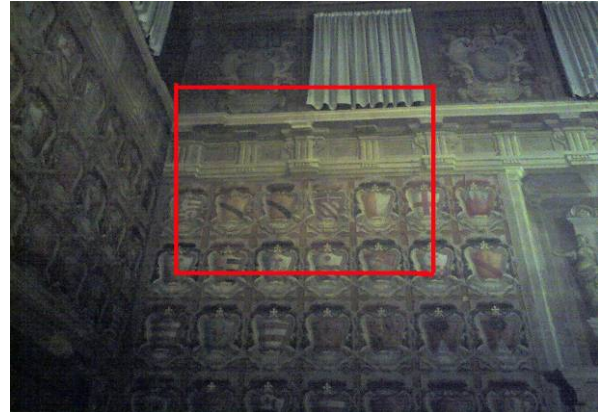
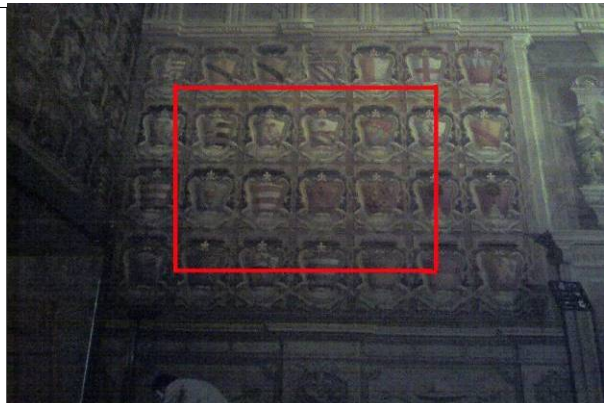
Test 15.

Comment: wall is characterized by diffused small colder areas, that could be ascribed to slight differences in plaster or decoration composition. More interesting is the presence of a closed aperture (area Ar1 and upper green arrow) positioned between the window and the commemorative plate; however, note how the temperature gradient is limited to some tenths of a degree. Also the plate shows a relatively higher temperature in its upper part, and this could be due to a local detachment, but it looks more like a reflection from room lamps.

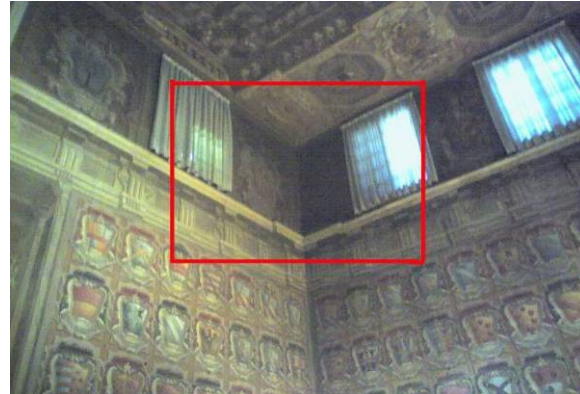
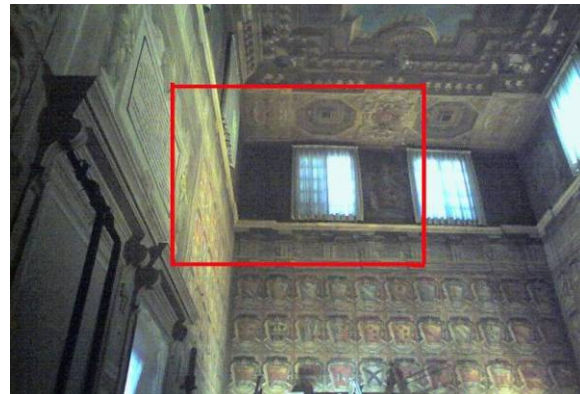
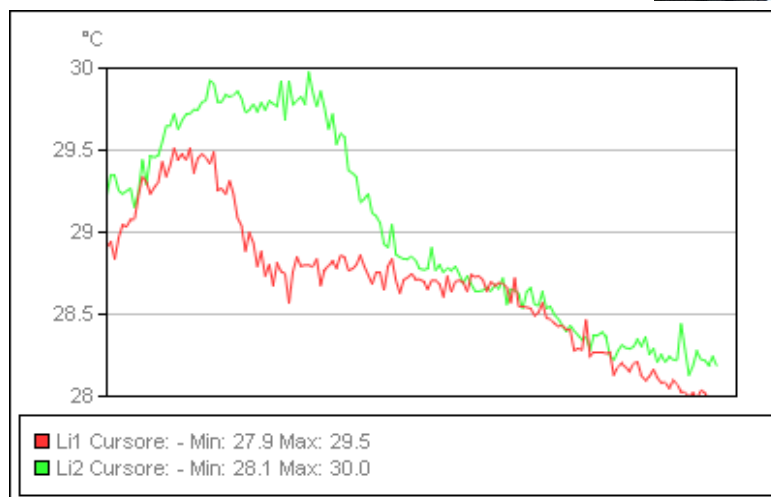
Test 18.

Comment: the evident warmer areas do not seem to be due to diffused detachments, their shape is too regular; and there seems to be no external structures that could explain such anomalies (e.g. air conditioning heat exchangers). Direct inspection and local demolition of external plaster would be required to understand such anomalies.

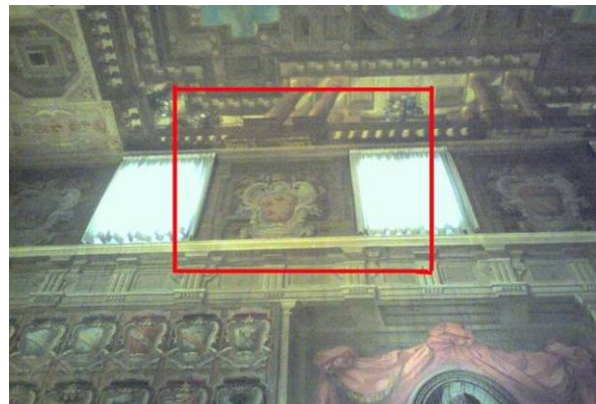
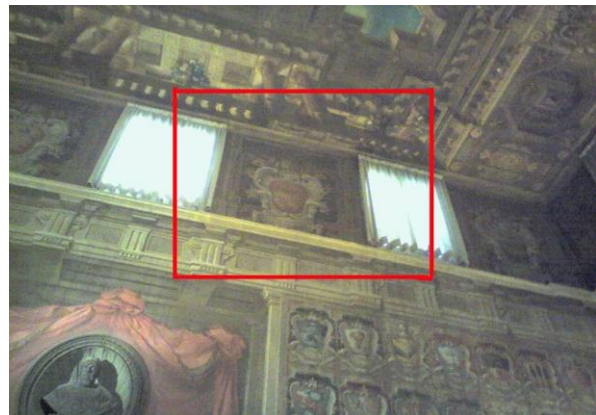
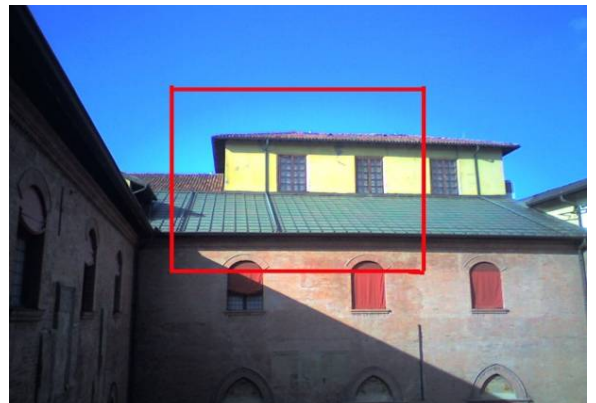
Test 21.

Comment: Test 21 has been repeated during a warmer day, and the most interesting feature is the high temperature area indicated by the green arrow; during Test 27 the same zone appeared colder, so this could identify a thermal bridge between the outside and the room (green arrow in Test 21). The same area has also been inspected by IRT from the outside and it is still warmer (green arrow in the test done at 17:14) than the surrounding areas, leading to the conclusion that probably identify a cavity; a high thermal resistance component, e.g. wood beam would not appear colder during the March measurement, while a concrete one would show a reversed thermal behavior.

Comment: also the left (Test 20) and right (Test 21) parts of the wall present warmer areas, that are colder during the March measurements (cold air outside). Again, this can be explained as seen with Test 21, but a closer inspection would be needed; also observe the presence of a crack put in evidence by the line Li1. The hottest spots could be due to metal parts inserted in the masonry. The right upper part of the wall seen from outside shows a hot area.

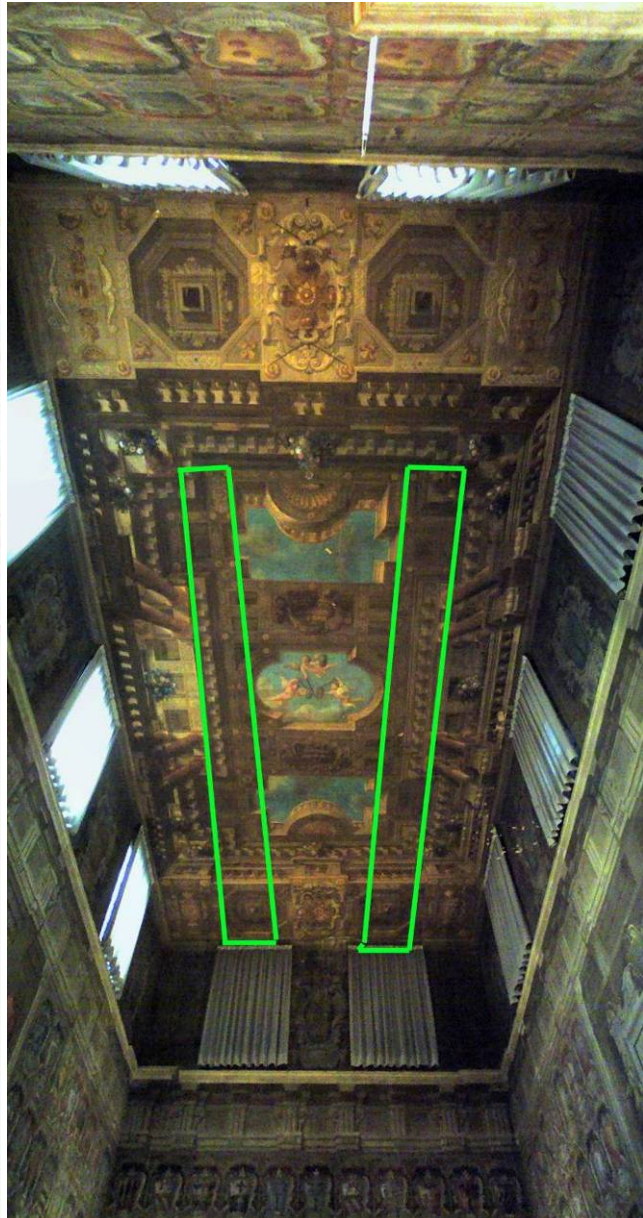
In the thermograms the structure of the roof is clearly visible, with thick transversal logs joined by thinner ones. An interesting feature of the roof is represented by two large warmer areas (green shapes in the following Tests); they seem to identify stripes of insulation material, or a second roof on top of the visible one. When the same shapes are superimposed on a photo of the roof, there appear no relationship with painted decoration, so the influence of different pigments is to be excluded (tests of 18/03/2011).

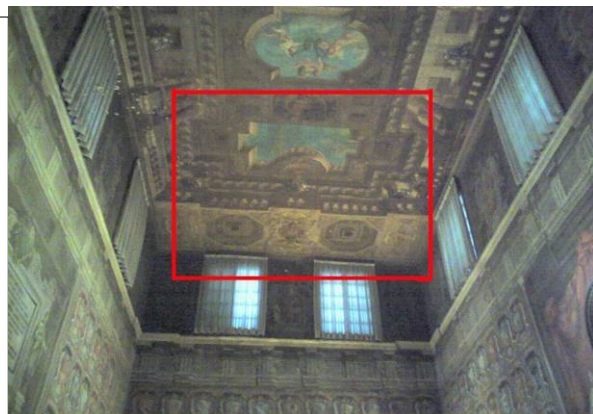
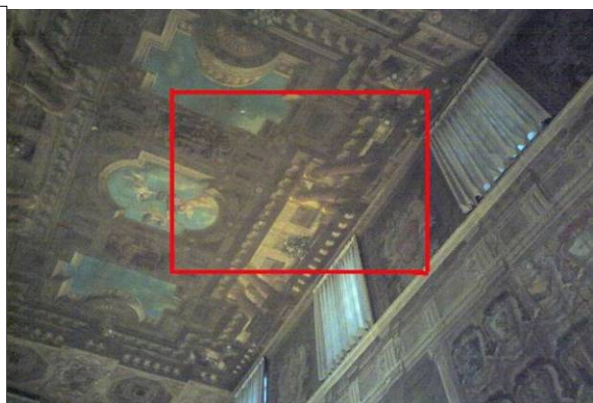
Date & Time: 2011-05-27

Comment: in the Sala Urbana room, on May 27 a series of hot spots have been recorded, whose origin is unknown. They are not objects laying on the protection net, could be the result of sun rays passing through some small apertures in the roof, but no certain explanation has been found. In the case of the first thermogram, their positions have been superimposed on the digital photo of the ceiling.

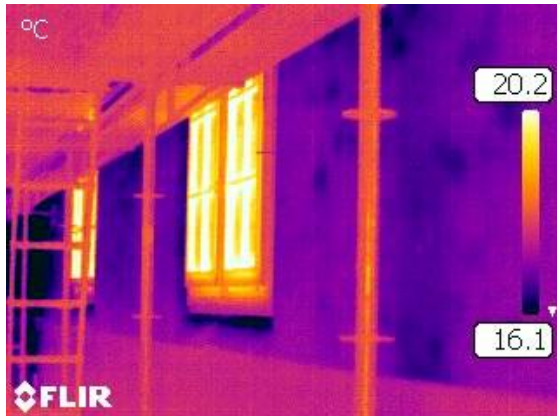
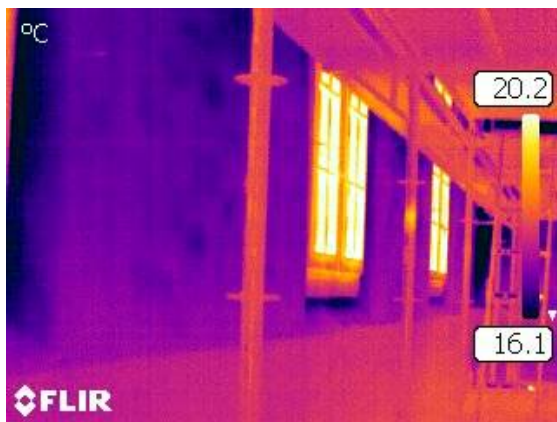
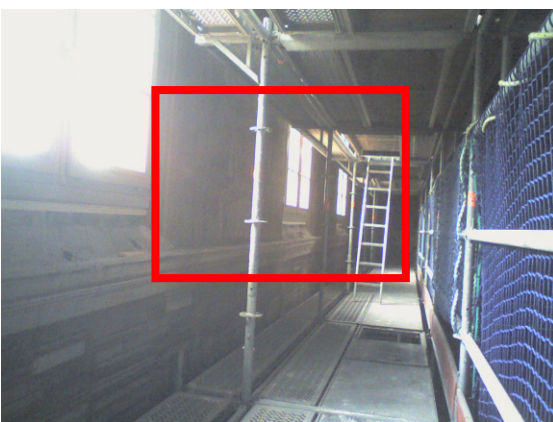
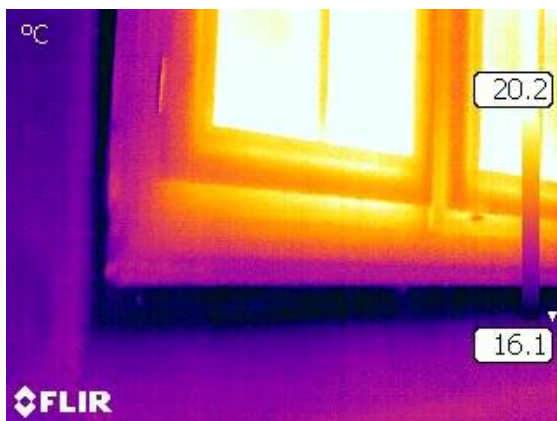
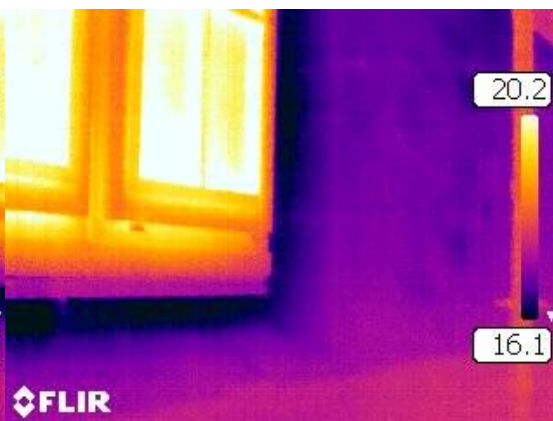
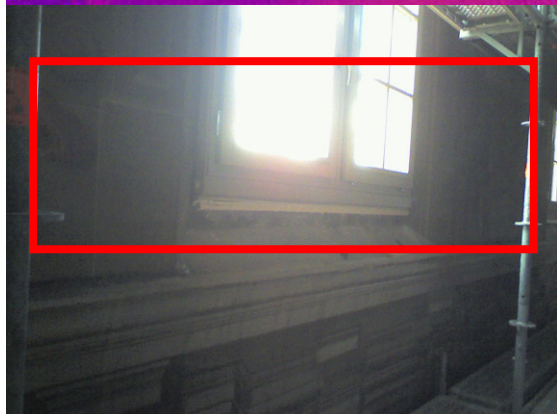
South wall

Comment: in the Sala Urbana room, on November 12, 2013, a series of thermograms have been recorded aiming at showing the insulation degree of the newly installed windows; it is evident how around the windows there is a lower temperature and a lesser degree of insulation but no air infiltration is appearing. The situation has been greatly improved afterwards by the insertion of foam and a metal sealing frame.

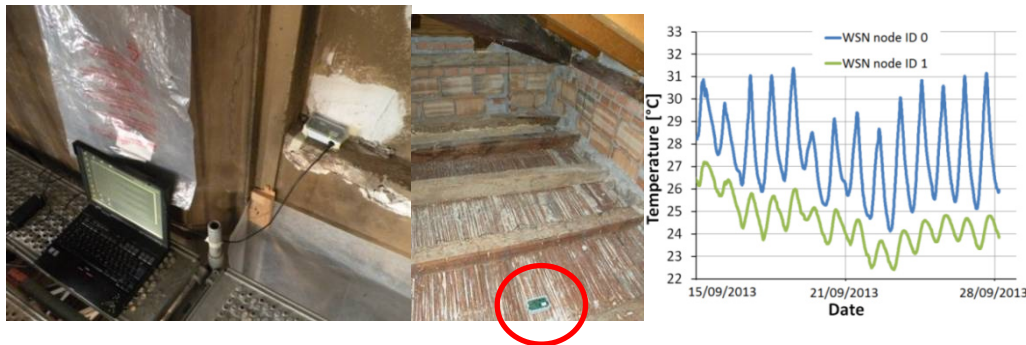
Figure 14: WSN monitoring of microclimatic conditions during refurbishment works: laptop and node 0 on the West wall of “Sala Urbana” (left), WSN node 1 in the roof space above the room (centre) example of monitor data (right), Source: [Colla C., Paci G., 2013], © DEI & DICAM Dept., University of Bologna

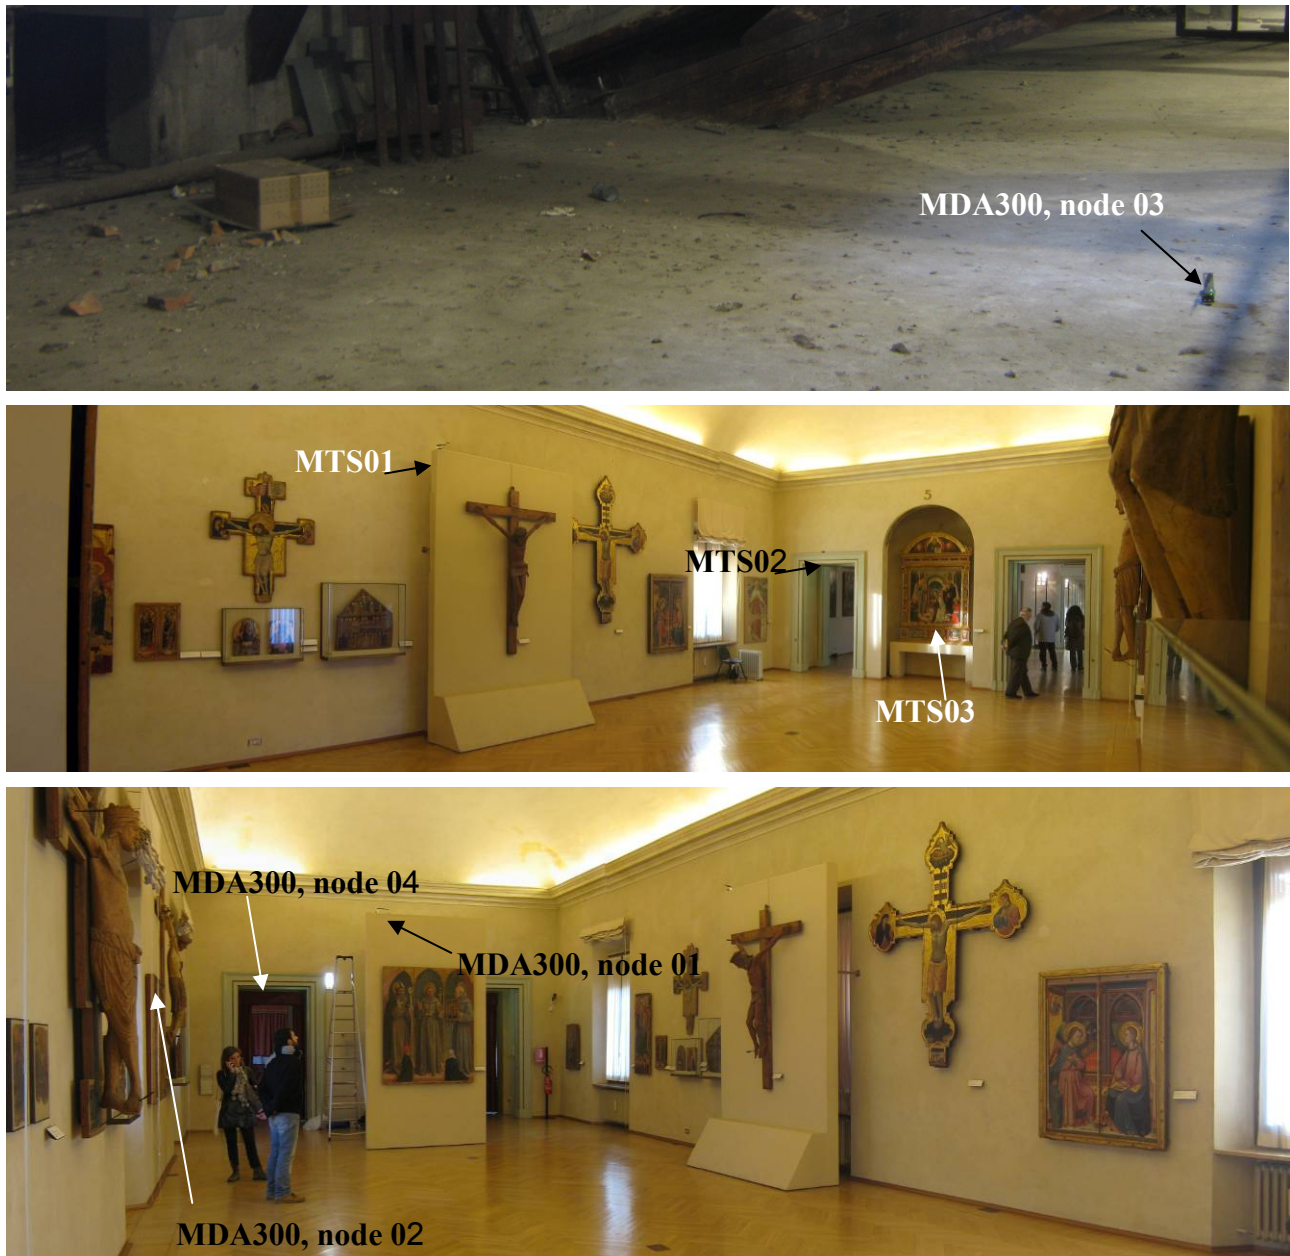
Figure 15: Plan of pilot Wireless Sensor Networks installed in Collezione Comunali and photos of installed nodes positions.

In the days 25-28/02/2011 two different small WSNs have been installed in Collezioni Comunali, specifically in Sala dei Primitivi and in the attic of Galleria Vidoniana, see Figure 15.

4 Memsic MDA300 nodes (01...04) with on-board air temperature and humidity sensors; node 4 was also equipped with a Cantherm CWF4B103G3380 thermistor to measure surface temperature and a Omron D6F-V03A1 MEMS flow sensor to measure air velocity.

3 Memsic MTS400 nodes with on board air temperature and humidity sensors, luxmeter, pressure sensor, two-axis accelerometer (MTS01....03).

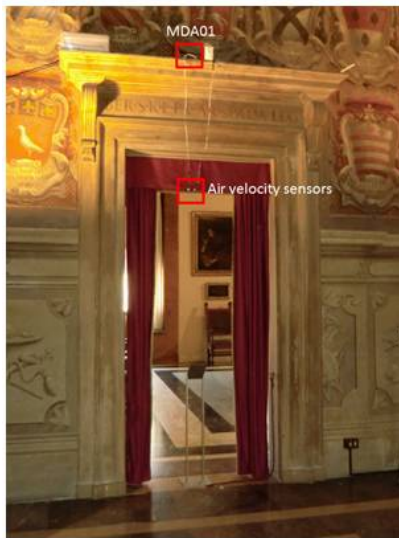
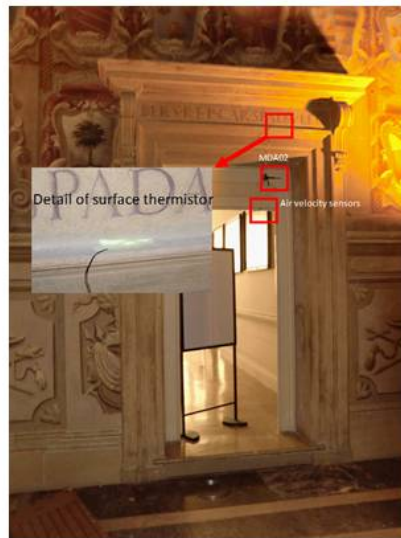
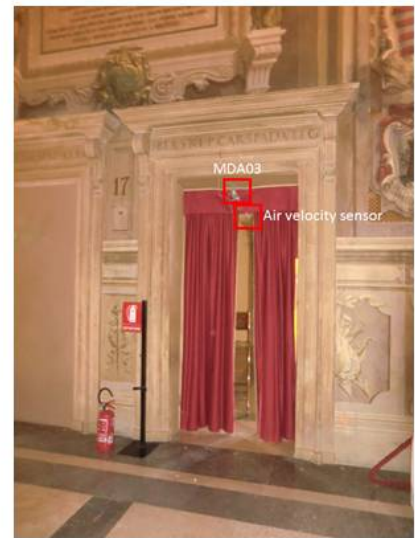
Positions of nodes MTS03, MDA01...04.

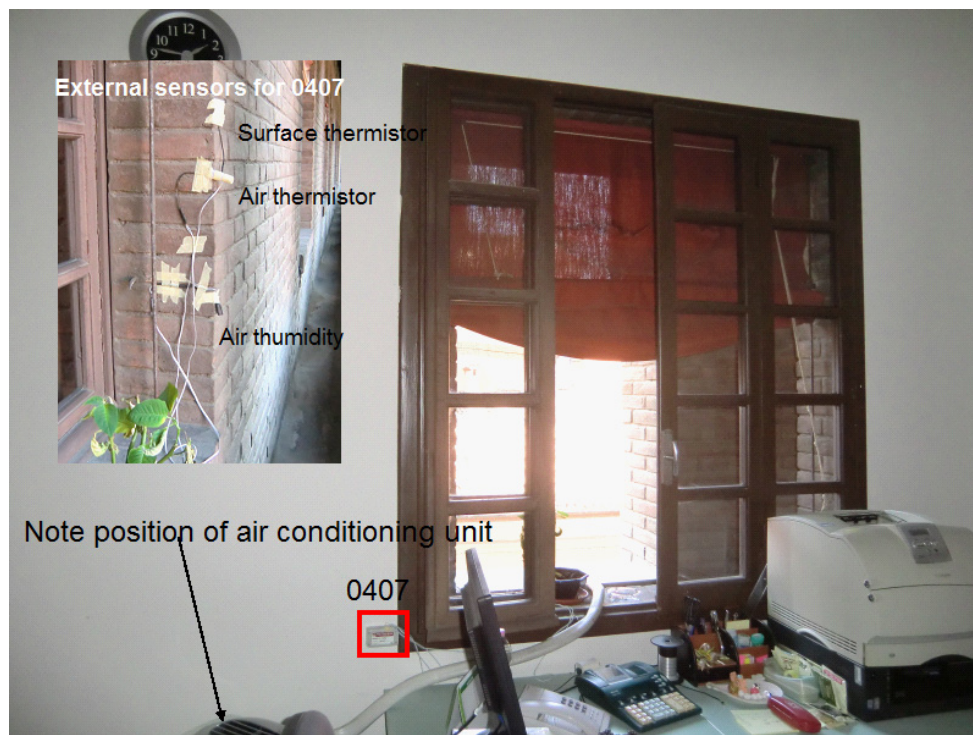
Map of nodes

Figure 23: Positions of node 0407 with attached sensors.

3. Node 0407 is placed on a wall facing to South, partially screened by a curtain of merlons, and close to a window and a portable air- conditioner: most probably for these reasons its daily oscillations are more relevant when compared to other nodes.

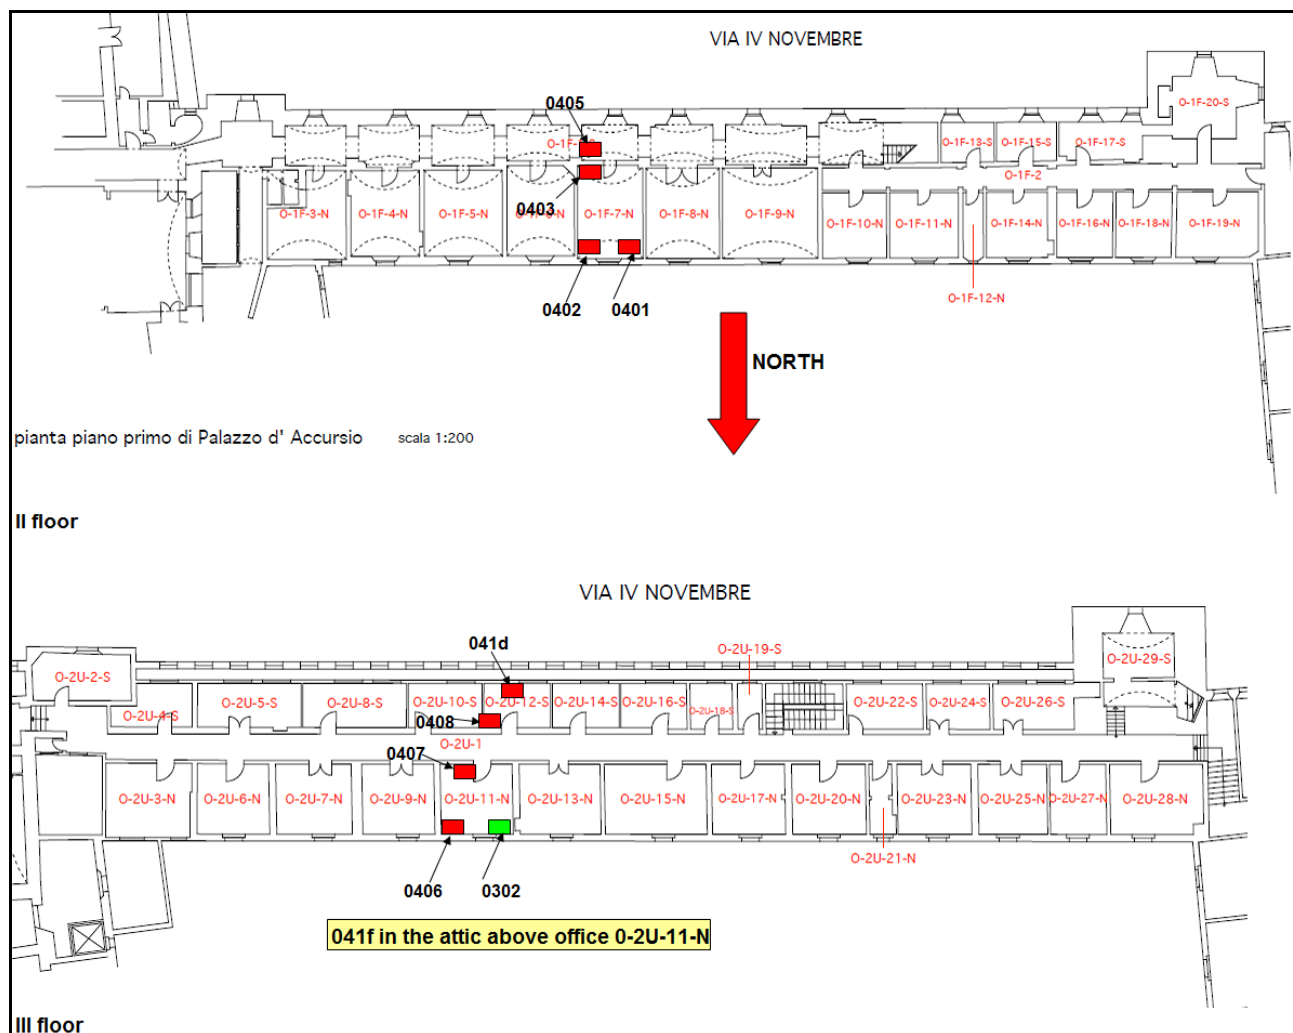
Map of nodes

1. Daily oscillations of outside temperature vary from about 11 °C at the official weather station at the airport of Bologna to 7 °C on the north prospect (node 0406 external sensor) to more than 20 °C on the South prospect, but in this latter case it was found out that the sun was heating the thermistor sensor directly, so data are to be discharged;

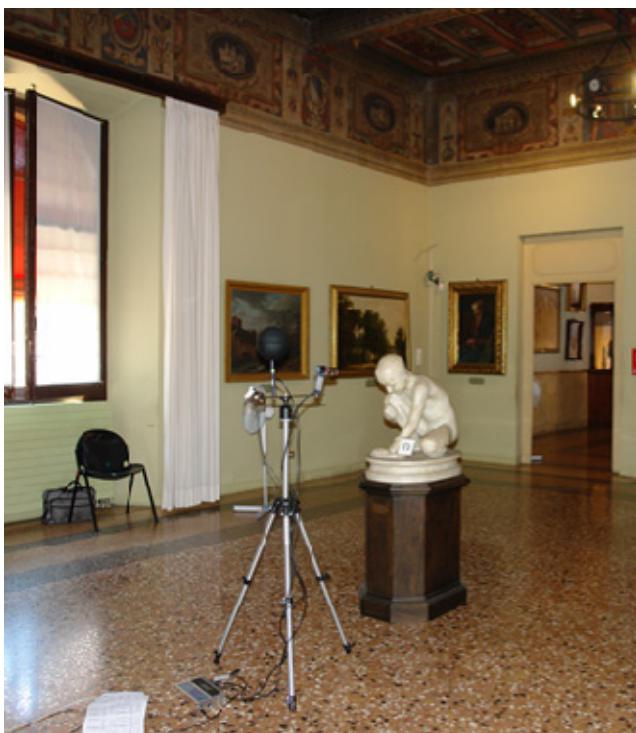
Figures 26: Technical equipment used

The monitoring could not affect the entire area studied by the energetic analysis. Therefore the most indicative points of measure for the analysis were identified, so that the observations done could be representative both of extremely critical and intermediate conditions.

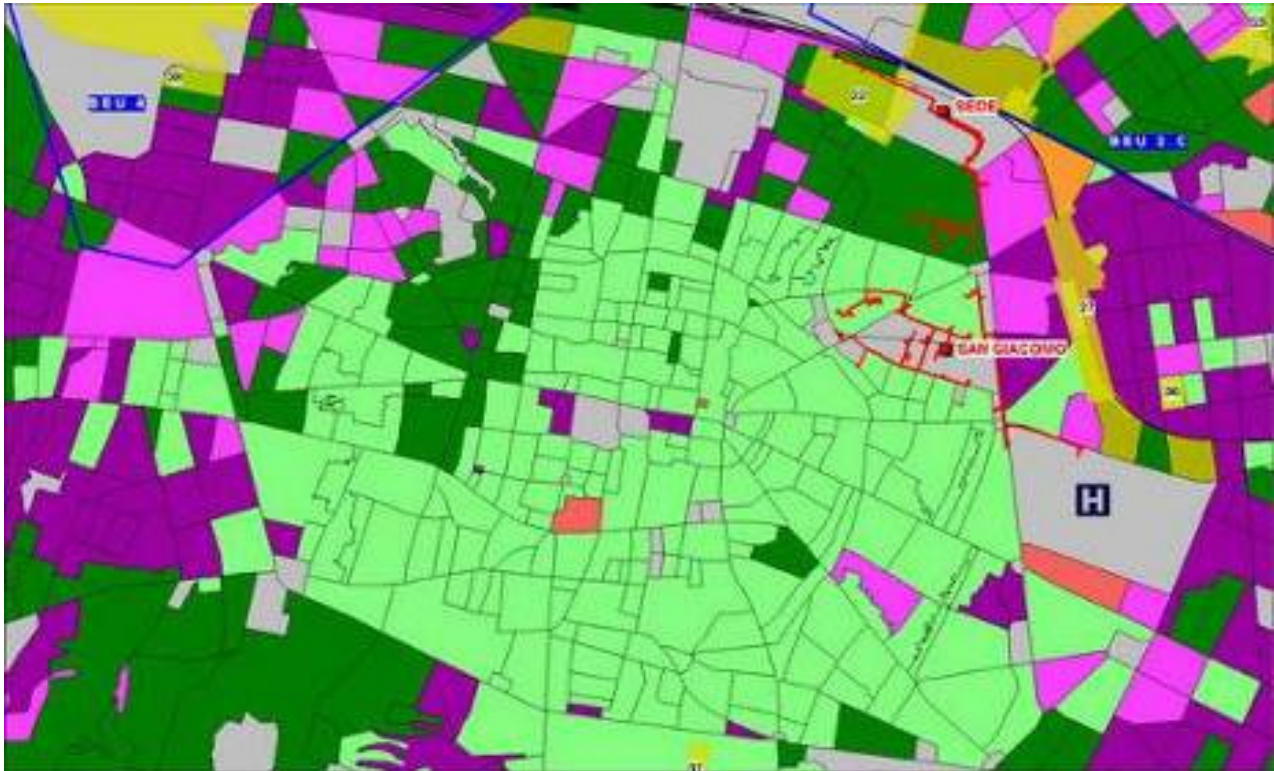
The following figure shows Bologna's historic center with its 4 different administrative zones: Porto, San Vitale, Santo Stefano and Saragozza. The figure also shows the prevalent buildings' age for the different census areas of the city.

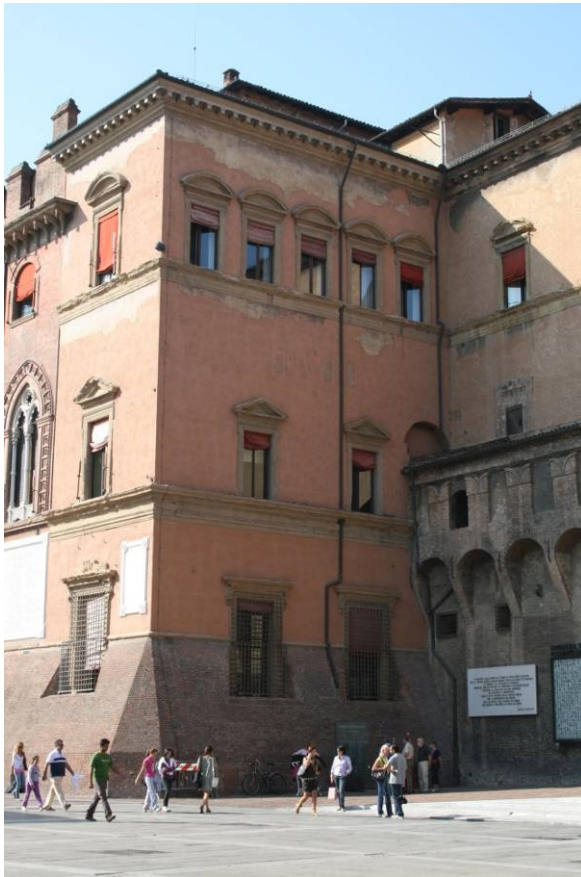
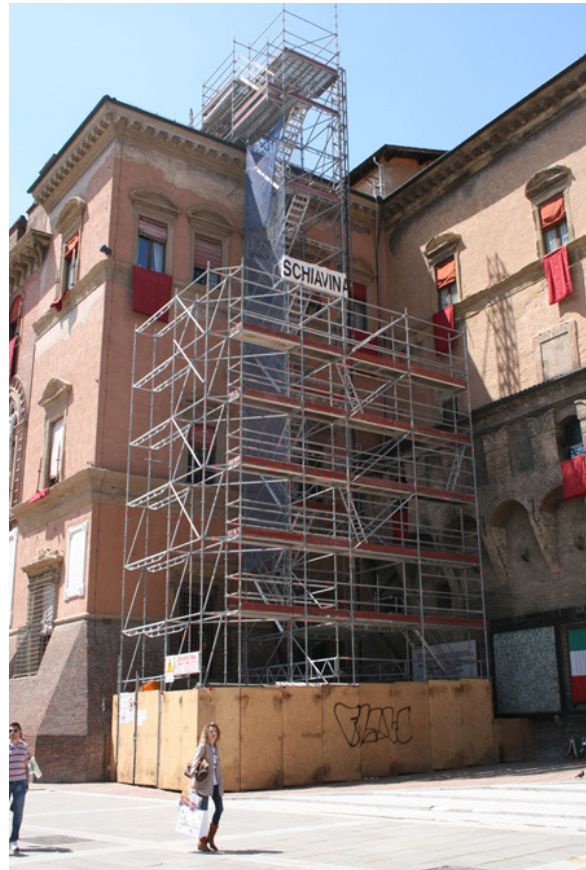
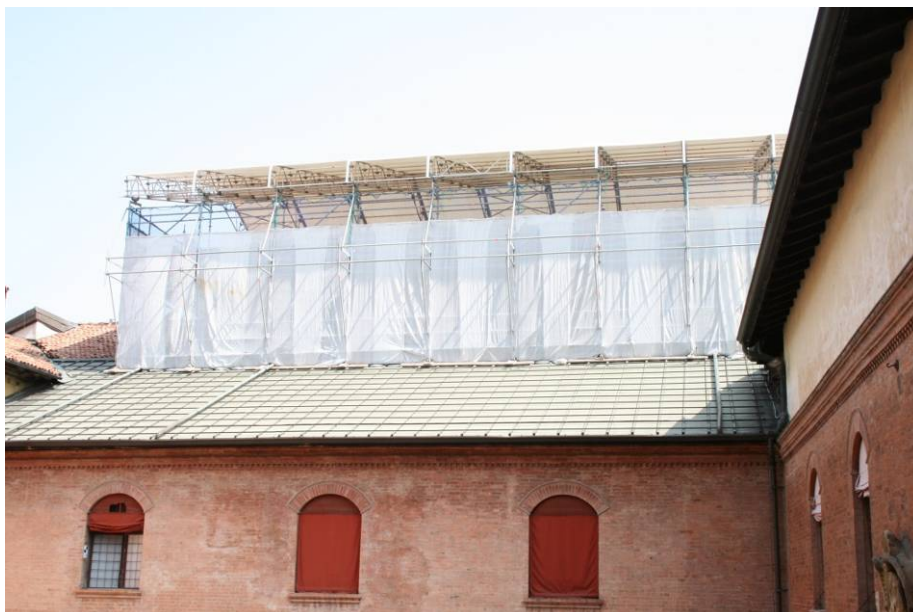
The works for the maintenance of Sala Urbana began in April 2013. Sala Urbana is the highest part of the whole palace building complex; it is made of a small tower surrounded by other buildings. In order to be able to work in safe conditions, it was necessary to build a scaffold along the main facade (facing Piazza Maggiore) and to create a connecting walkway to get to Sala Urbana. In order to be able to support the metal structure of the scaffolding along the perimeter walls, it was chosen to lay it down using the surrounding roofs as anchorage points, placing props on them at the backing points in the wooden structure, at the intrados.

The scaffolding was provided with a roof covering the entire room extension, in order to make it possible to remove the existing roof avoiding the decorated ceiling underneath to be damaged in case of rain.

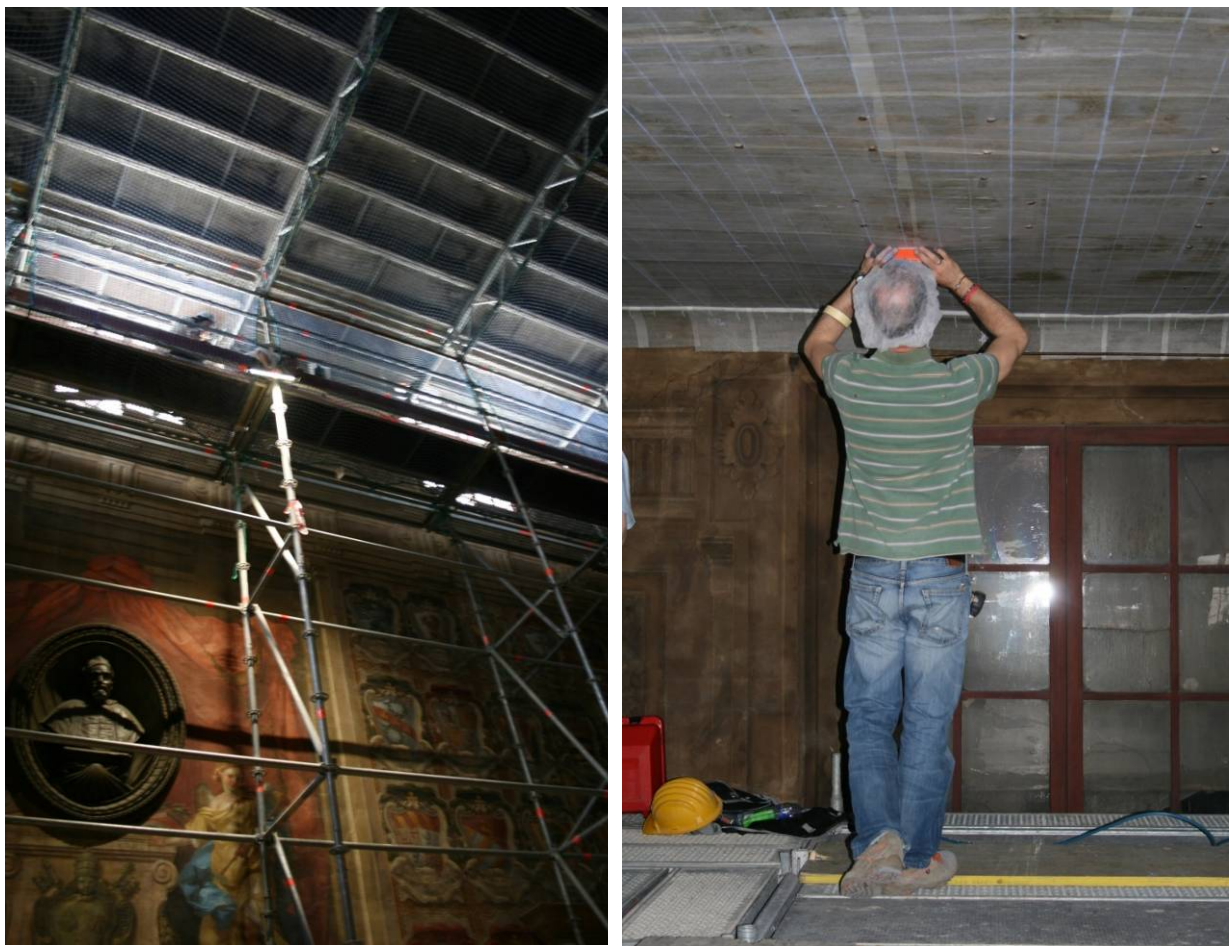
In this phase the metal structure that holds the metal bars, to which the room's lighting system are connected, was also assembled, by hanging it at the roof structure. These interventions lasted 6 months.
