**D 6.2 Documentation of each study case
CS2 Palazzo d'Accursio/Municipal Palace,
Bologna (Italy)
Delivered at M42**

**[Compatible solutions for improving the energy efficiency
of historic buildings in urban areas]**

Project Acronym	3ENCULT
Project Title	Efficient ENergy for EU Cultural Heritage
Project Coordinator	Alexandra Troi EURAC research, Viale Druso 1, 39100 Bolzano/Italy Alexandra.troi@eurac.edu
Project Duration	1 October 2010 – 31 March 2014 (42 Months)

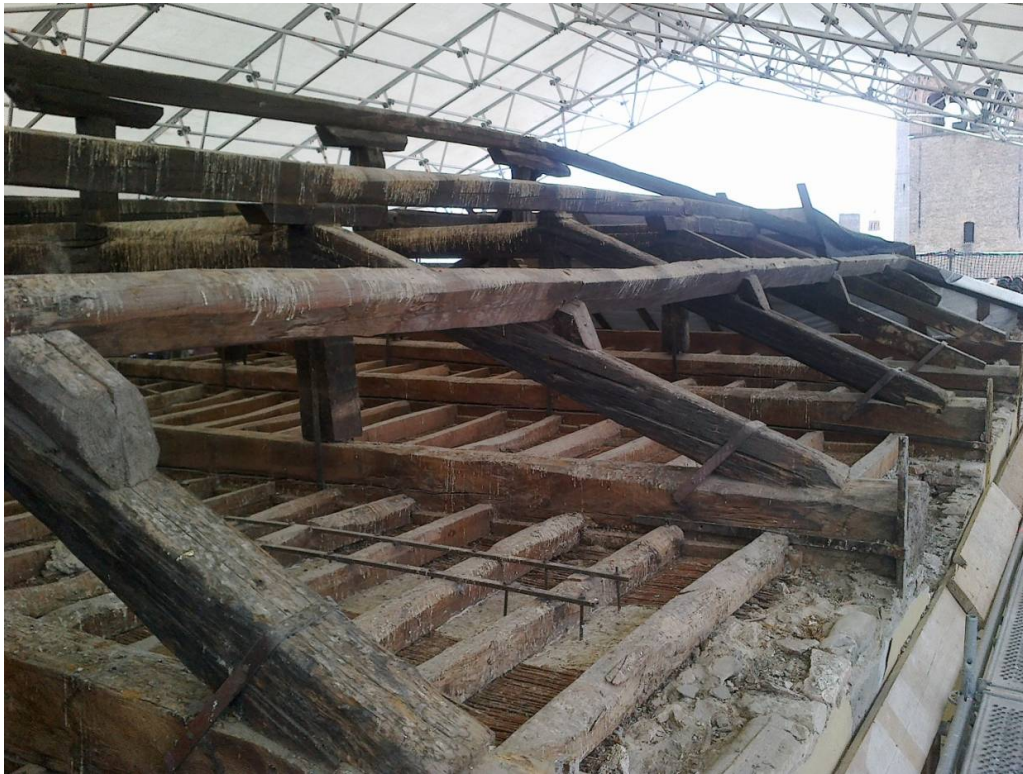
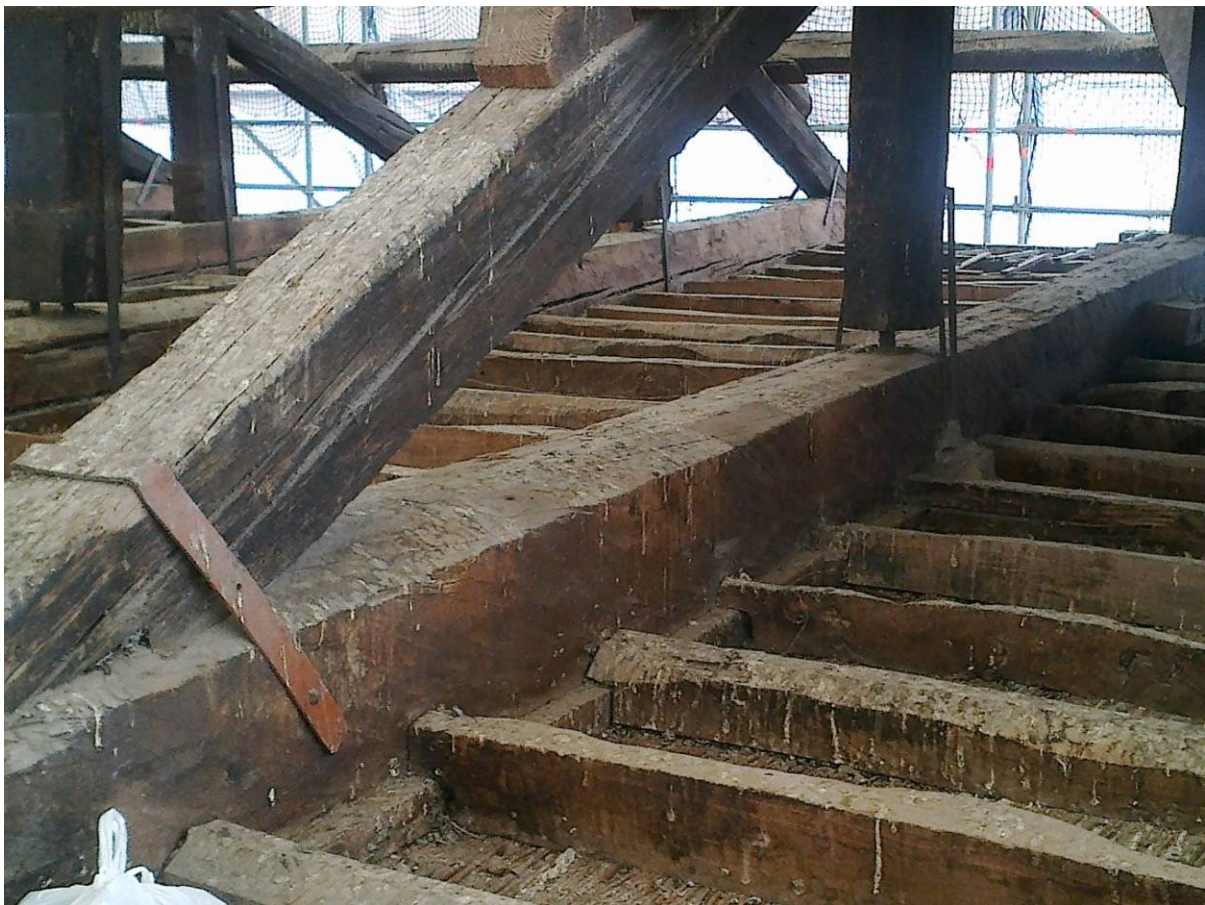
Figure 35-36: Deterioration of the wooden structure of the roof

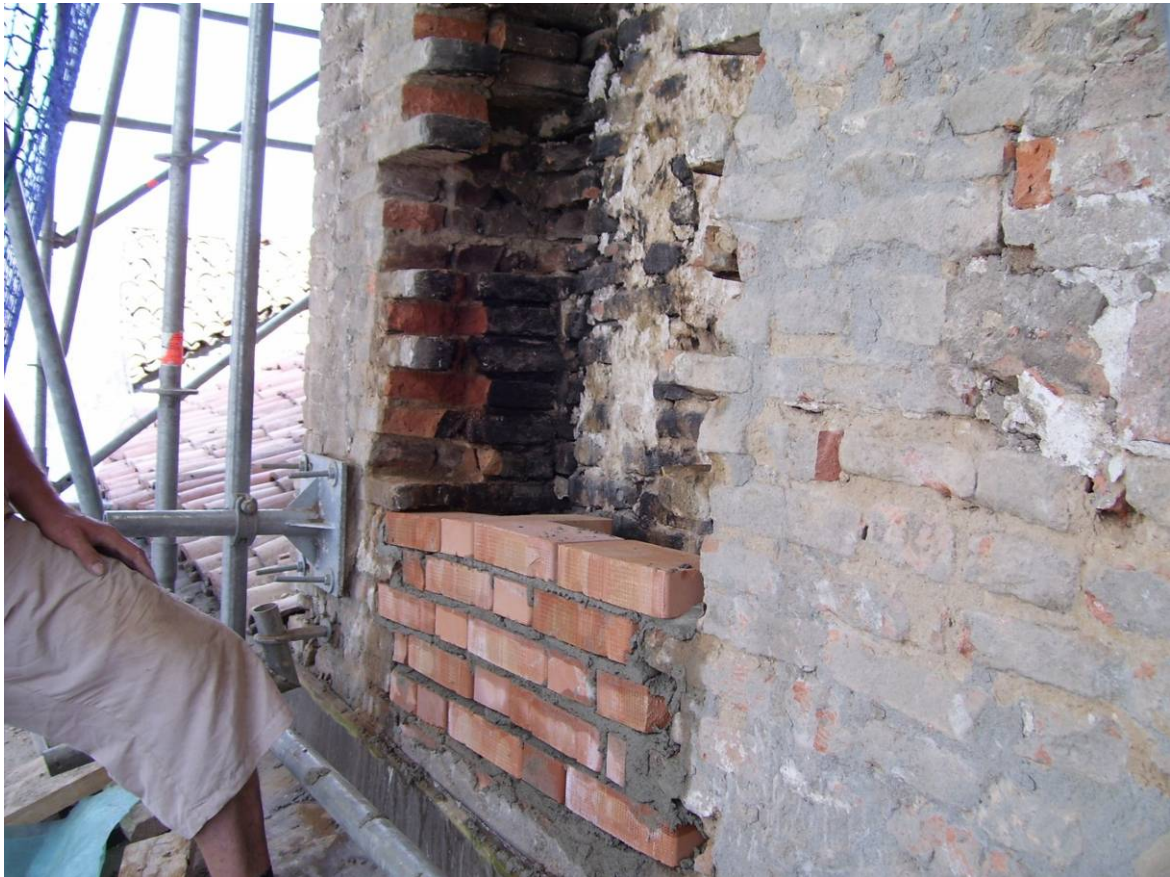
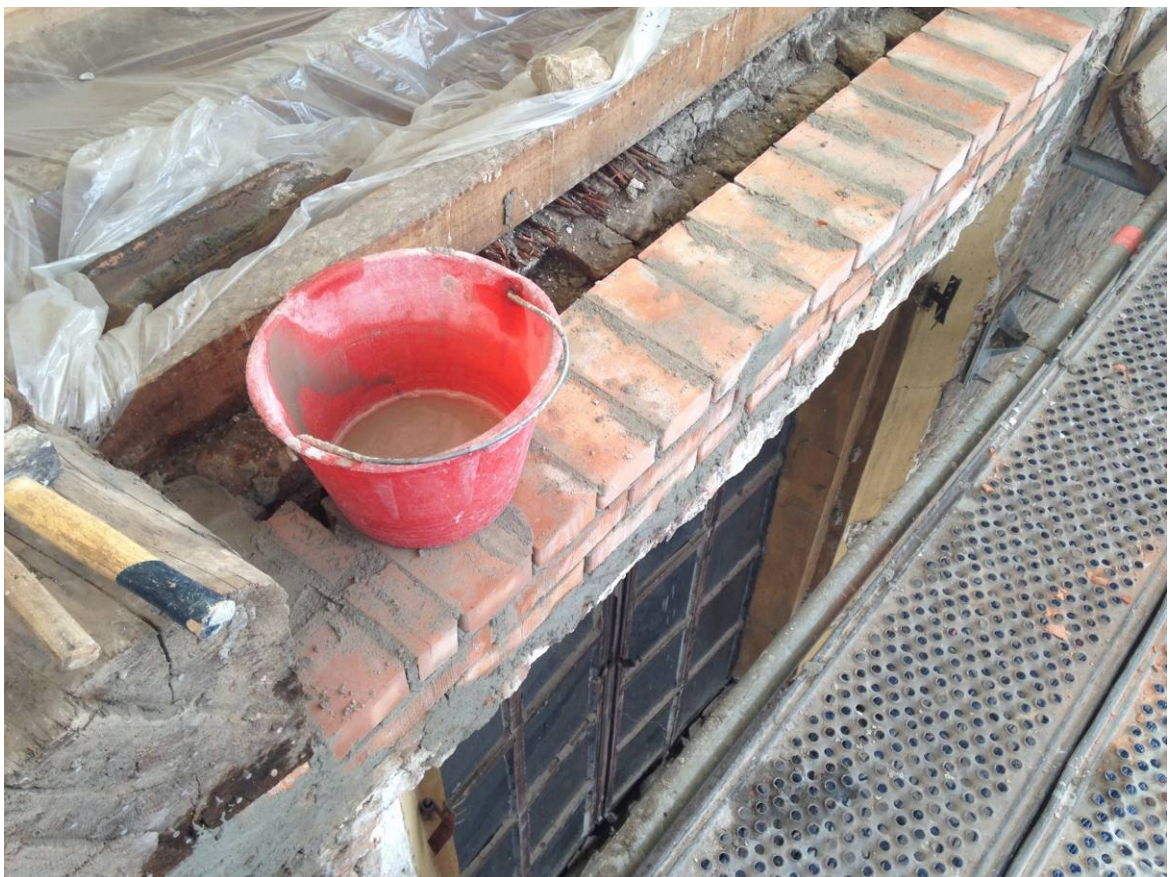
Figure 37-38: ancient chimneys and intervention of consolidation of the masonry

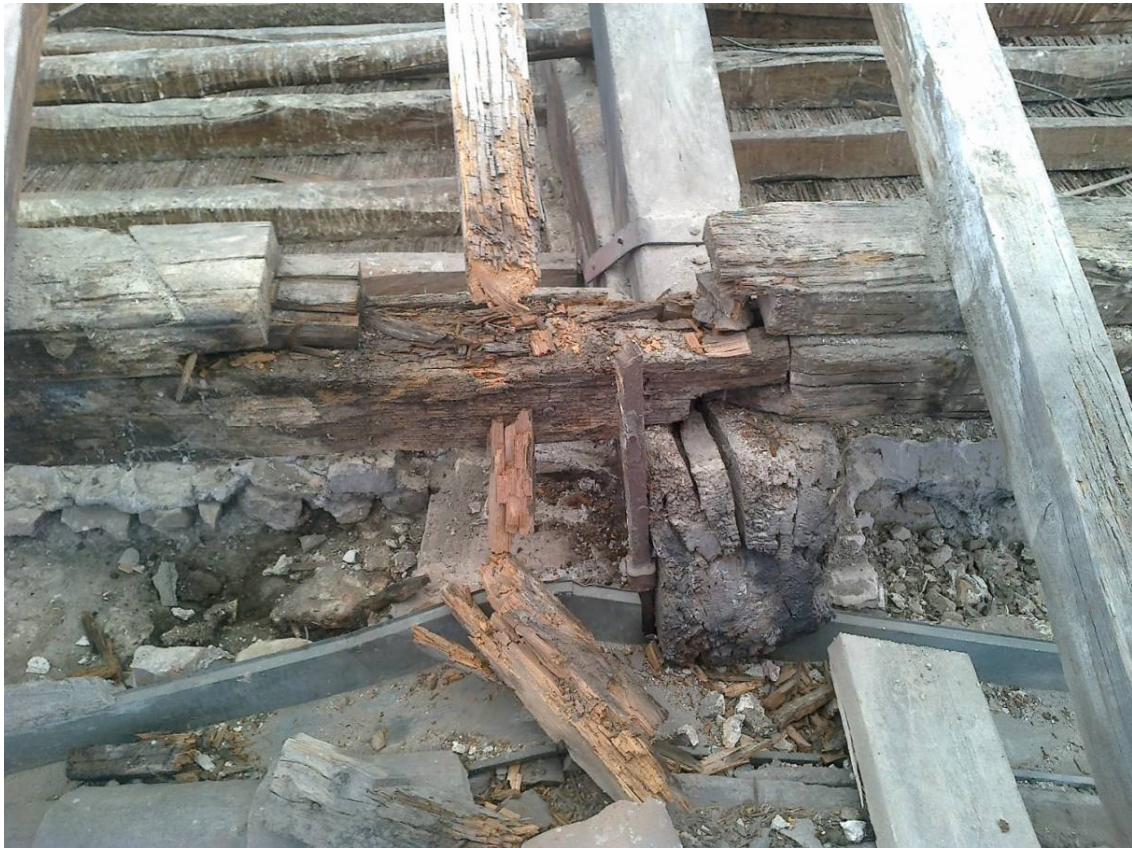
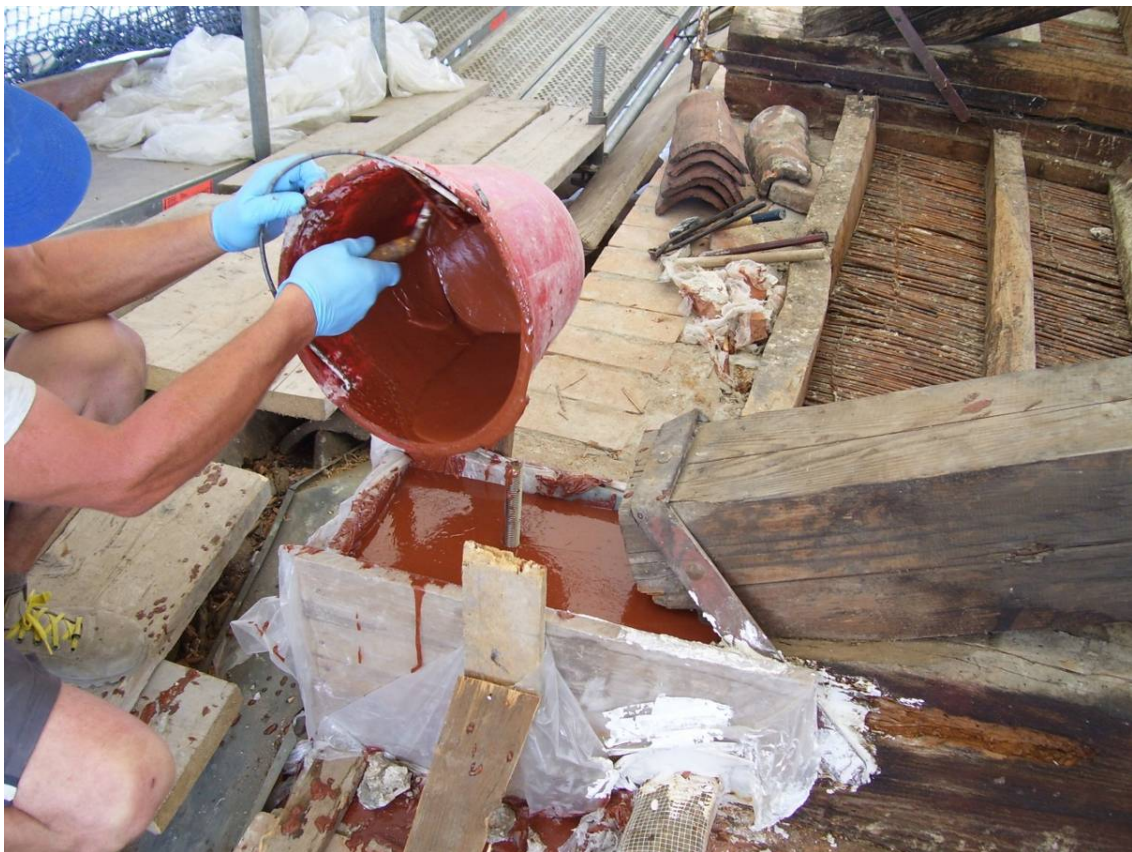
Fig. 39-40: wooden truss gear and consolidation with steel bars and resins

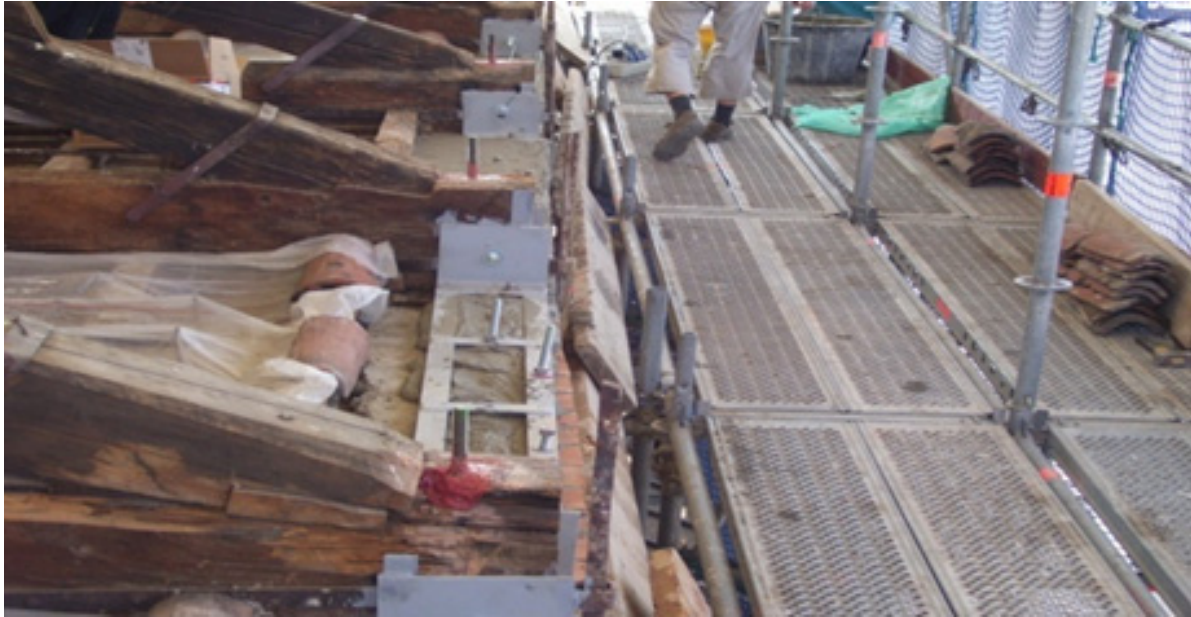
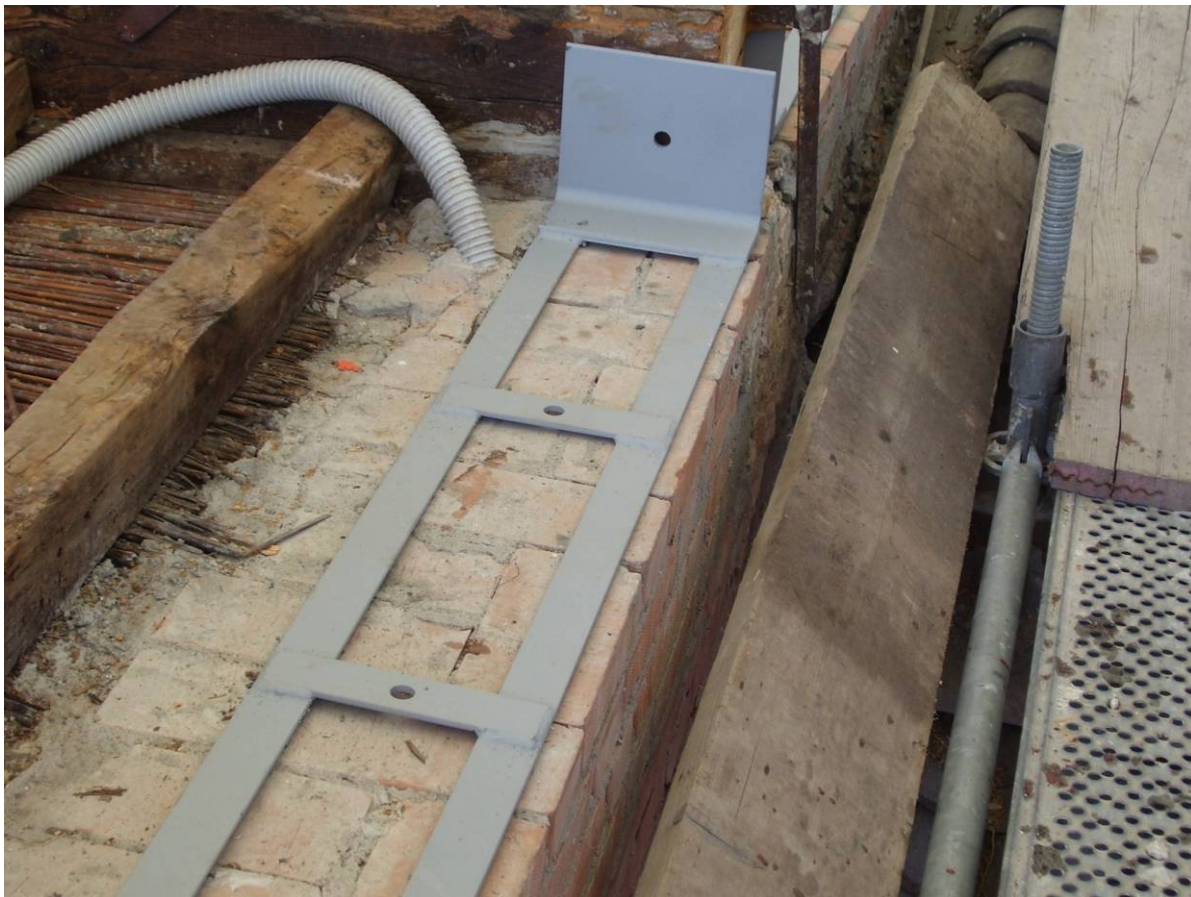
Fig. 41-42: metal curb for the consolidation of perimeter walls

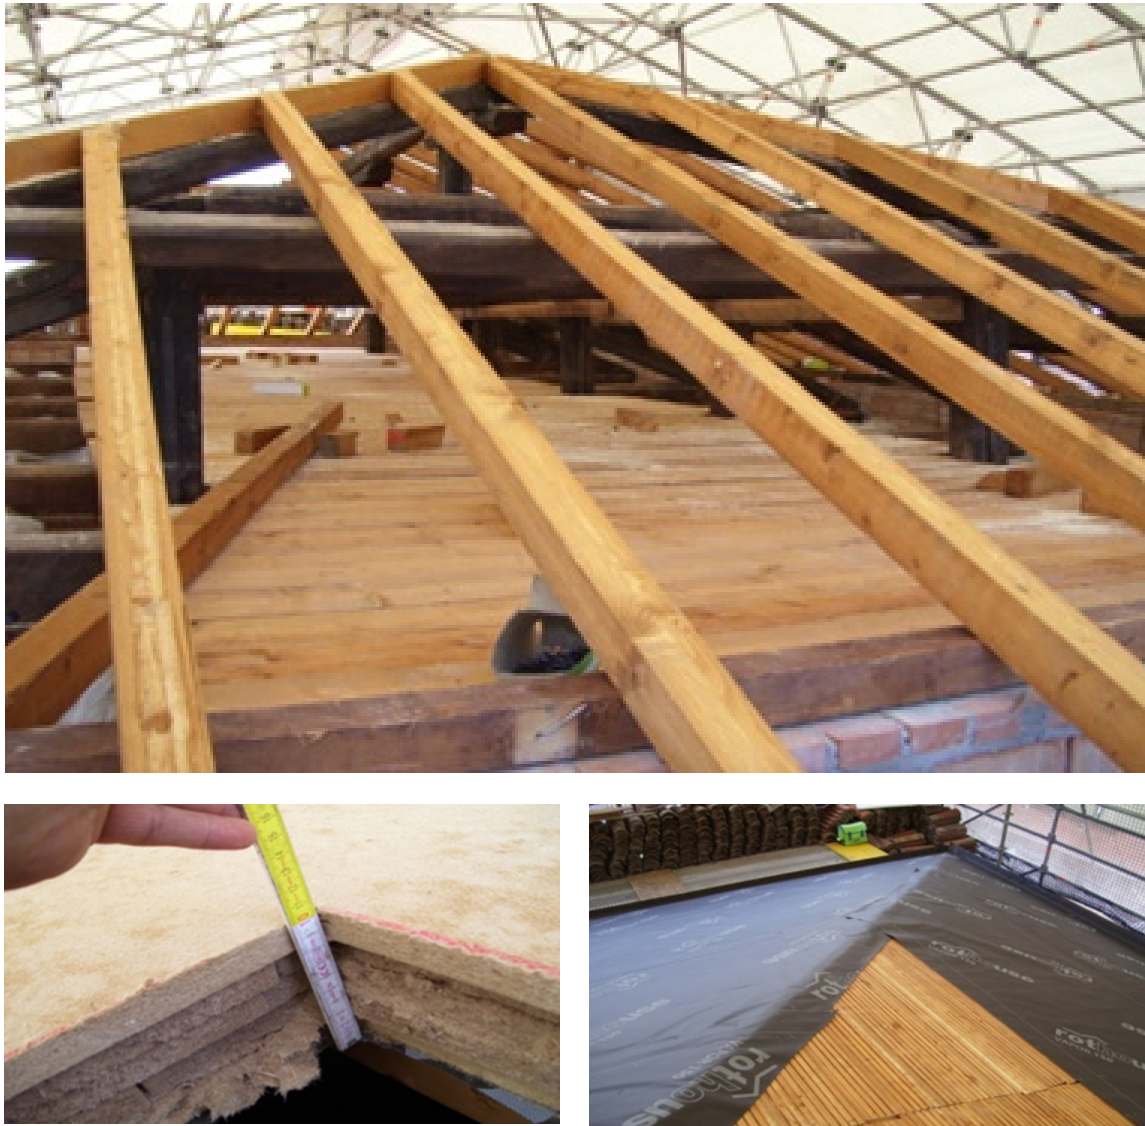
Fig. 43-44: replacement of the wooden beams and installation of insulation on the roof

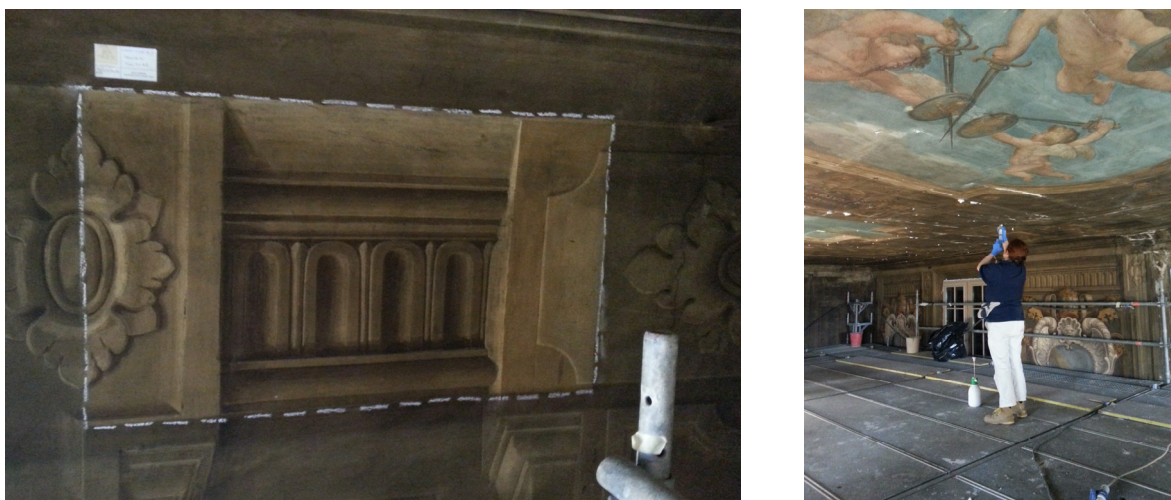
Fig. 45-46: Test for the renovation of frescoes

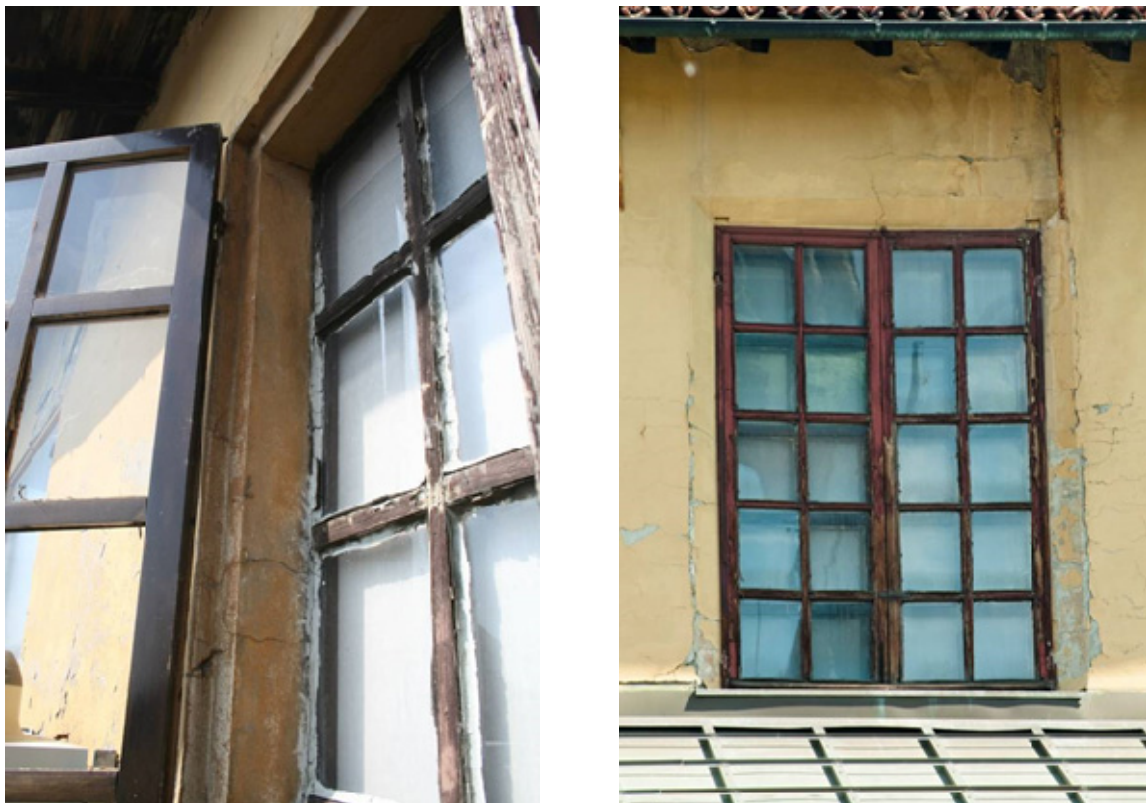
Fig. 47-48: View of the external and internal old windows

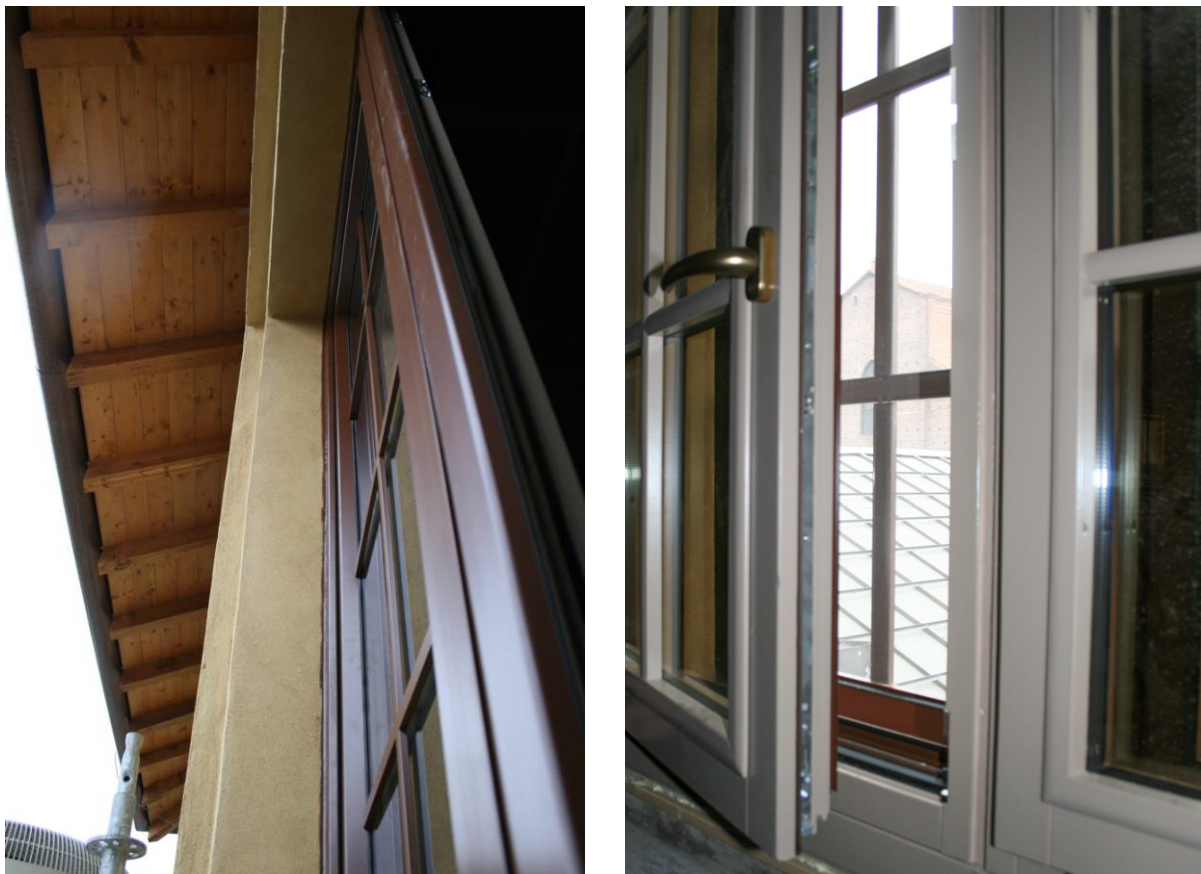
Fig. 49. Scheme and section detail of the new window frames

For windows facing east and west: we have replaced the windows while keeping the existing design, leading to a total transmittance of the window equal to $U_w = 2.2 \text{ W/m}^2\text{K}$ (with reduced thickness of the frame, which could be around to 70 mm). To get this performance should be the window with double glazing and cavity (16 mm) the introduction of gas (type: Argon), to increase performance.

For windows oriented to the north: it is recommended to replace the frames, which while maintaining the current design will lead to overall transmission of the frame of $U_w = 1.9 \text{ W/m}^2\text{K}$. The glass also in this case will have to be selective.

Given the nature of the historic building, the type of window should be wood , but to address the maintenance issue, we have chosen a window with a wood frame coloured in grey and outside with an aluminium coating with thermal break, treated with brown colour.

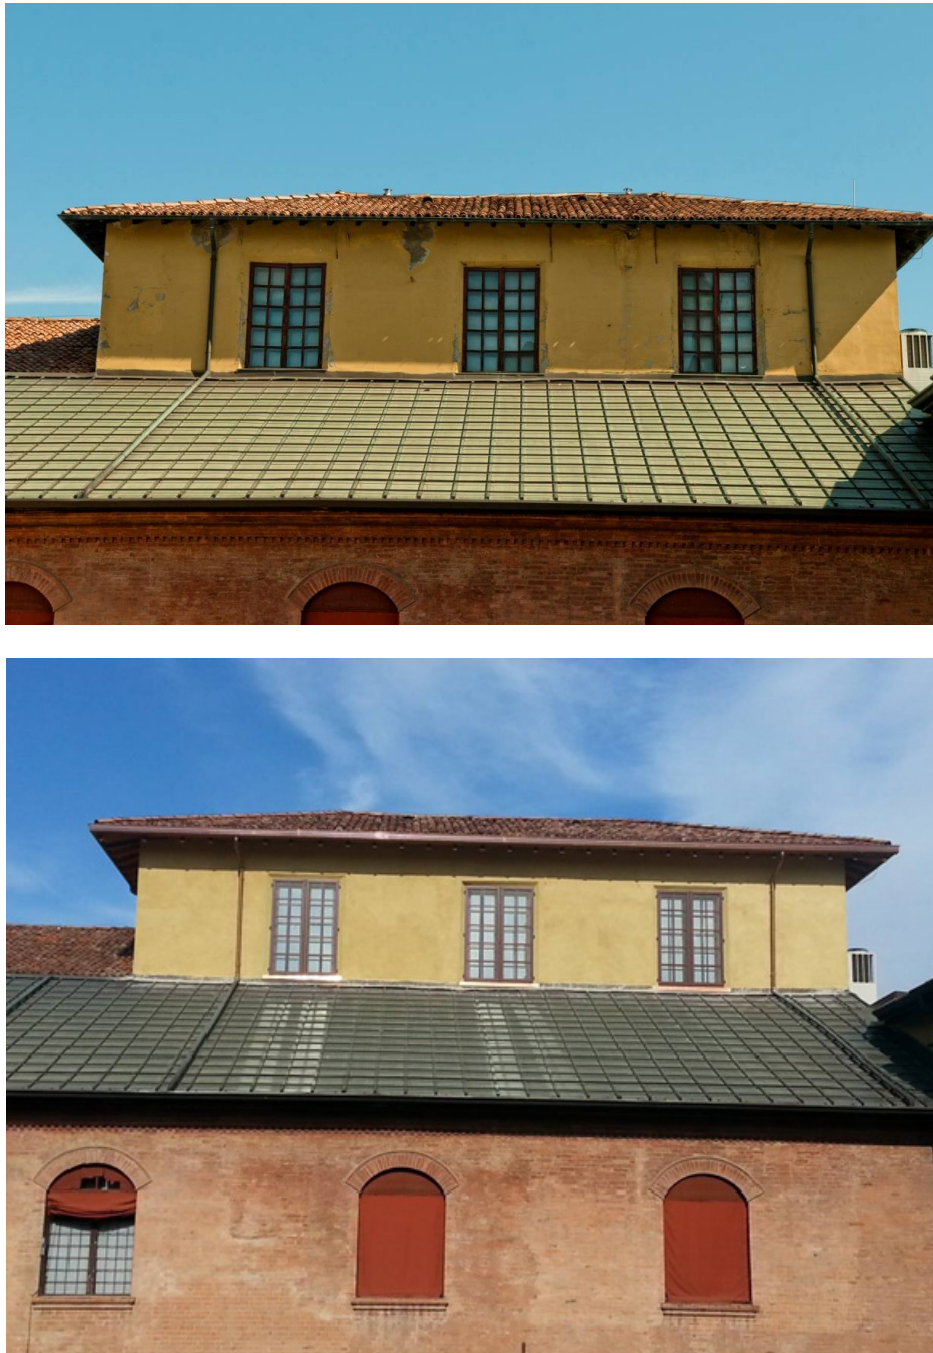
Figure 50: External window before and after the interventions, Source: [Faustini, F. M. 2012-2014], © Municipality of Bologna.

The windows, with double opener have been provided with automatic openings activated on the basis of the ratio between the internal and the external temperature value; the opening at night favour the activation of a chimney effect which is able to guarantee a natural cooling of the Room and at a certain degree also of the adjacent spaces in summer months.

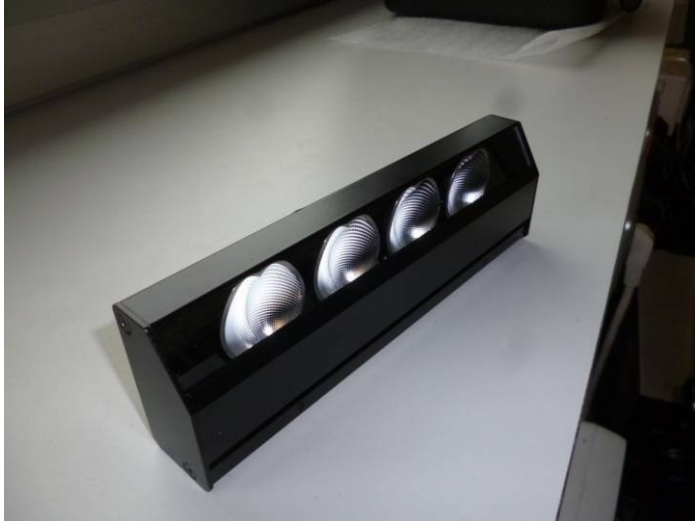
Figure 55: 3Encult wallwasher in rectangular housing.

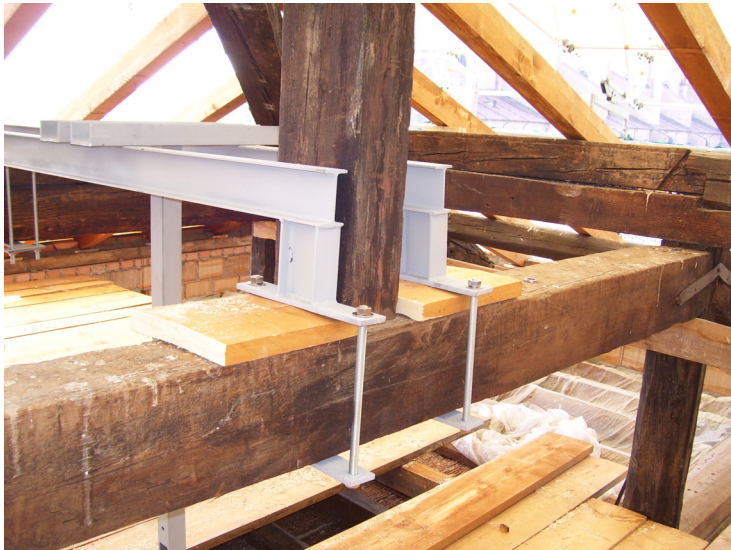
Figure 56: anchoring structure for hanging the bar for central lighting

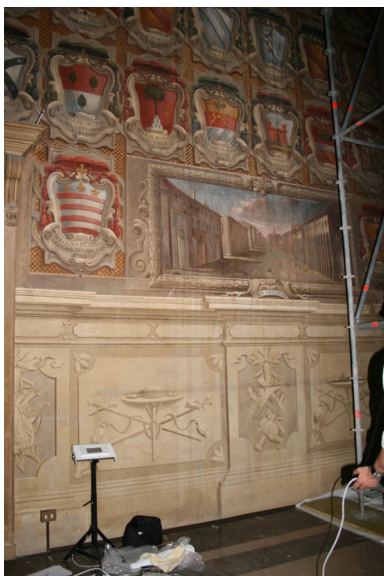
Figure 57 : test of lighting

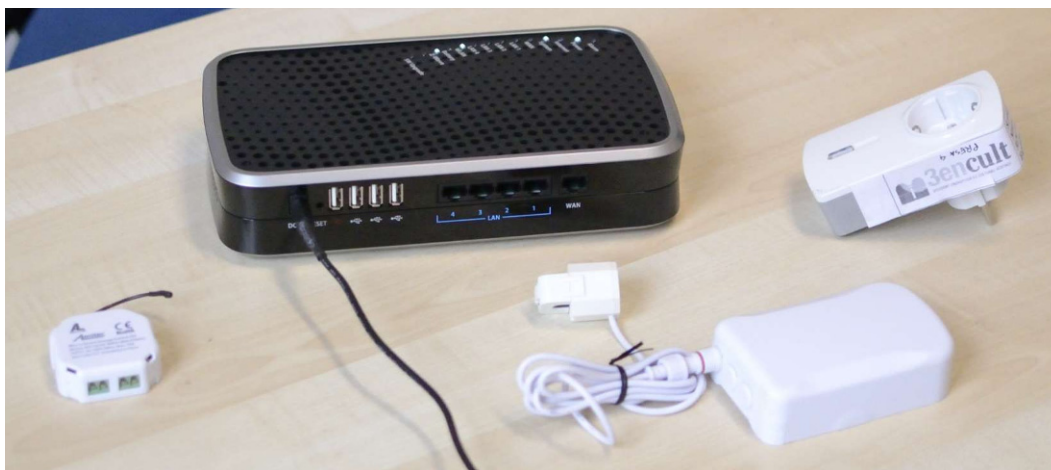
In February 2014 a Z-Wave domotic network has been installed in the offices area to acquire parameters that are quite difficult to be monitored by a standard WSN network, mainly electrical consumptions; although feasible, the interfacing of power monitoring sensors to the existing WSN would have required extensive interfacing works and so a network that is natively born to implement such a task has been selected, acquired and installed (see Appendix A for technical details). *Acquired data are still under analysis* and in this report we will only show the photos below, with the “Virtuoso2 gateway and installations of a reed contact and a measuring/actuating plug.

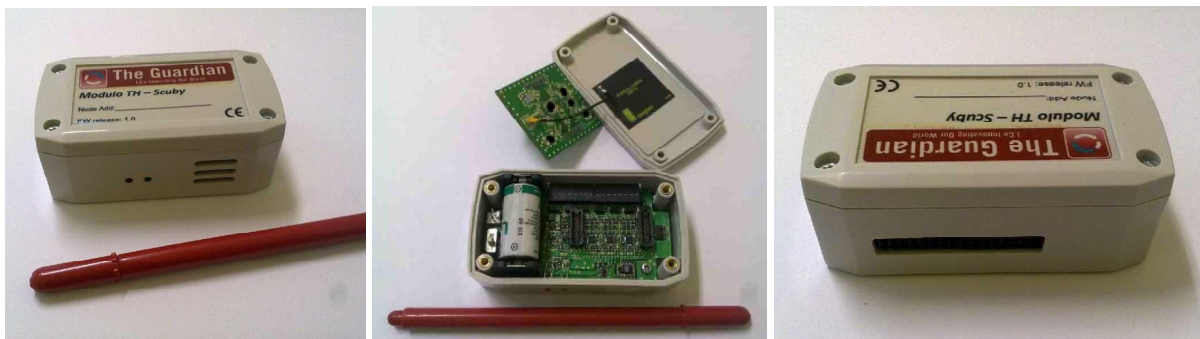
Figure 69: Photos of WSN nodes

- Dimensions: 90x59x35 mm, see Figure 69
- Integrated omnidirectional antenna
- 7 analog input modules (0-2.5 V) for NTC sensors with a resolution of 0.6 mV;
- Selectable low pass analog filter at 50 Hz;
- Supply voltage 5 V/100 mA;
- T and RH sensors on board (Sensirion SHT11, see description for Memsic nodes):
 - Resolution of 0.01°C / 0.05%RH (typ.)
 - Accuracy of $\pm 0.4^{\circ}\text{C}$ / $\pm 3\%\text{RH}$ (typ.)
- “Clip on” terminals for external sensors
- Powering: 1 3.6V battery
- Sleep mode current: $< 0.1\mu\text{A}$
- Selectable acquisition rate (5 minutes min, 30 minutes max)
- Radio transmitter
 - 2.4 GHz IEEE802.15.4 compliant
 - Sleep mode current: $< 0.1\mu\text{A}$
 - Interoperability with all 2.4 GHz standard devices
 - Very low Packet Error Rate
 - Encrypted data transmission

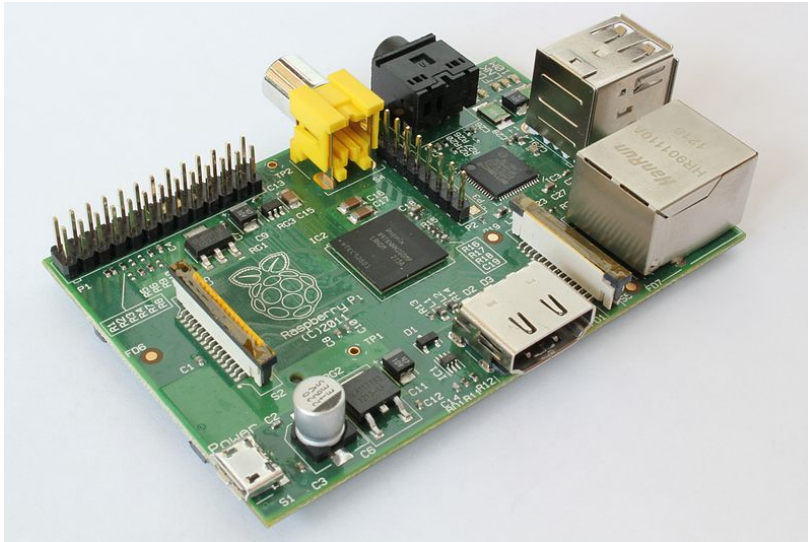
Figure 72: Raspberry Pi computer Model-B Rev1.

ample power to run your Raspberry Pi. Typically, the model B uses between 700-1000mA depending on what peripherals are connected, and the lower performance model A can use as little as 500mA with no peripherals attached. The maximum power the Raspberry Pi can use is 1 Amp. If you need to connect a USB device that will take the power requirements of the Raspberry Pi above 1 Amp then you must connect it to an externally powered USB hub. The power requirements of the Raspberry Pi increase as you make use of the various interfaces on the Raspberry Pi. The GPIO pins can draw 50mA safely (that is 50mA distributed across all the pins! An individual GPIO pin can only safely draw 16mA), the HDMI port uses 50mA, the camera module requires 250mA, and keyboards and mice can take as little as 100µA or over 1000mA.

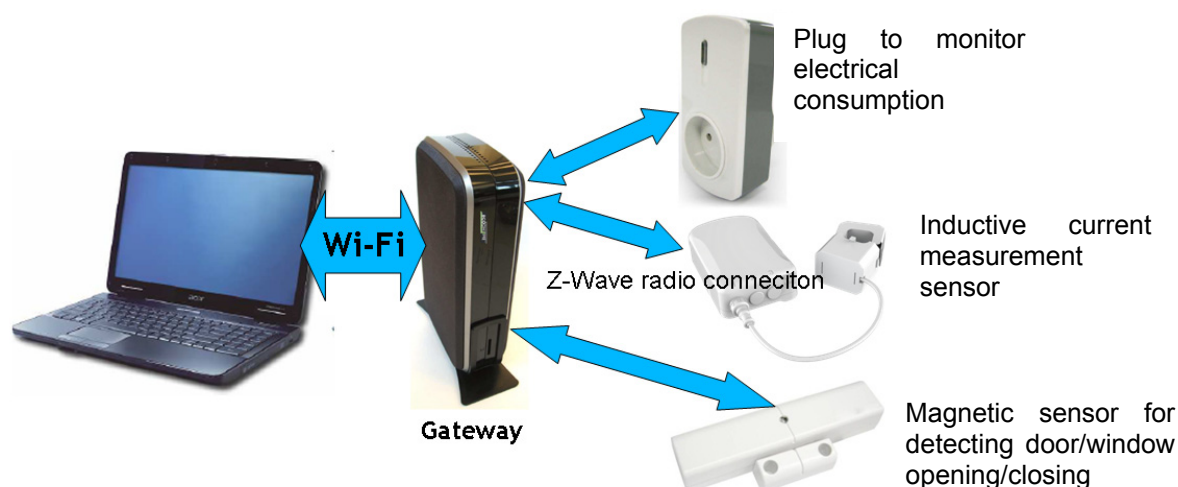
Figure 74: A Z-Wave domotic network schematic.

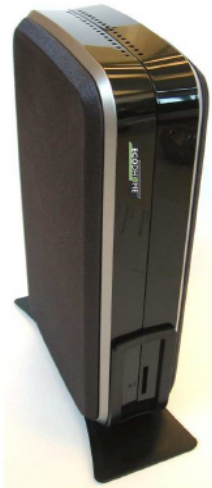
"Virtuoso" gateway: it is a self-contained Linux-based PC that collects data from sensors

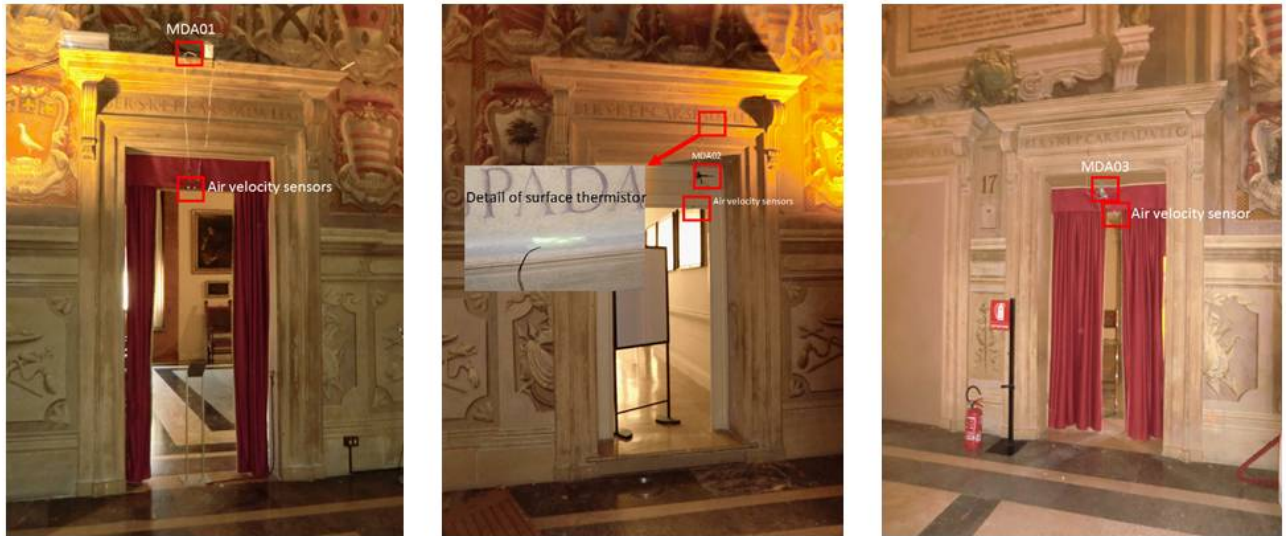
Positions of nodes MTS03, MDA01...04.

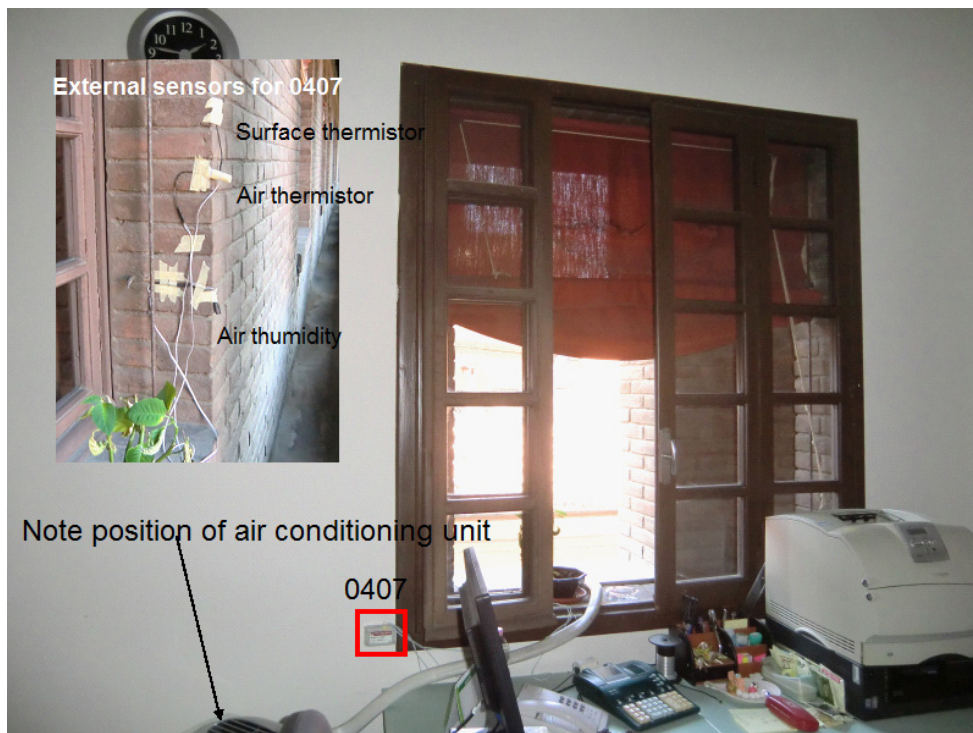
Positions of node 0407 with attached sensors.

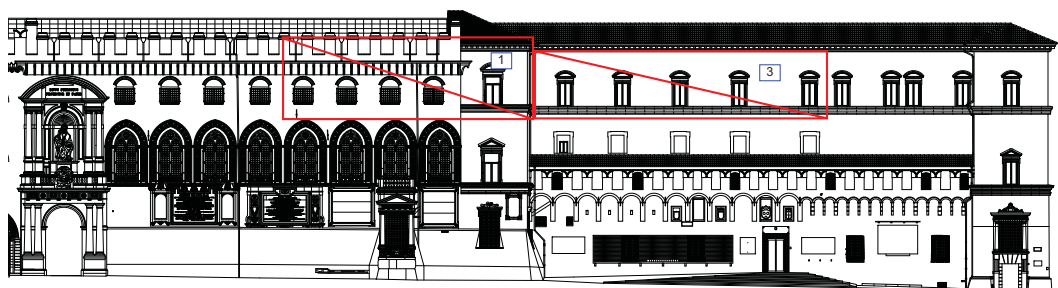
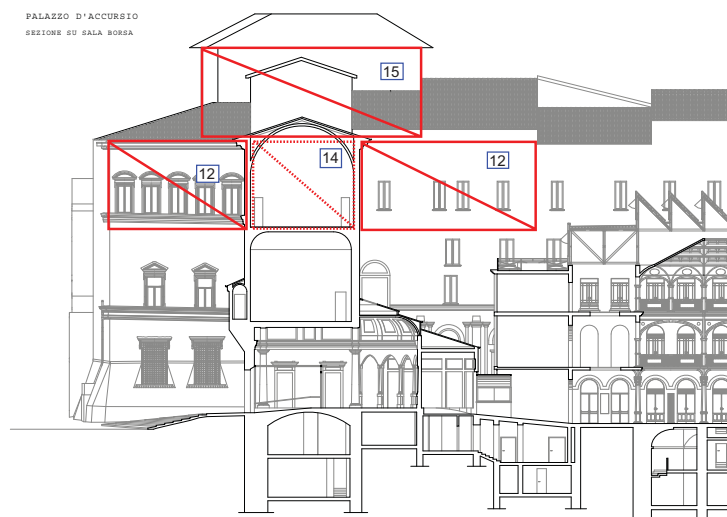
(a) Main Square Façade

(b) North Façade with section

Figure 1.3: Subdivision of selected part of building: North and East Façade.

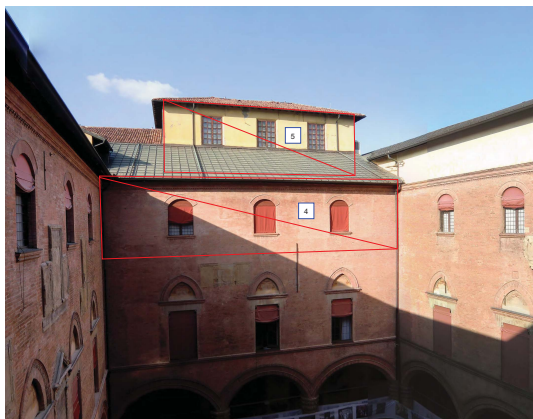
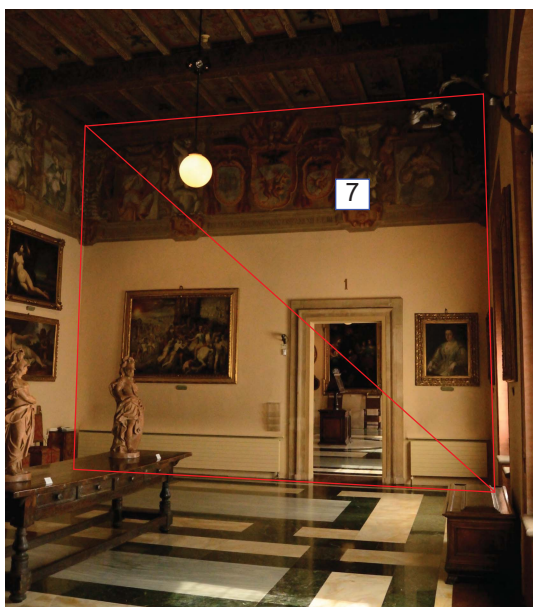
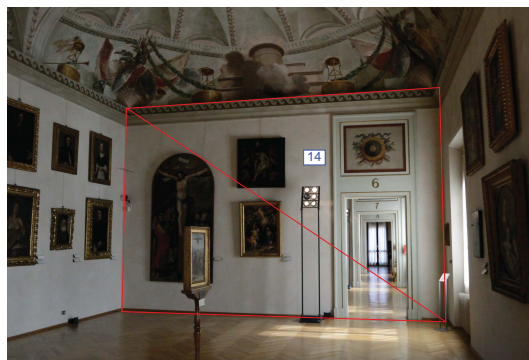
(a) South Façade

(c) Adiabatic partition wall

(d) Adiabatic partition wall

Figure 1.5: Surfaces of balance boundary.

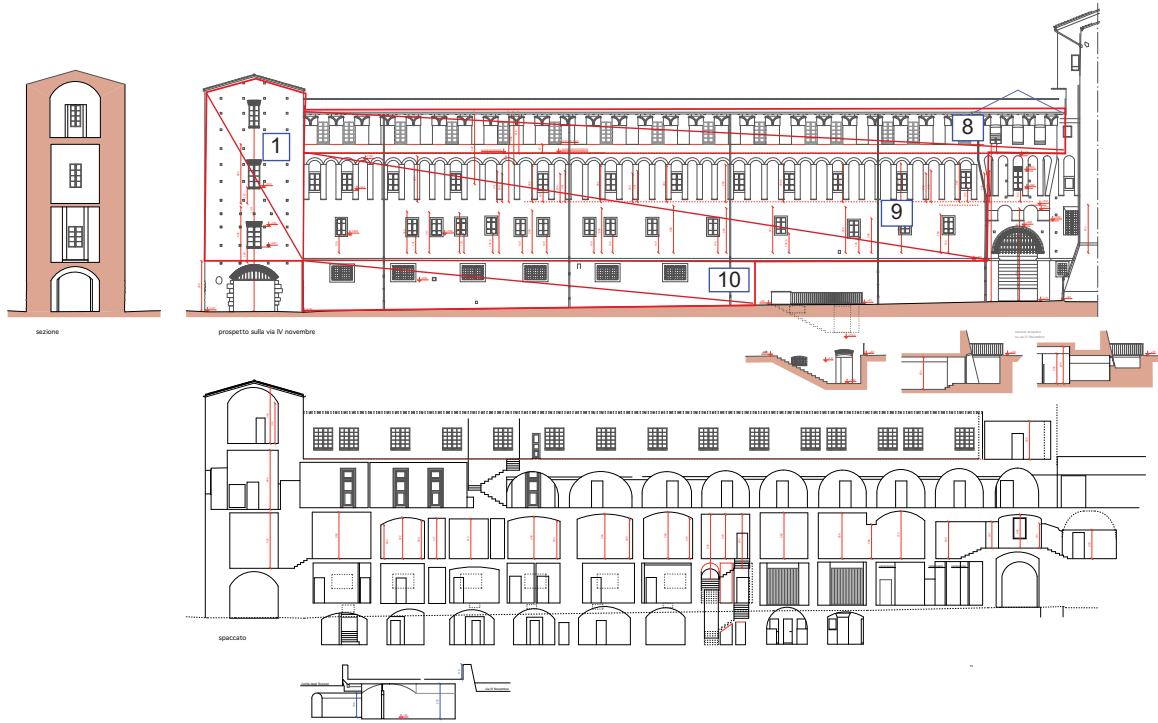
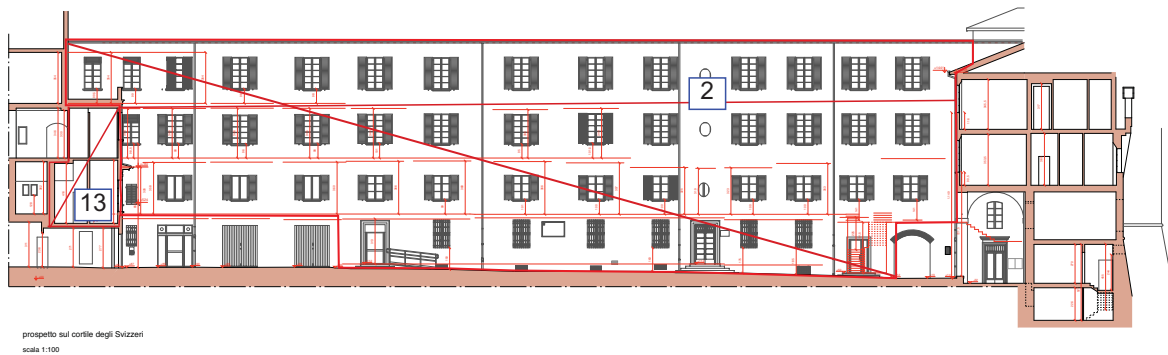
(a) South Façade

(b) North Façade with section

Figure 2.2: Subdivision of selected part of building: North and South Façade.

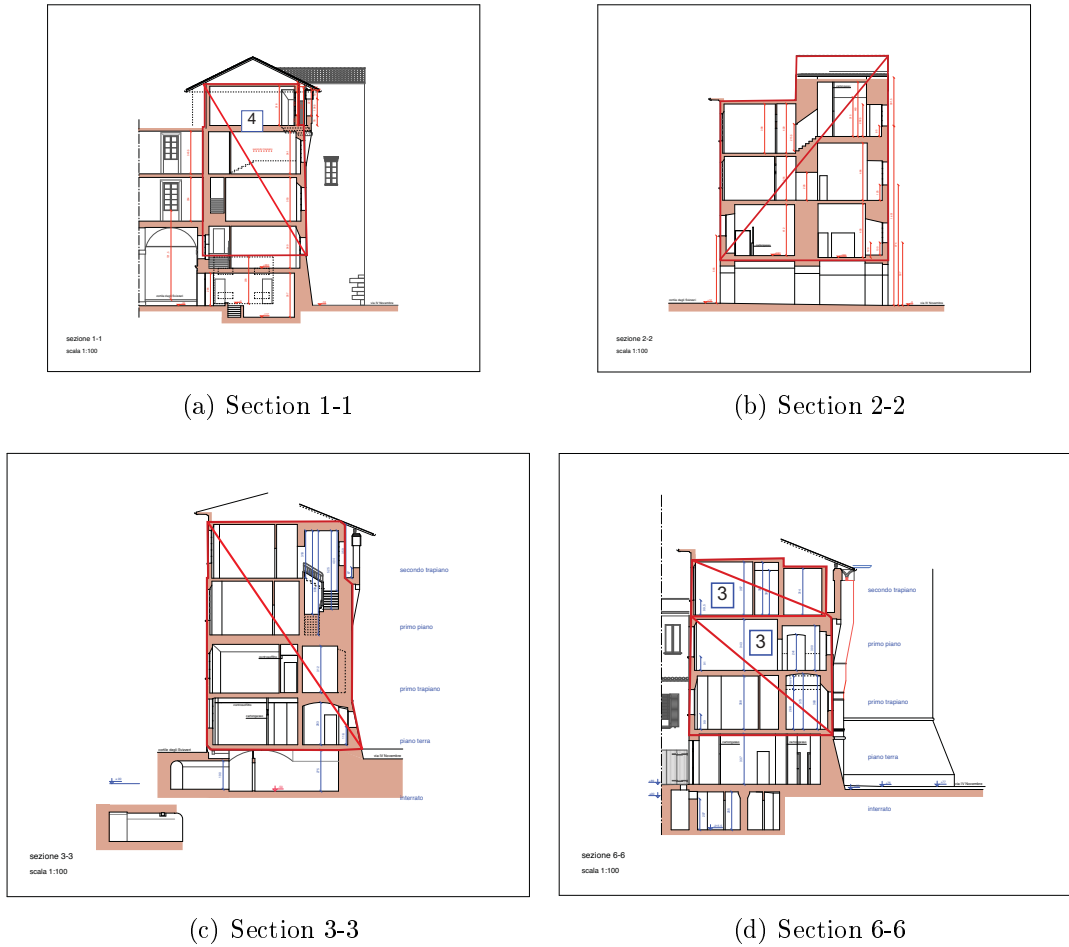
Figure 2.3: Sections of Office Building.
