**D 6.2 Documentation of each study case
CS2 Palazzo d'Accursio/Municipal Palace,
Bologna (Italy)
Delivered at M42**

**[Compatible solutions for improving the energy efficiency
of historic buildings in urban areas]**

Project Acronym	3ENCULT
Project Title	Efficient ENergy for EU Cultural Heritage
Project Coordinator	Alexandra Troi EURAC research, Viale Druso 1, 39100 Bolzano/Italy Alexandra.troi@eurac.edu
Project Duration	1 October 2010 – 31 March 2014 (42 Months)

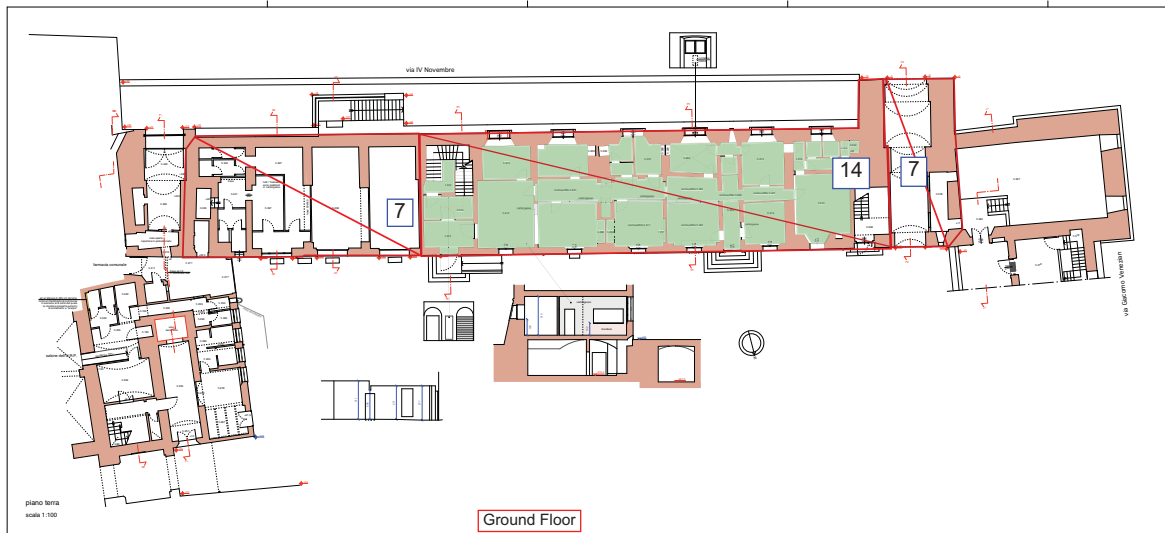
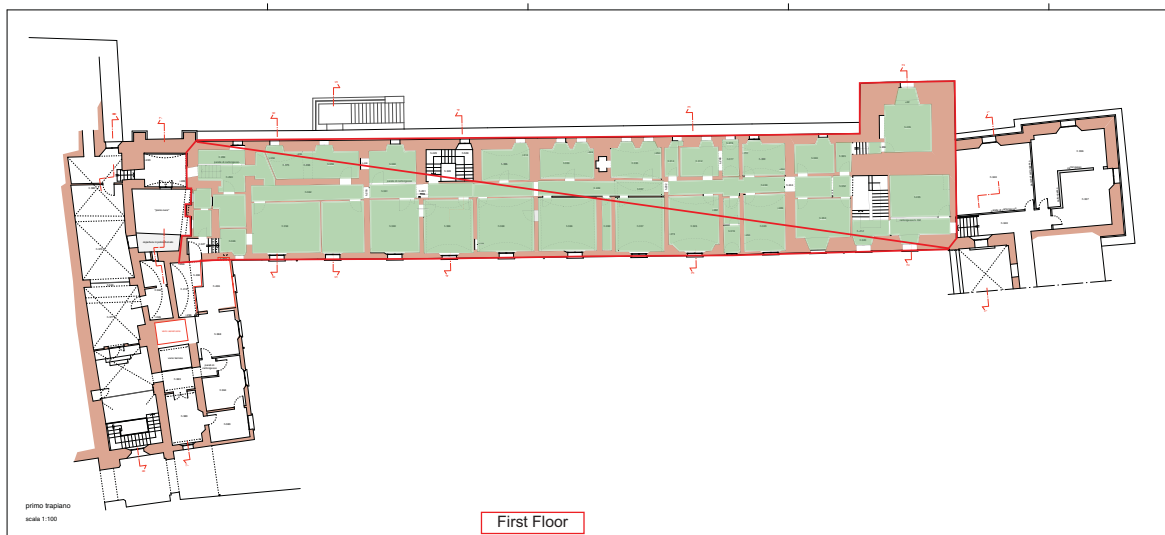
(a) TFA Ground Floor

(b) TFA First Floor

Figure 2.8: Treated floor Area of Office building.

The areas are presented with green color on the Figure 2.8 2.9. It is the standard representation of TFA, following the indication of the PHPP manual. More details are available in the tables 2.5 2.6 2.7, used to calculate the TFA starting from the analysis of each room.
