**D 6.2 Documentation of each study case:
CS7 Engineering School of Béjar, Salamanca
(Spain)
Delivered at M42**

**Seventh Framework Programme
Theme [EeB.ENV.2010.3.2.4-1]
[Compatible solutions for improving the energy efficiency
of historic buildings in urban areas]**

Project Acronym	3ENCULT
Project Title	Efficient ENergy for EU Cultural Heritage
Project Coordinator	Alexandra Troi EURAC research, Viale Druso 1, 39100 Bolzano/Italy Alexandra.troi@eurac.edu
Project Duration	1 October 2010 – 31 March 2014 (42 Months)

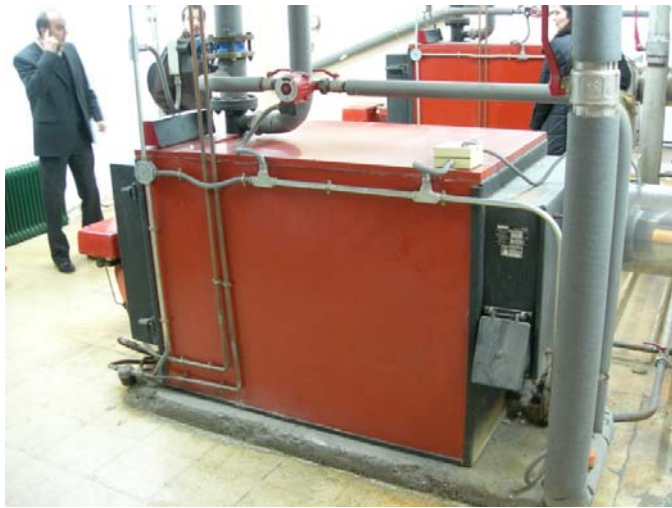
Description	<p>There are two gas-oil boilers from ROCA trademark where one of them is working in support mode. The main boiler has a power of 581kW whereas the second has 418.6kW. The performance of both boiler are 88.5% and 88.1% respectively. To supply of boilers, they have a tank/cistern of 25000 litres. The normal consumption during winter season is 60000 litres. This year they think that will be decreased the consumption to 45000 litres due to the timetable is reduced one hour. Years ago the boiler performs from 7:00 to 20:00. Currently, it performs from 7:00, but to 19:00. Weekends, the university college is closed and the boilers are switched off. It is estimated the consumption of boilers are about 600 litres each 13 hours. Although, it was before managed from the building, actually it is remote managed from Salamanca.</p>

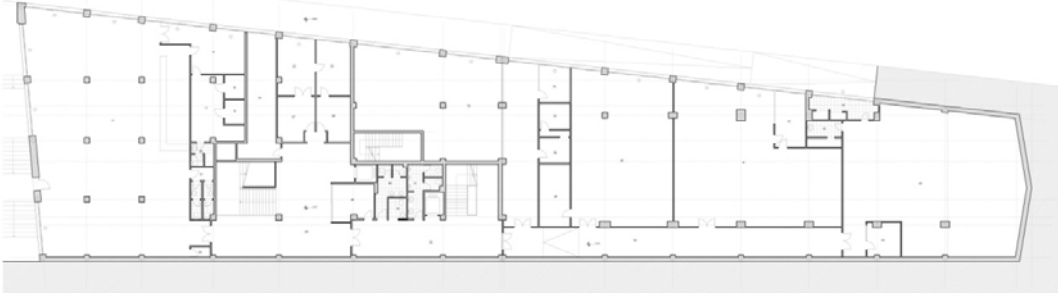
First basement

Description	This floor is assigned to common services of clinic and bar-canteen, in one part. In another part, it is assigned to machinery specialty workshop. Its installation will need special foundation lying.
Height interpolated average net (m)	----
Surface area	1470.75 m ²
Volume (gross/net) heated (m ³)	All the volume in this floor is heated
Number of rooms	32
Comments	----
Heritage aspects regarding the floor	Not applicable

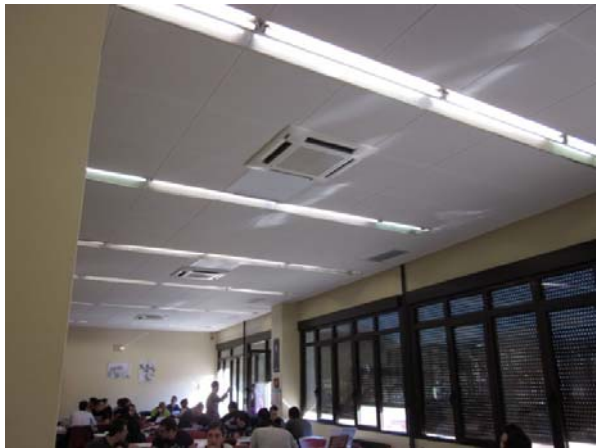
Description	Luminaires number: 48- Philips TL-D 36W/840 1SL (Low-pressure mercury discharge lamps with a diameter of 26 mm)
Other

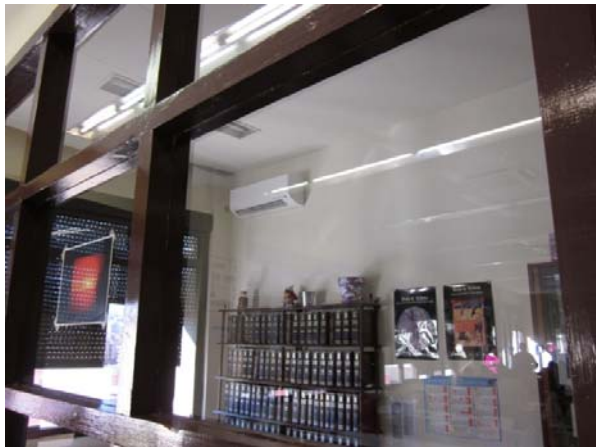
Description	Fan-coils units – There are 3 cassettes on library and 1 split in each office. All systems are inverter. Although the equipment is only used on summer, it was detected that in one of the offices, it is connected to heating generation

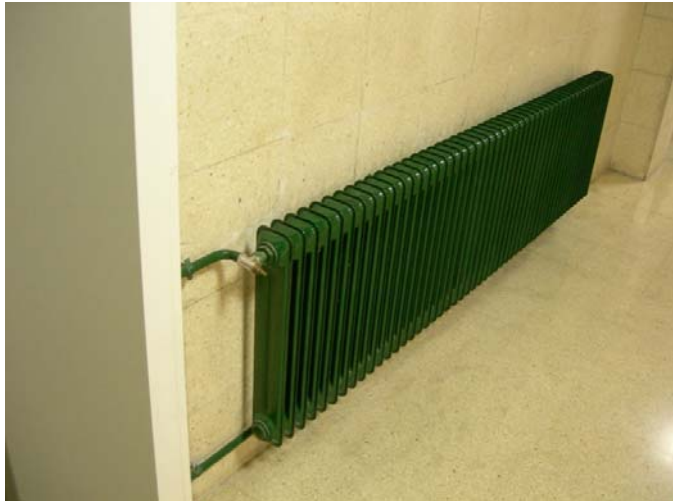
Description	Radiators number: 3
Ventilation

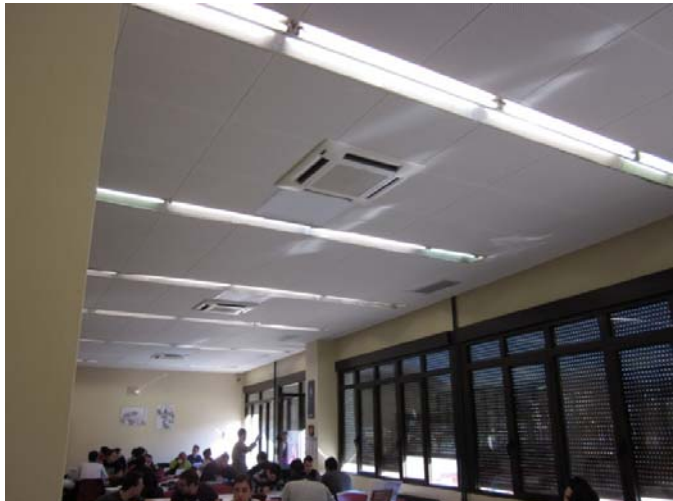
Description	Extractors number: 8
Potential and Limitations regarding the room	
Heritage value of room and its equipment in general	Not applicable
Possibility of additional window openings in exterior walls (max. size/limitations)	Not applicable
Possibility of additional layer inside ---> see also facade level	Not applicable
Possibility of installation of additional shading system (typology, integration in	There is a possibility for including shadow system in the windows on the East façade.

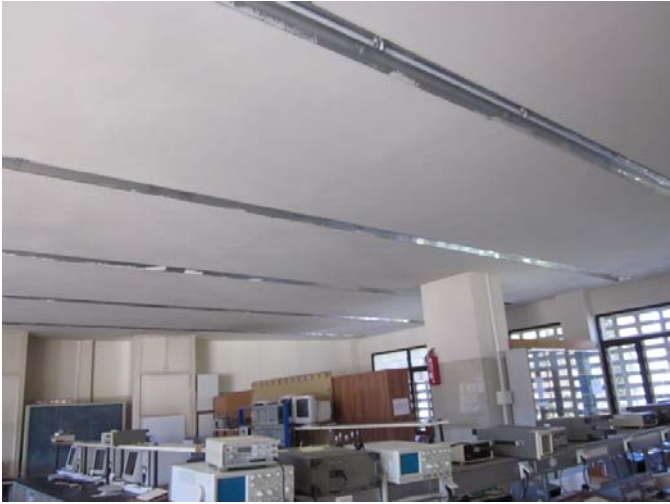
Description	Luminaires number: 60- Philips TL-D 36W/840 1SL (Low-pressure mercury discharge lamps with a diameter of 26 mm)
Other	See above
Description	Radiators number: 8

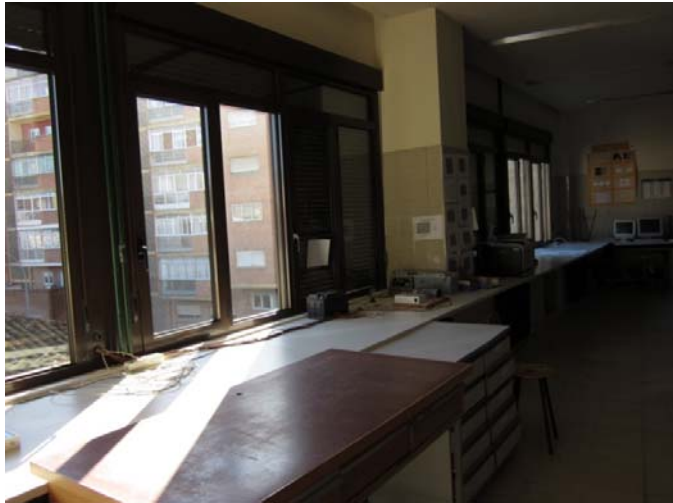
Description	<p>The windows on the building are relatively news. They are frames with glasses "Isolarglas". (They are looking for the invoices to obtain the features).</p> <p>"Isolarglas" is a thermic and acoustic isolated glazing formed by two or more glass panes separated by an aluminium profile filled in of molecular tapestry which absorbs residual humidity that avoids condensation inside the air chamber.</p> <p>An "Isolarglas" glazing with 12 mm chamber offers an energetic transmission coefficient U of 2.8W/m²K, while one simple glass pane reaches a coefficient of 5.8W/m²K.</p> <p>It is able of reduce the transmission loss of energy through the glass on 50% with this kind of glass.</p>
Potential and Limitations regarding the room	
Heritage value of room and its equipment in general	Not applicable
Possibility of additional window openings in exterior walls (max. size/limitations)	Not applicable

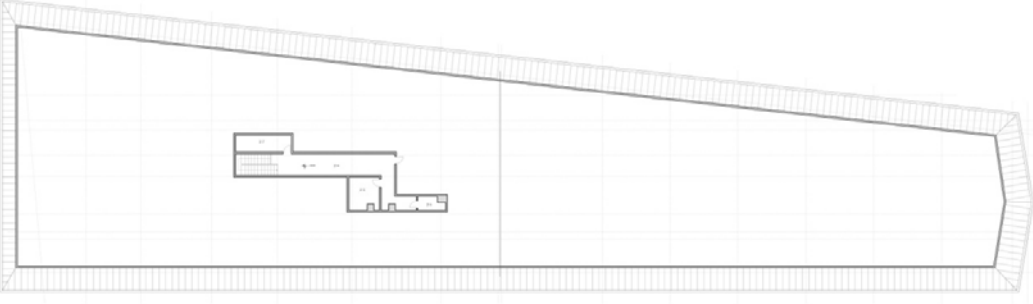
Top floor

Description	This top floor is the corresponding to the roof of the building where the weather station is installed, as well as the lift rooms.
Height interpolated average net (m)	----
Surface area	46.65 m ²
Volume (gross/net) heated (m ³)	No volume is heated in this floor.
Number of rooms	4
Comments	----
Heritage aspects regarding the floor	Not applicable

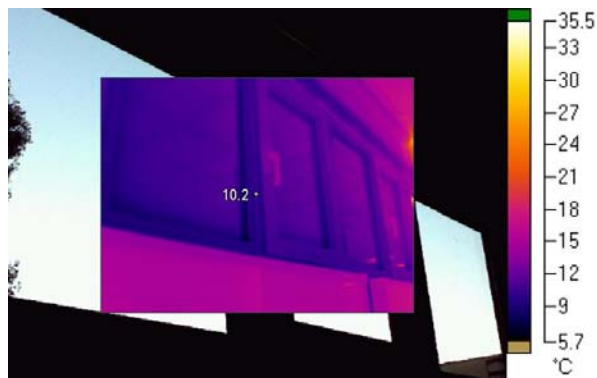
Figure 10: Windows infrared thermography

- Problem: Windows frame insulation (Thermal Bridge)
- Emissivity: 0.85
- Reflected temperature: 25.9°C

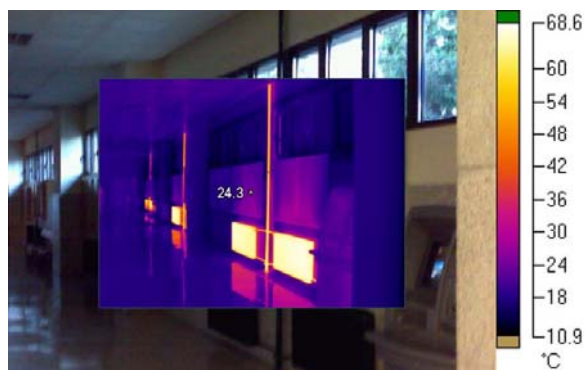
Figure 11: Radiators infrared thermography

- Problem: Radiator emission
- Emissivity: 0.85
- Reflected temperature: 25.9°C

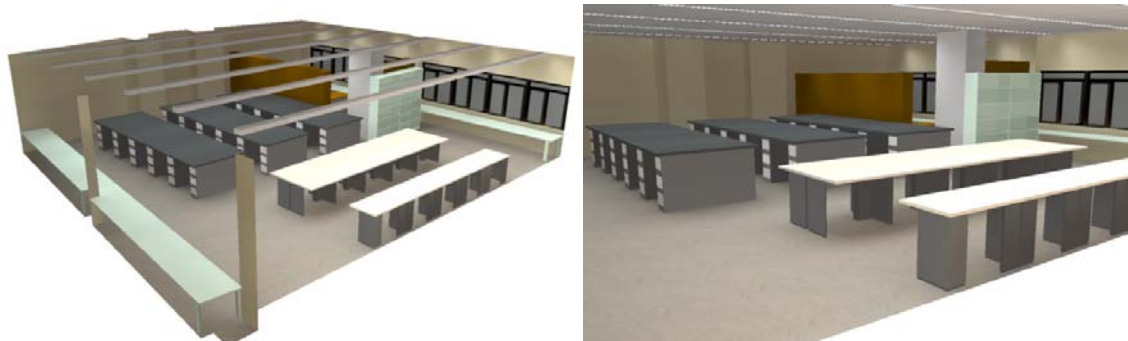
Figure 12: 3D model for the dialux simulation

As starting point, Figure 12 displays the 3D model for the physics laboratory as input of the simulation tool.
