D8.9 Educational Material for University Studies

Innovative concepts for energy saving refurbishment in historic buildings

Title of the lesson: "Innovative Konzepte der energetischen Sanierung im Baudenkmal"

Description of the contents: The energy requirement of a historic building can be substantially reduced finding the right solutions and implementing the high quality. This is the guiding principle in the European research project 3ENCULT "Efficient Energy for EU Cultural Heritage": for the energy retrofit of a historic building the multidisciplinary exchange between all stakeholders starts with a comprehensive diagnosis of the status quo, supports the development of solutions and selection of the most appropriate one, and does not end before an integrated monitoring and control, which verifies and guarantees performance. Methods to be applied include (i) conservation inventory system (as e.g. "Raumbuch") which are further developed in order to well interface with energy issues, but also (ii) conservation related non or minor destructive testing (NDT) technologies (as e.g. IR-thermography, ground penetrating radar, ultrasonic tests) as well as (iii) energy performance related

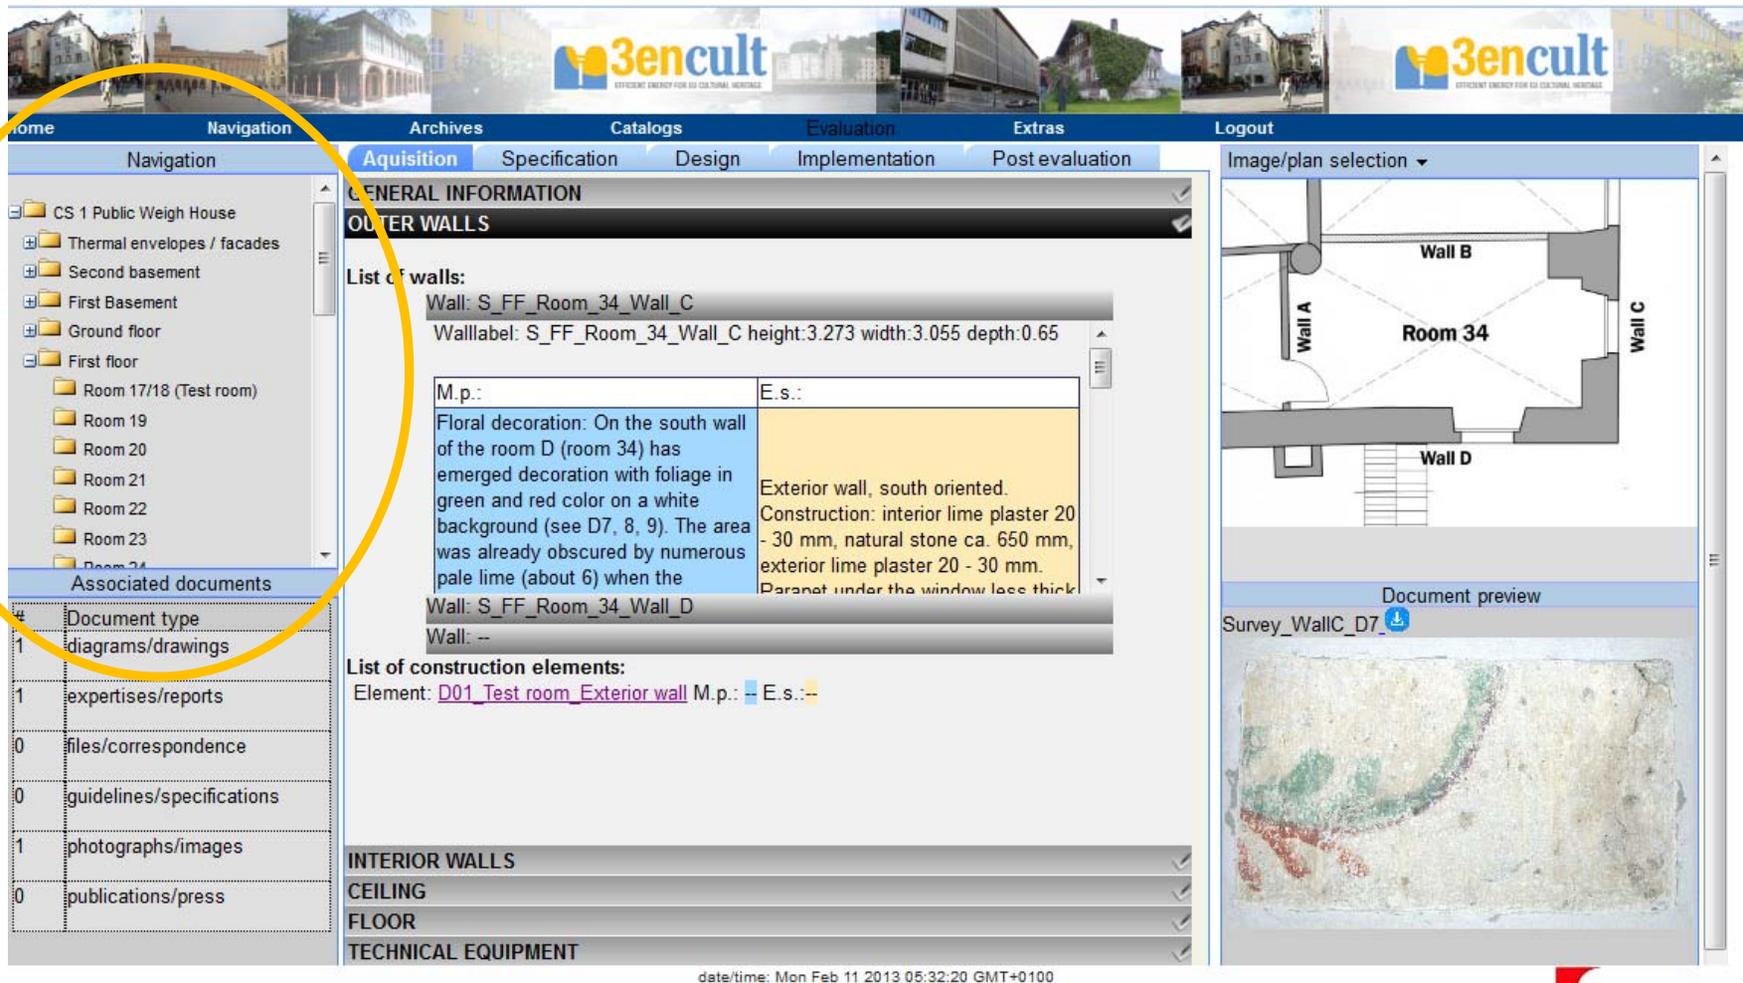
Navigationsstruktur

The screenshot displays the 3encult web application interface. A yellow circle highlights the navigation tree on the left side, which is structured as follows:

- GENERAL INFORMATION**
- OUTER WALLS**
- List of walls:**
 - Wall: S_FF_Room_34_Wall_C
 - Walllabel: S_FF_Room_34_Wall_C height:3.273 width:3.055 depth:0.65
 - M.p.: Floral decoration: On the south wall of the room D (room 34) has emerged decoration with foliage in green and red color on a white background (see D7, 8, 9). The area was already obscured by numerous pale lime (about 6) when the
 - E.s.: Exterior wall, south oriented. Construction: interior lime plaster 20 - 30 mm, natural stone ca. 650 mm, exterior lime plaster 20 - 30 mm. Parapet under the window less thick
 - Wall: S_FF_Room_34_Wall_D
 - Wall: --
- List of construction elements:**
 - Element: [D01_Test room_Exterior wall](#) M.p.: E.s.:-
- INTERIOR WALLS**
- CEILING**
- FLOOR**
- TECHNICAL EQUIPMENT**

The right side of the interface shows a plan view of Room 34 with walls labeled Wall A, Wall B, Wall C, and Wall D. Below the plan view is a document preview titled 'Survey_WallC_D7' showing a photograph of a wall with floral decorations.

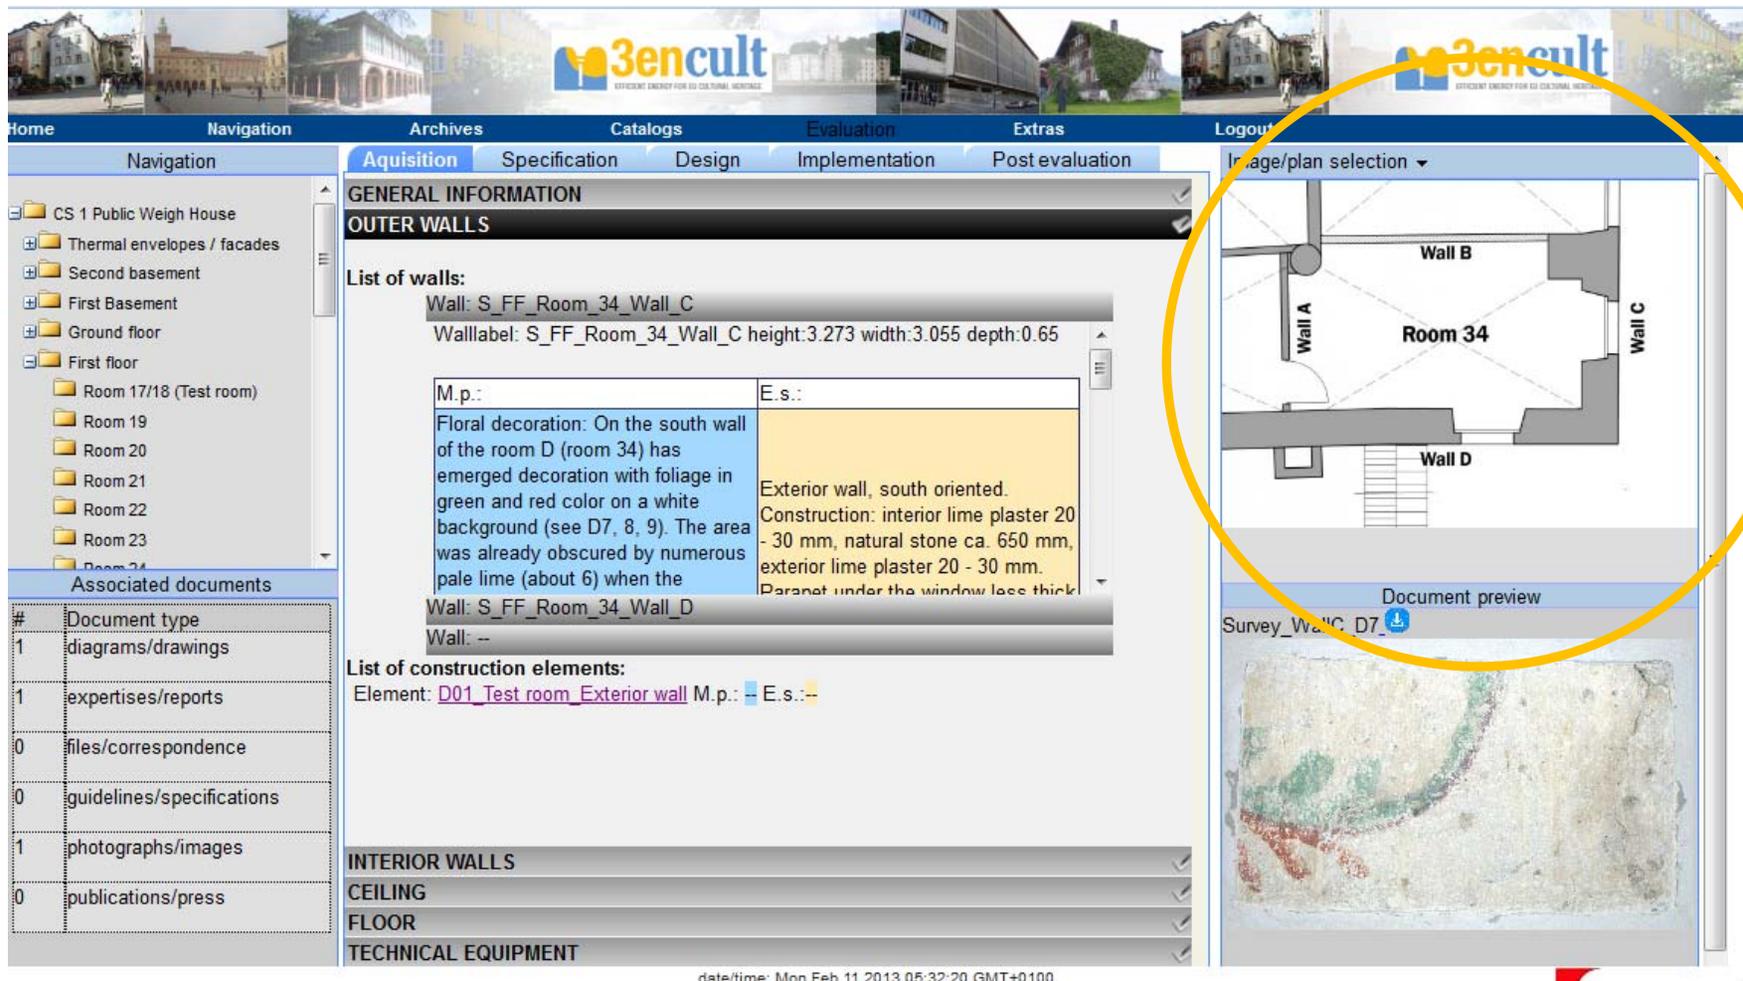
Pläne und Bilder zur Orientierung

Wall: S_FF_Room_34_Wall_C
Walllabel: S_FF_Room_34_Wall_C height:3.273 width:3.055 depth:0.65

M.p.:	E.s.:
Floral decoration: On the south wall of the room D (room 34) has emerged decoration with foliage in green and red color on a white background (see D7, 8, 9). The area was already obscured by numerous pale lime (about 6) when the	Exterior wall, south oriented. Construction: interior lime plaster 20 - 30 mm, natural stone ca. 650 mm, exterior lime plaster 20 - 30 mm. Parapet under the window less thick

Room 34

Wall A, Wall B, Wall C, Wall D

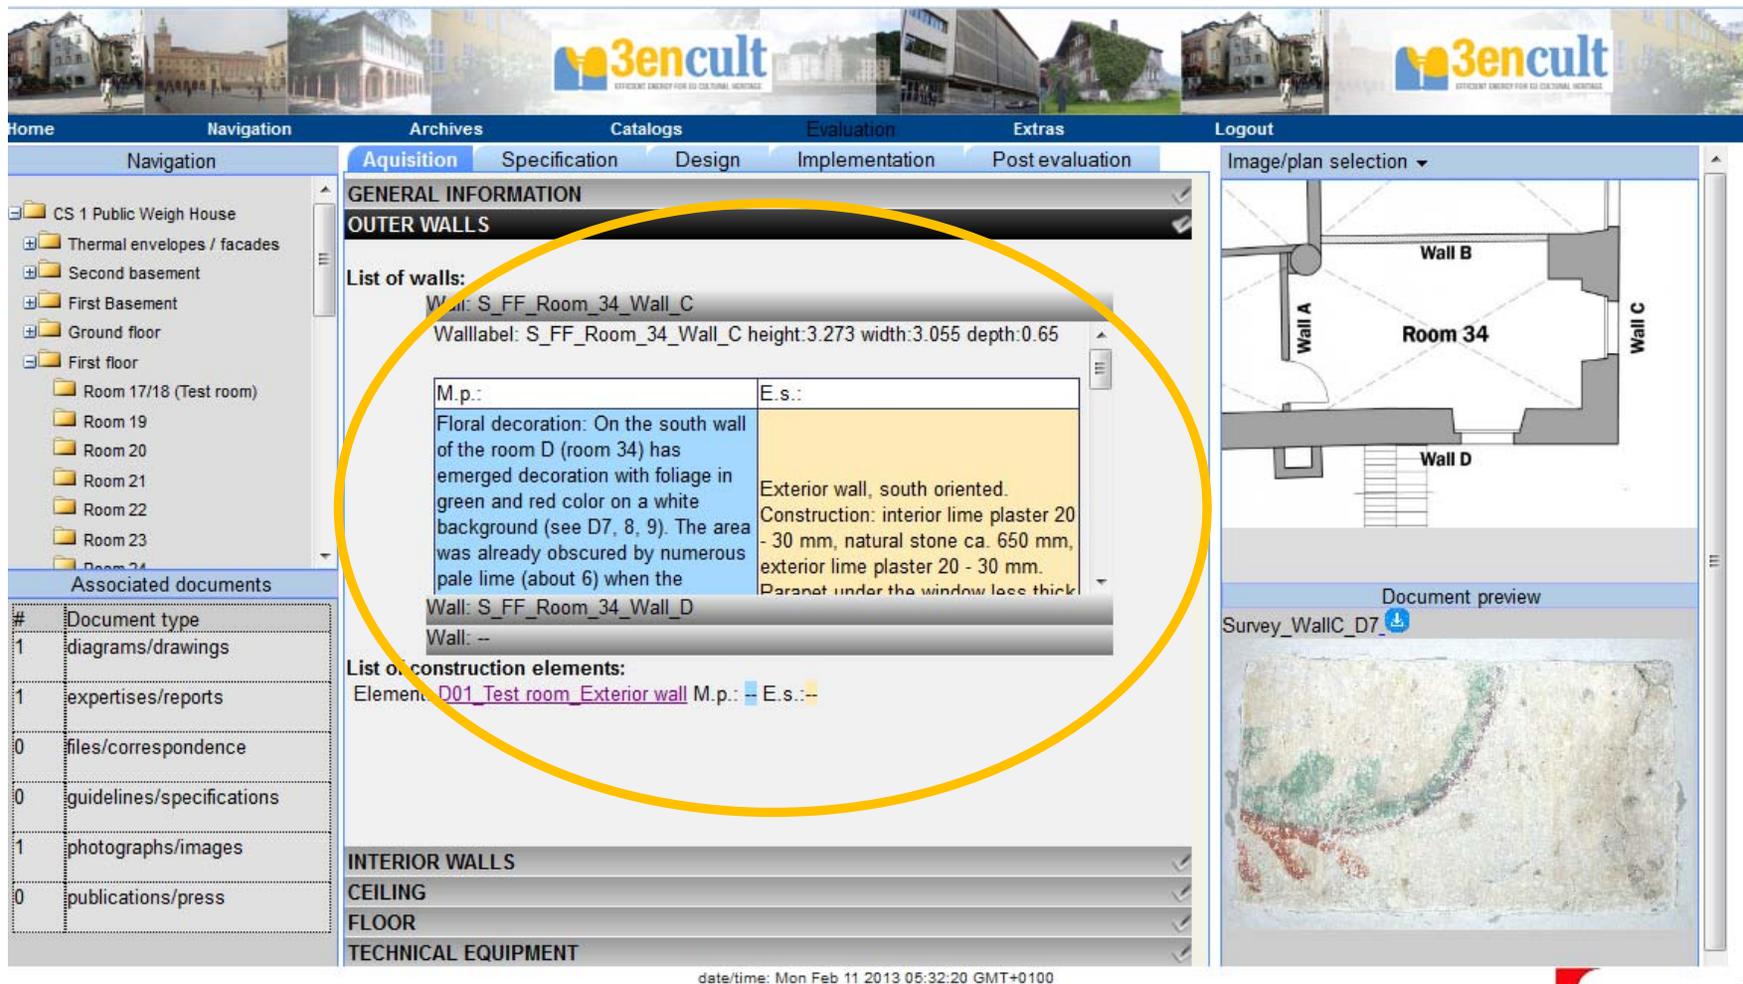
Mittelteil mit der parallele Beschreibung

The screenshot shows the 3encult web application interface. The main content area is titled "GENERAL INFORMATION" and "OUTER WALLS". A yellow circle highlights a specific wall element, "Wall: S_FF_Room_34_Wall_C". The details for this wall are as follows:

M.p.:	E.s.:
Floral decoration: On the south wall of the room D (room 34) has emerged decoration with foliage in green and red color on a white background (see D7, 8, 9). The area was already obscured by numerous pale lime (about 6) when the	Exterior wall, south oriented. Construction: interior lime plaster 20 - 30 mm, natural stone ca. 650 mm, exterior lime plaster 20 - 30 mm. Parapet under the window less thick

Element: [D01_Test room_ Exterior wall](#) M.p.: [-](#) E.s.: [-](#)

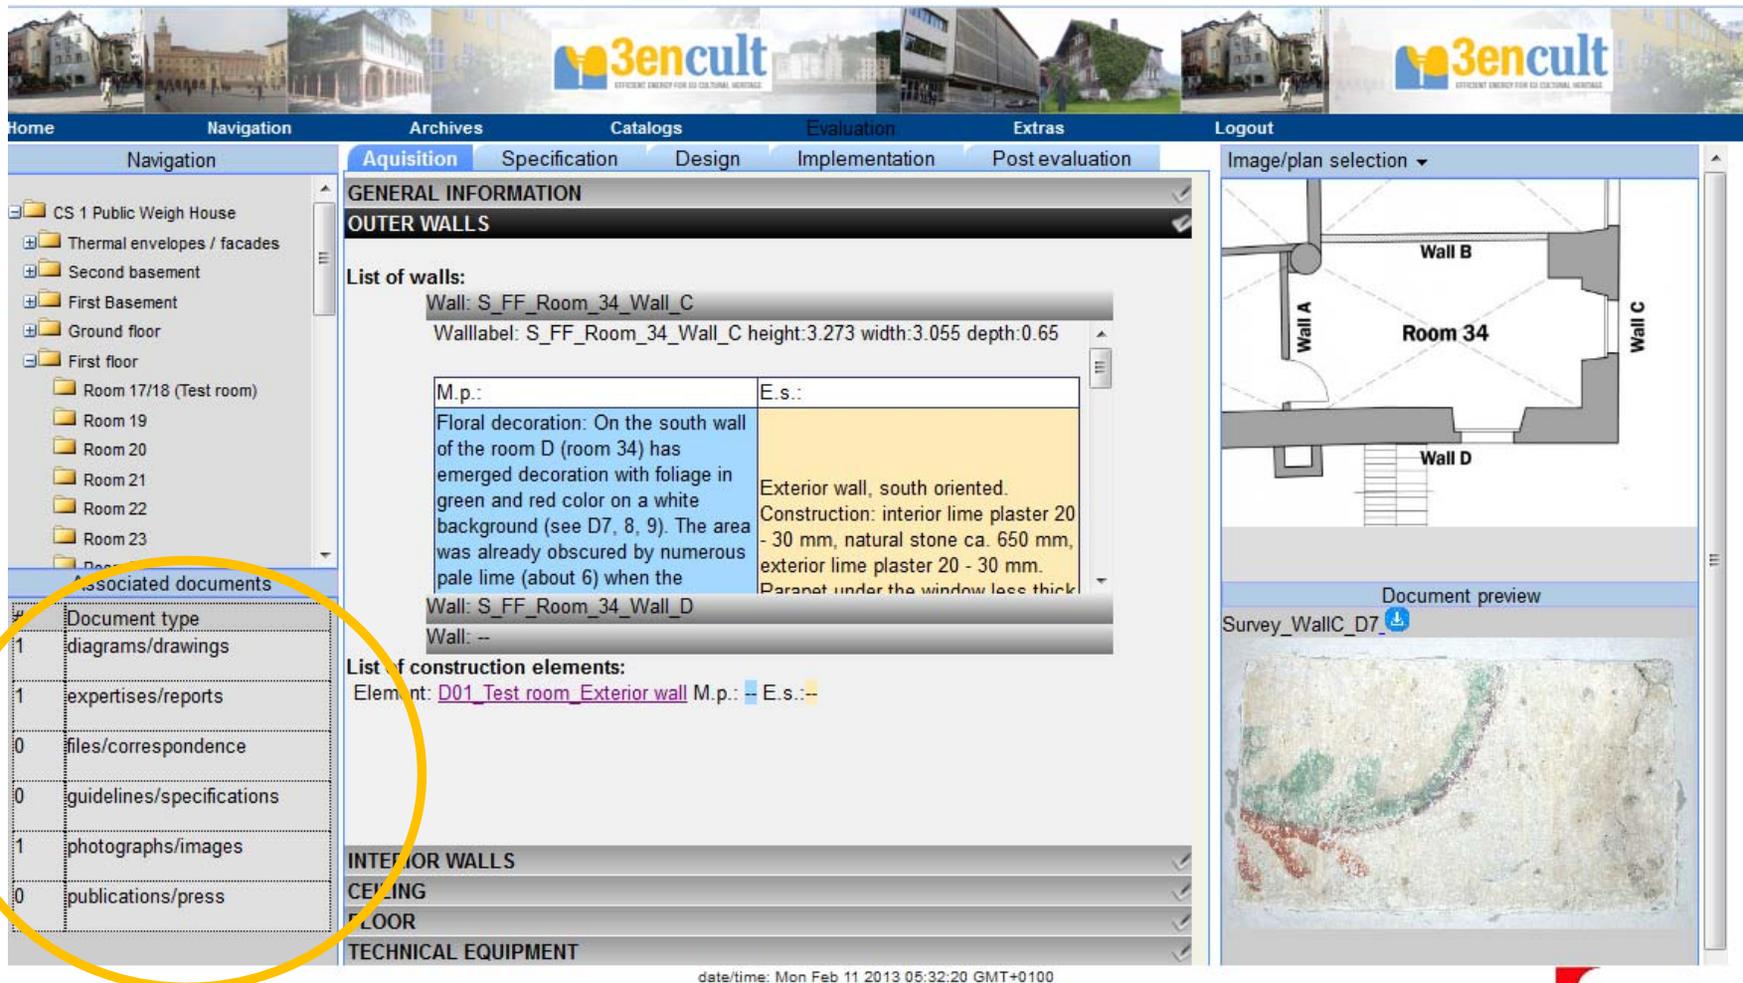
Zusatzdokumente

- Navigation:** A tree view on the left shows the project structure, including 'CS 1 Public Weigh House', 'Thermal envelopes / facades', 'Second basement', 'First basement', 'Ground floor', and 'First floor'. Under 'First floor', there are rooms 17/18 (Test room), 19, 20, 21, 22, and 23. A yellow circle highlights the 'Associated documents' section, which lists document types and their counts: diagrams/drawings (1), expertises/reports (1), files/correspondence (0), guidelines/specifications (0), photographs/images (1), and publications/press (0).

- GENERAL INFORMATION:** The main content area shows 'OUTER WALLS' and a 'List of walls:' section. The selected wall is 'Wall: S_FF_Room_34_Wall_C' with dimensions: height: 3.273, width: 3.055, depth: 0.65. Below this is a table with 'M.p.' and 'E.s.' columns. The 'M.p.' column contains text about floral decoration on the south wall of room D (room 34). The 'E.s.' column contains technical details about the exterior wall construction.

- Image/plan selection:** A diagram on the right shows a plan view of 'Room 34' with walls labeled Wall A, Wall B, Wall C, and Wall D.
- Document preview:** A preview of a document titled 'Survey_WallC_D7' is shown at the bottom right, featuring a photograph of a wall with decorative elements.

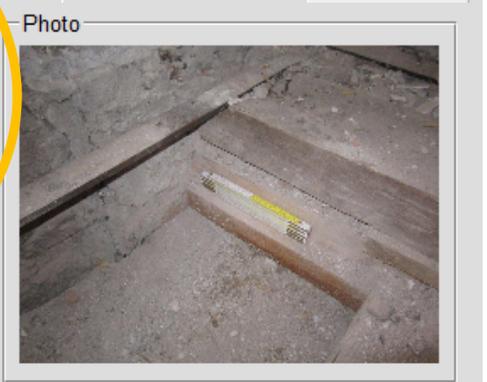
... mit Detailzeichnung

Construction element: D01_Test room_Ceiling over Portici 1
Area: 467
Entered by: Dagmar Exner
Total Thickness (mm): 467
Comment: --
Date: 2012-12-13 22:31:34

U-value (calculated): 1.34
U-value (measured): 0
RSI: Downward(0.17)
RSE: Thermal Resistance of the exterior surface(0.04)

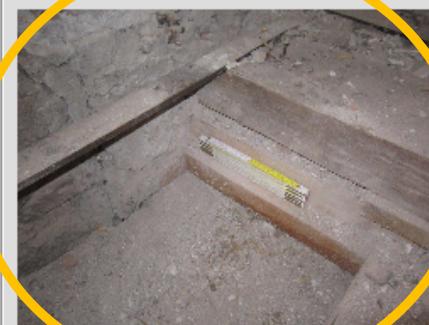
Photo

Construction element: D01_Test room_Ceiling over Portici 1
Area: 467
Entered by: Dagmar Exner
Total Thickness (mm): 467
Comment: --
Date: 2012-12-13 22:31:34

U-value (calculated): 1.34
U-value (measured): 0
RSI: Downward(0.17)
RSE: Thermal Resistance of the exterior surface(0.04)

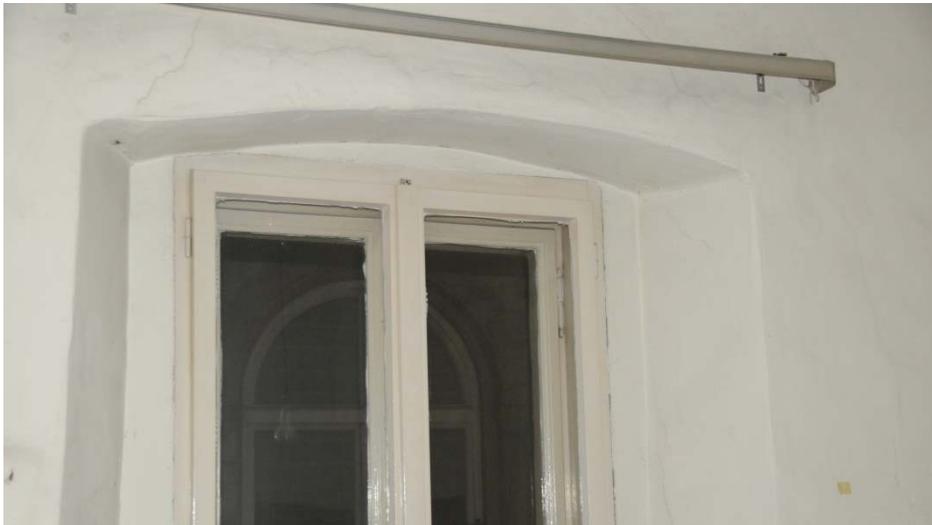
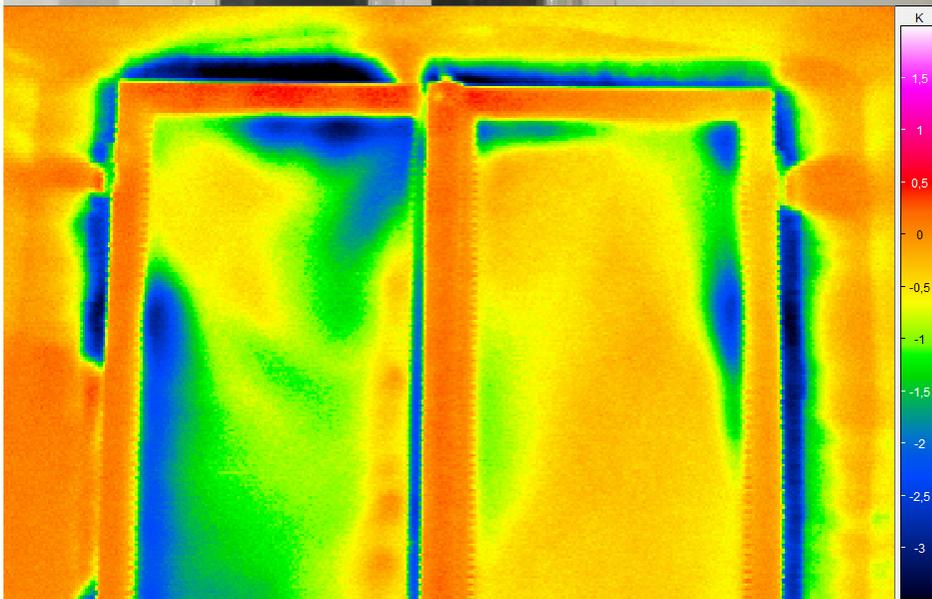
Fenster im Gebäudebestand ...

... sind in der Regel

- nicht wärmeisolierend

z.B. CS1 Waaghaus / Bozen:

→ 33 kWh/m²

= 11% der gesamten
Transmissionverluste

- nicht luftdicht

→ ~40 kWh/m²

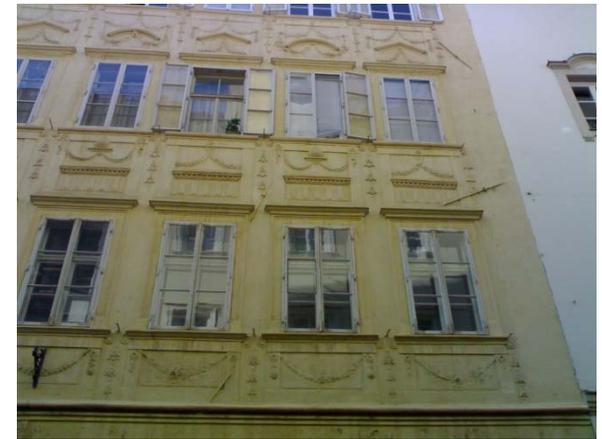
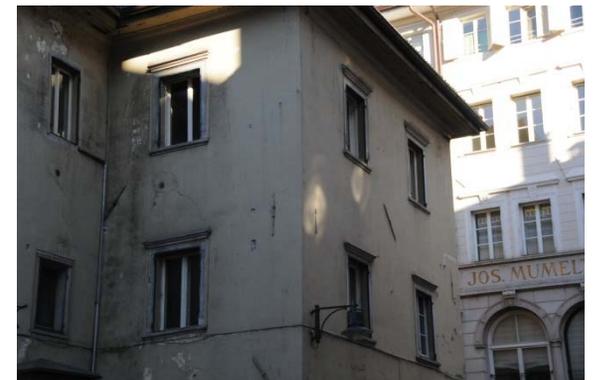
- Bei Originalfenstern mit Denkmalwert
 - Restaurierung des bestehenden Fensters
- Oft aber wurden – wie im 3ENCULT CS1 – die originalen Fenster bereits ausgetauscht
 - Neues energieeffizientes und ästhetisch passenderes Fenster

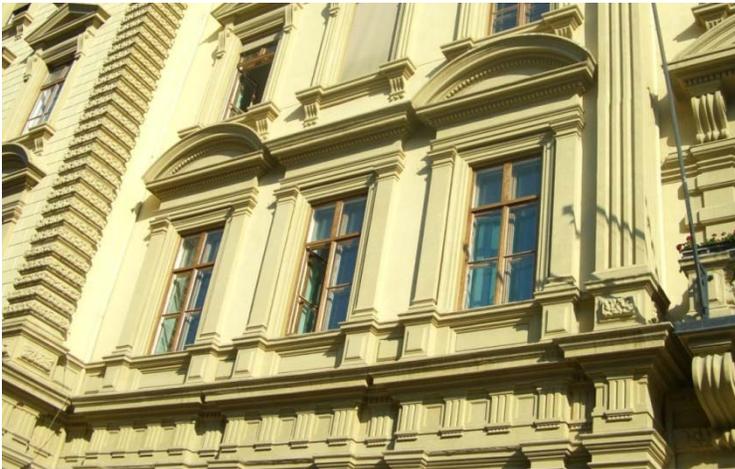
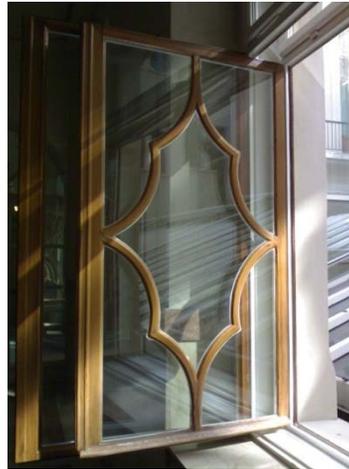
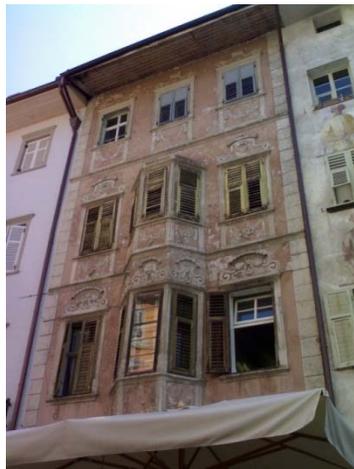
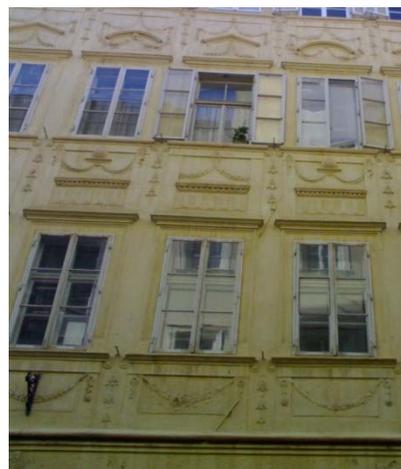
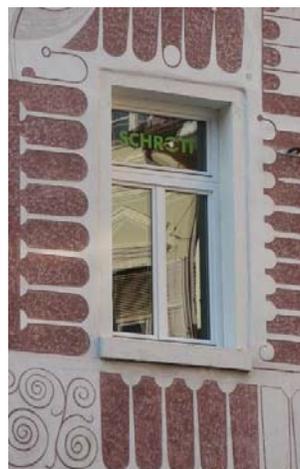
Workshop in Bozen

- Die Fenstergröße ist typisch für eine barockes Fenster
- Da die Fenster Mitte des 20. Jh ausgetauscht wurden und über die originalen keine Informationen vorhanden sind empfiehlt die Denkmalpflege ein regional typisches „barockes“ Fenster:
 - Zwei Flügel mit jeweils zwei Unterteilungen
 - Sowohl Kasten- als auch Verbundfenster sind möglich
- Dokumente & Zeichnungen für Recherche

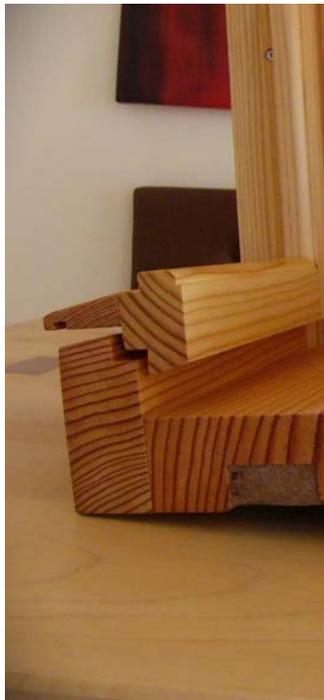
Workshop in Bozen

- Energetisches Ziel: “Passivhaus” Fenster
- Fenster mit zwei verschiedenen Gläsern
 - außen, um der historischen Optik gerecht zu werden eine Einfachverglasung
 - innen eine isolierende Dreifachscheibe

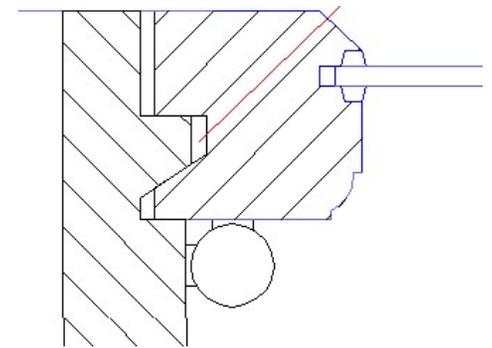
Beim Studium der alten Zeichnung hat Freundorfer auch den sogenannten „Geißfuß“ gefunden, eine clevere geometrische Anordnung, die es erlaubt dass sich der Flügelrahmen beim Schließen von außen seitlich hinter den Blendrahmen hineindreht. Mit dieser Idee ist es ihm schlussendlich auch gelungen, das Fenster auch als Kastenfenster in die energieeffiziente Fassung zu bringen.

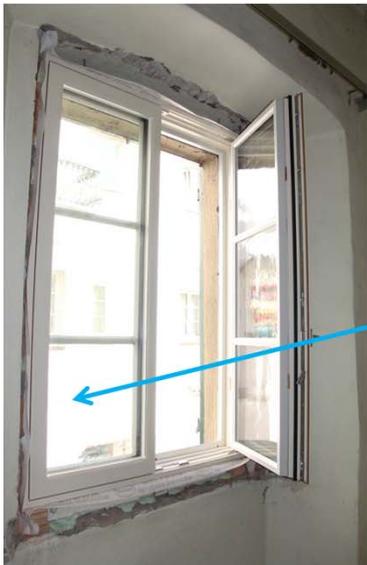
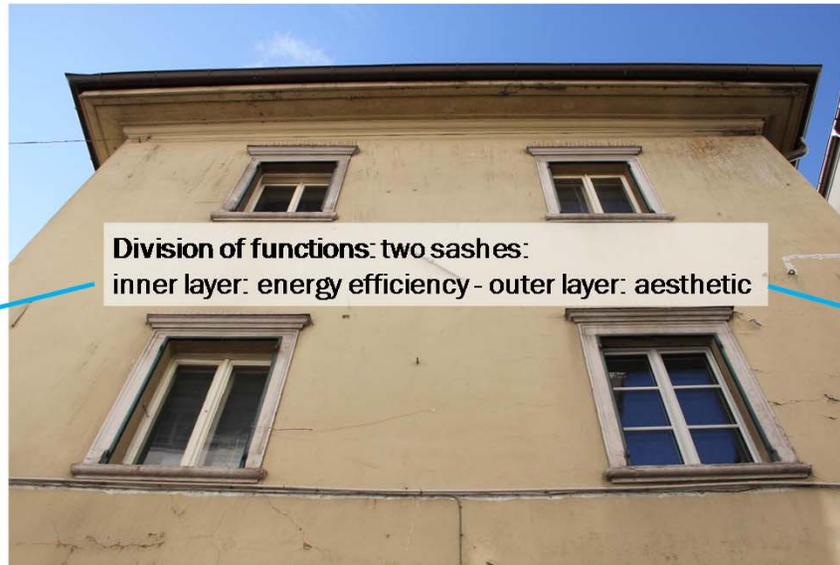
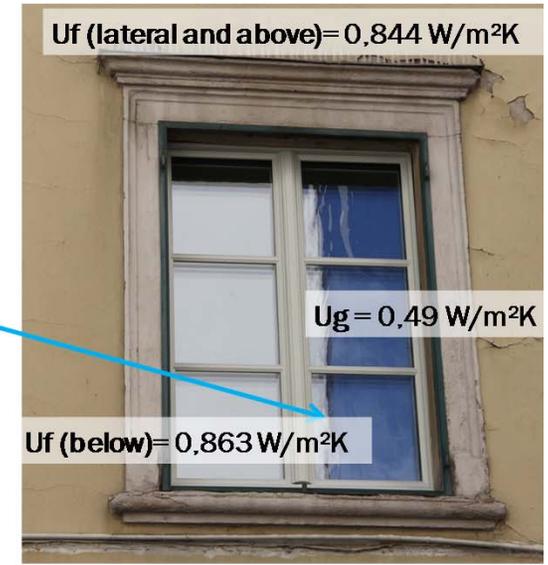
Installation des 1. Prototypen am Waaghaus

Division of functions: two sashes:
inner layer: energy efficiency - outer layer: aesthetic

Uf (lateral and above) = 0,844 W/m²K

Ug = 0,49 W/m²K

Uf (below) = 0,863 W/m²K

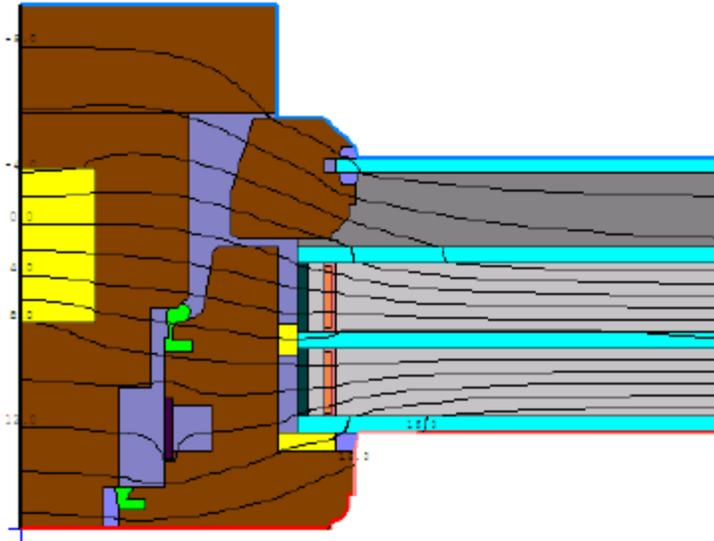
Effizienz des 1. Prototypen

Wärmestrom = 8,6102 W
 $U_f = 0,840 \text{ W}/(\text{m}^2\text{K})$
 $\text{Psi}_{\text{Spacer}} = 0,0206 \text{ W}/(\text{mK})$

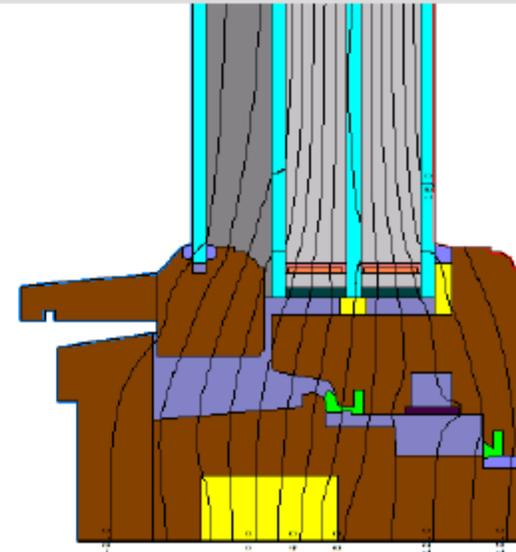
Wärmestrom = 8,6504 W
 $U_f = 0,861 \text{ W}/(\text{m}^2\text{K})$
 $\text{Psi}_{\text{Spacer}} = 0,0203 \text{ W}/(\text{mK})$

$U_w = 0,726 \text{ W}/(\text{m}^2\text{K})$
 $\text{Psi}_{\text{opak}} = 0,0985 \text{ W}/\text{mK}$

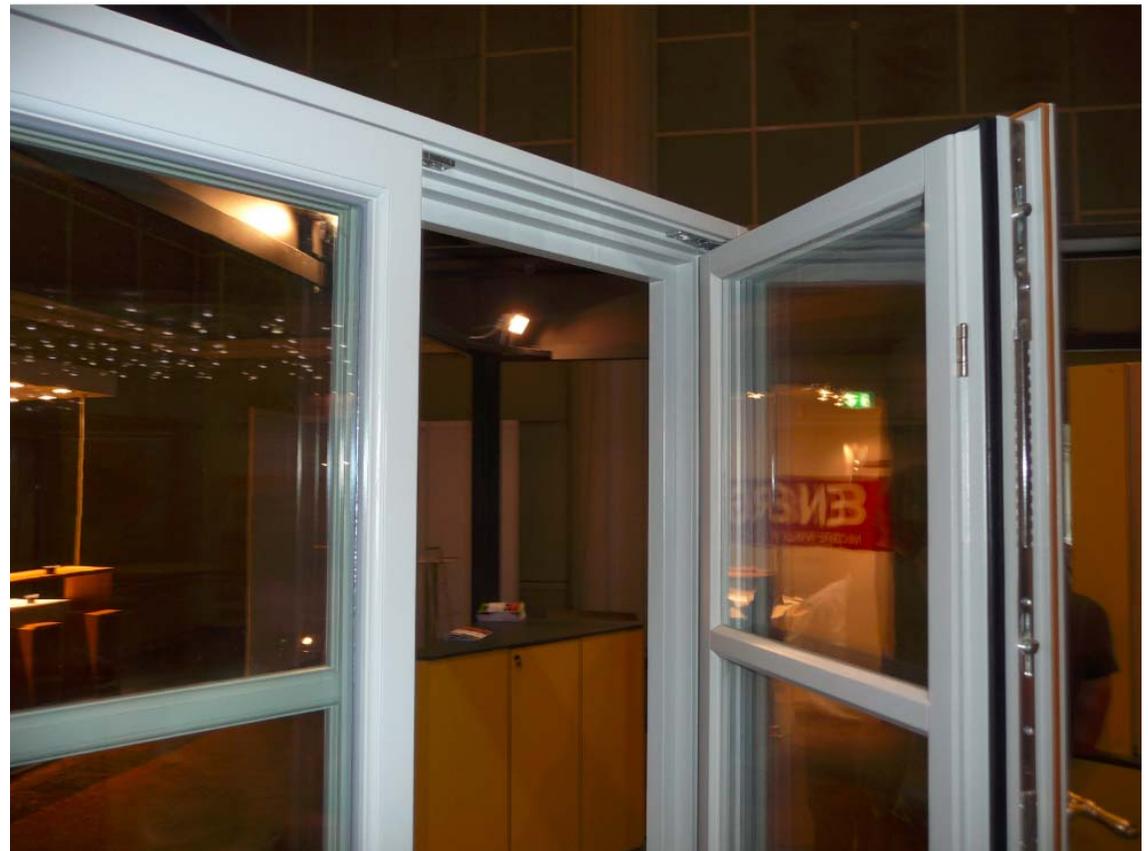
u.a. Anwendung von Dünnglas → 2mm!

- $2+8+2+8+2$
= 22 mm

- $4+12+4$
= 20 mm

- macht die Konstruktion noch leichter und graziler
- öffnet für die Fensterrestaurierung neue Wege

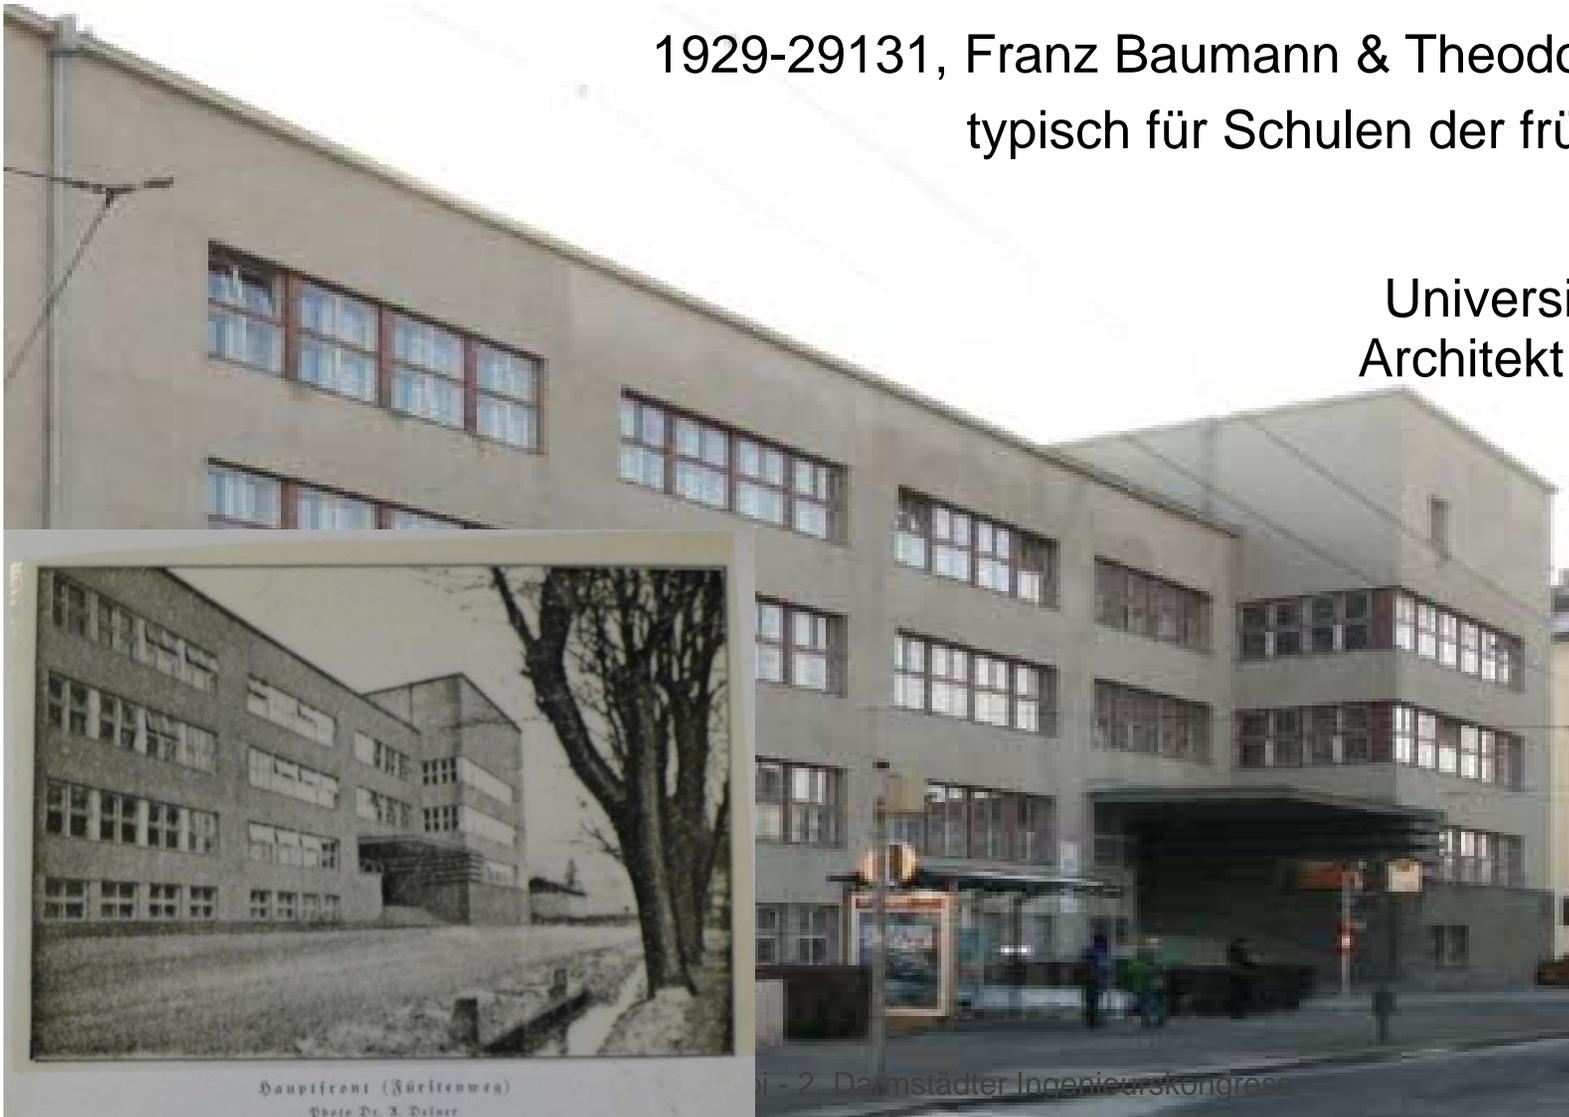
1929-29131, Franz Baumann & Theodor Prachensky
typisch für Schulen der frühen Moderne

In 3ENCULT:
Universität Innsbruck,
Architekt Gerald Gaigg

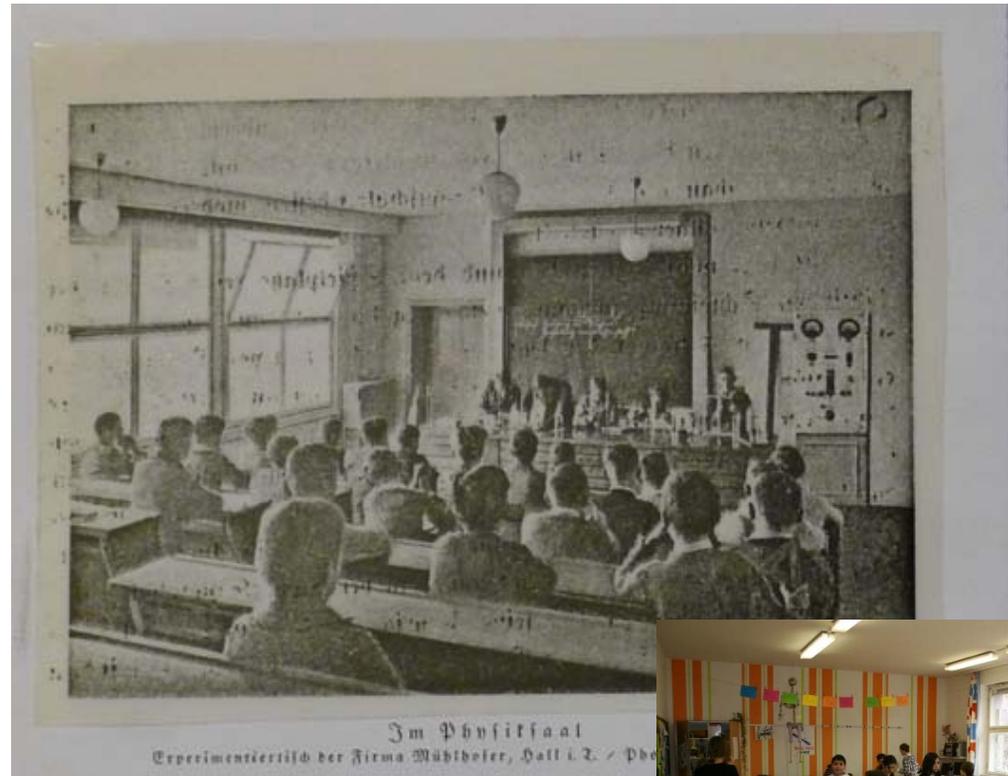
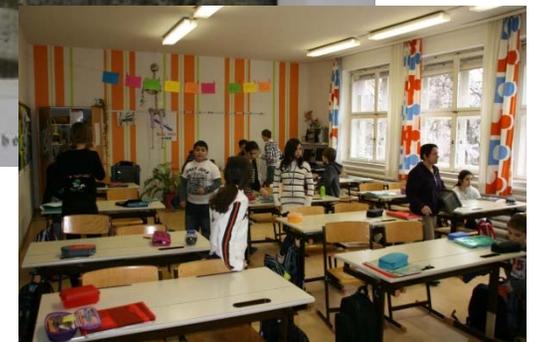
... kann durch Stoßlüften zwischen den Unterrichtsstunden nicht gewährleistet werden

Frischluftbedarf ...

CO₂ (ppm)

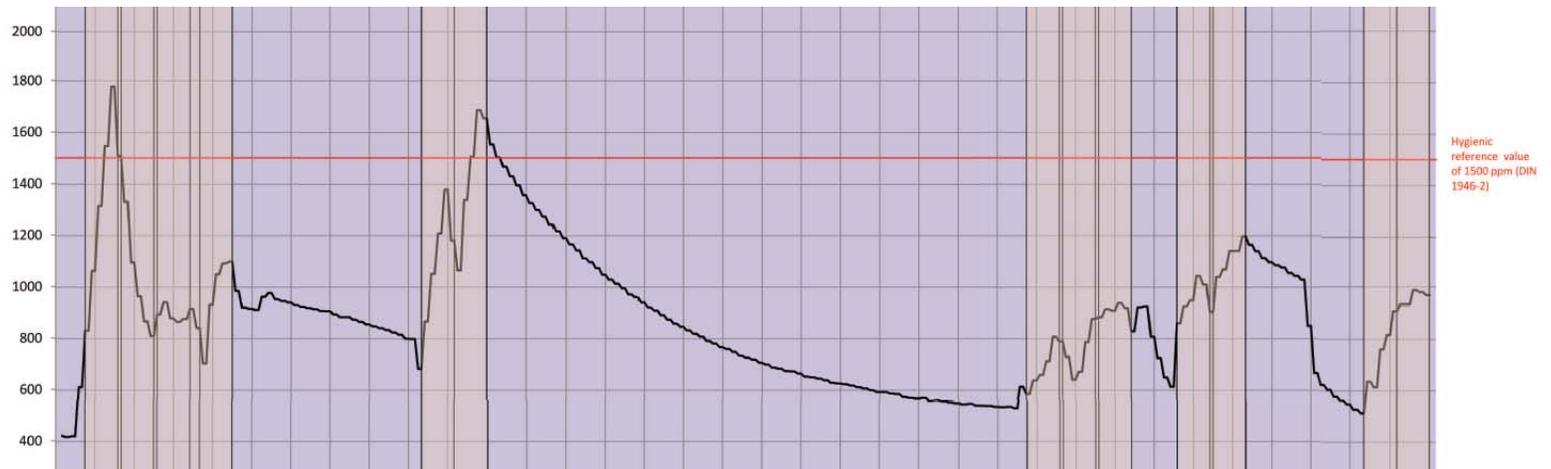
Frischluftbedarf ...

→ Fenster werden auch während des Unterrichts geöffnet

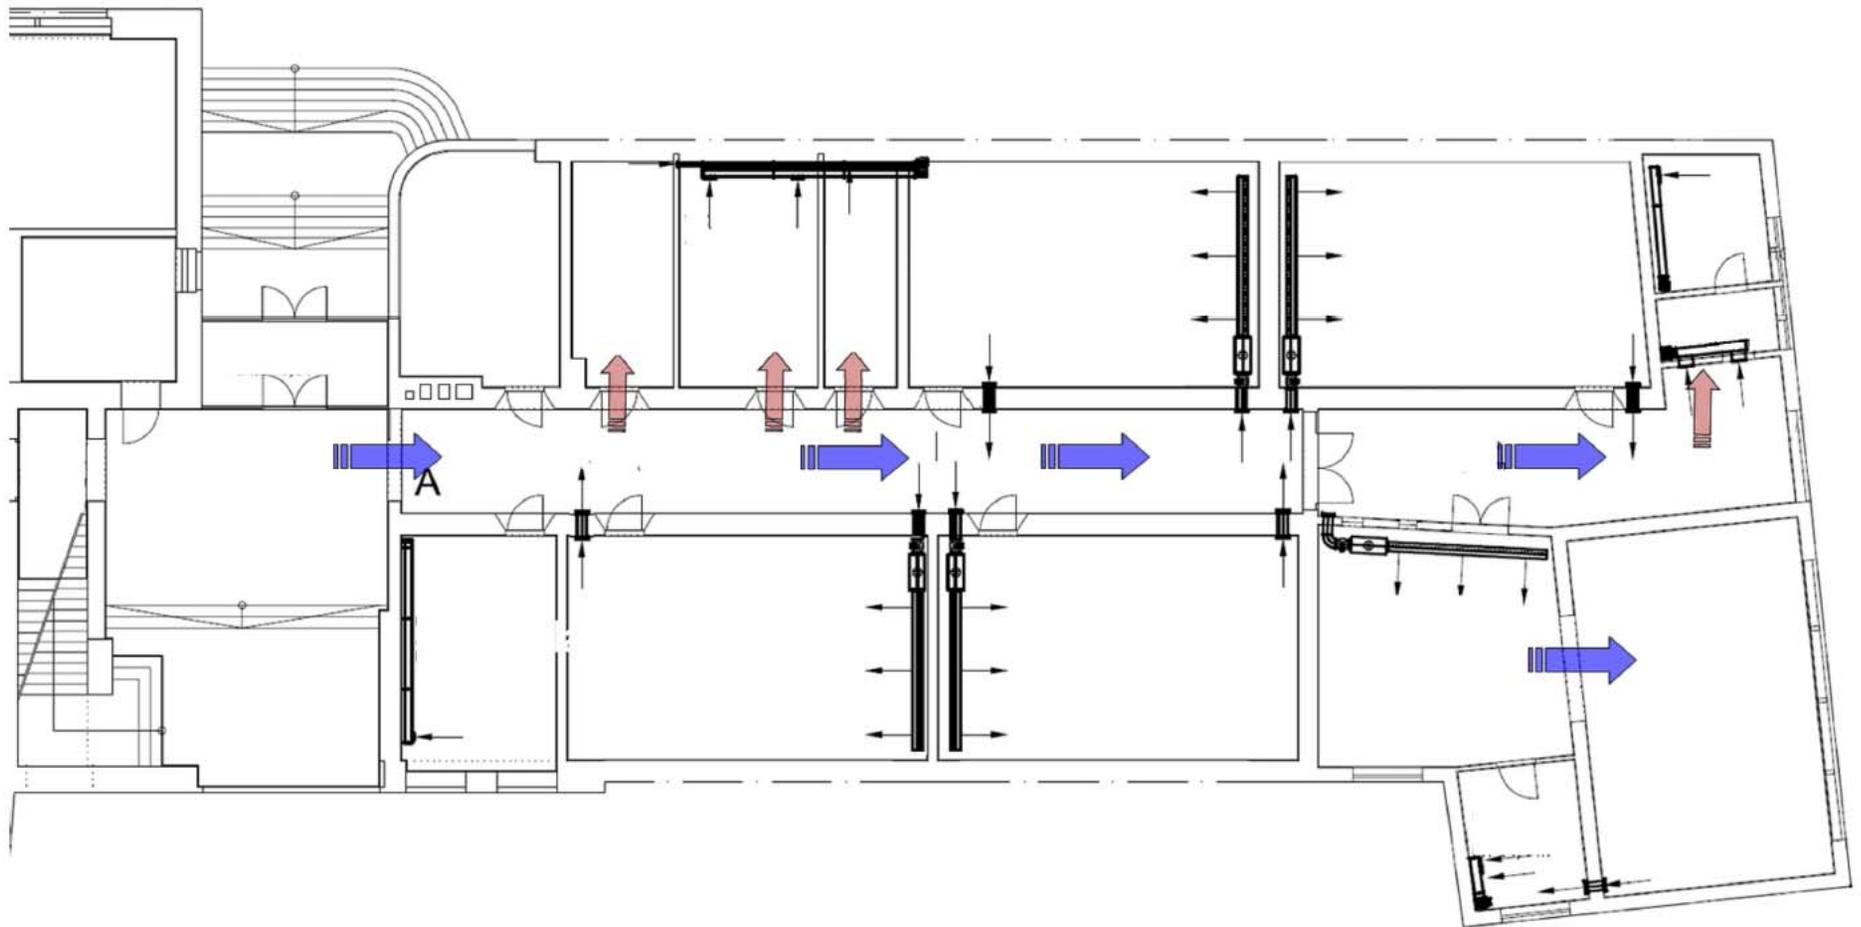
Korridore als Frischluftreservoir

- **Frischluftreservoir** in den Gängen

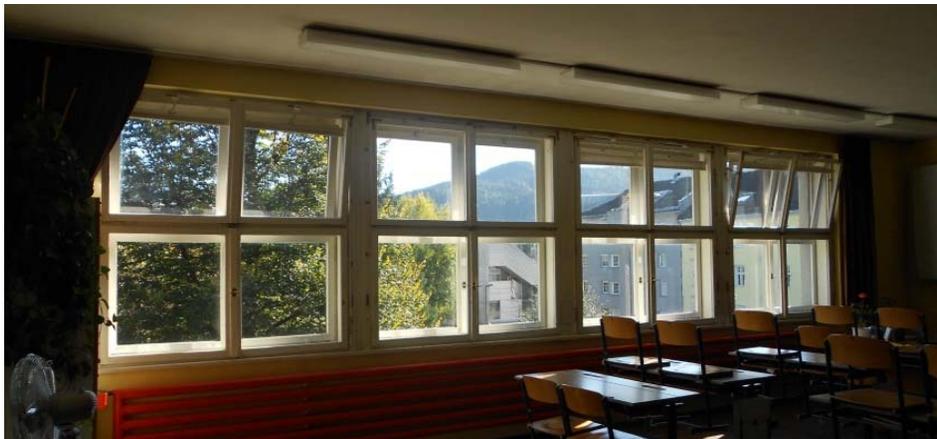
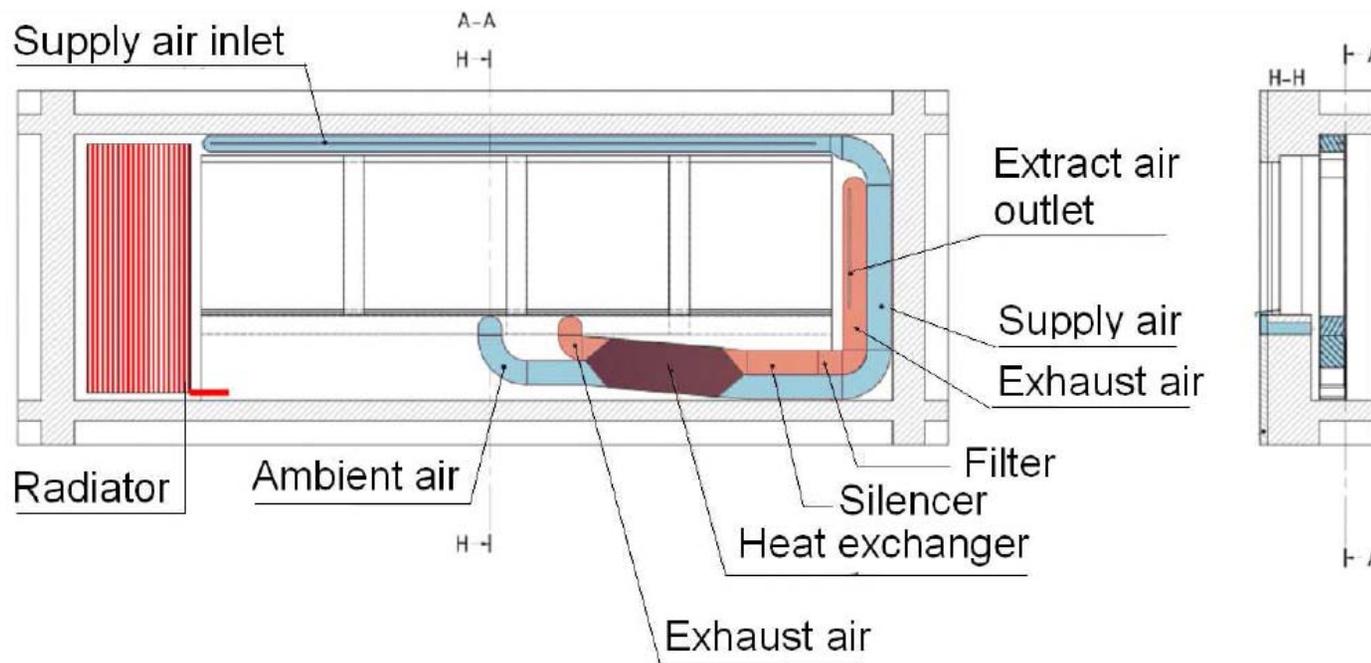
Dezentrale Lüftung

- minimal invasiv und ästhetisch unauffällig im Parapett untergebracht

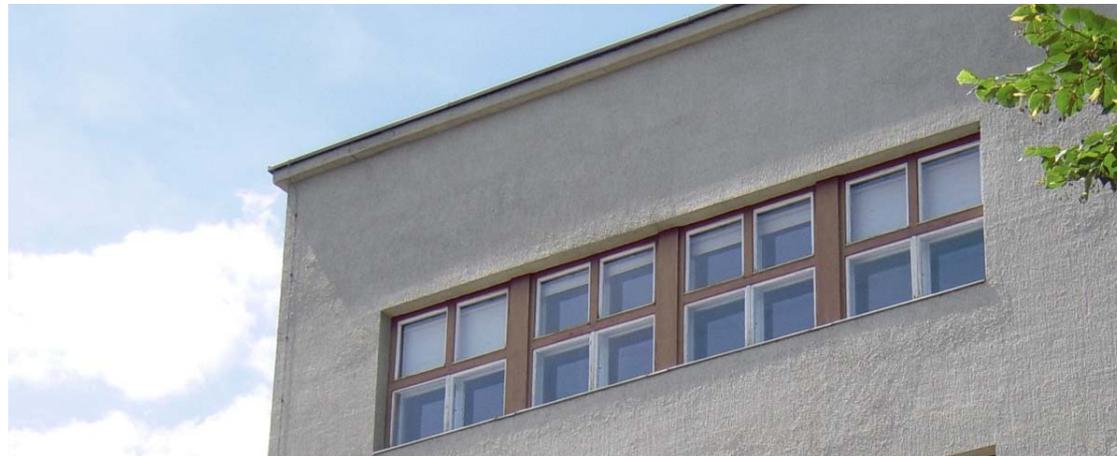
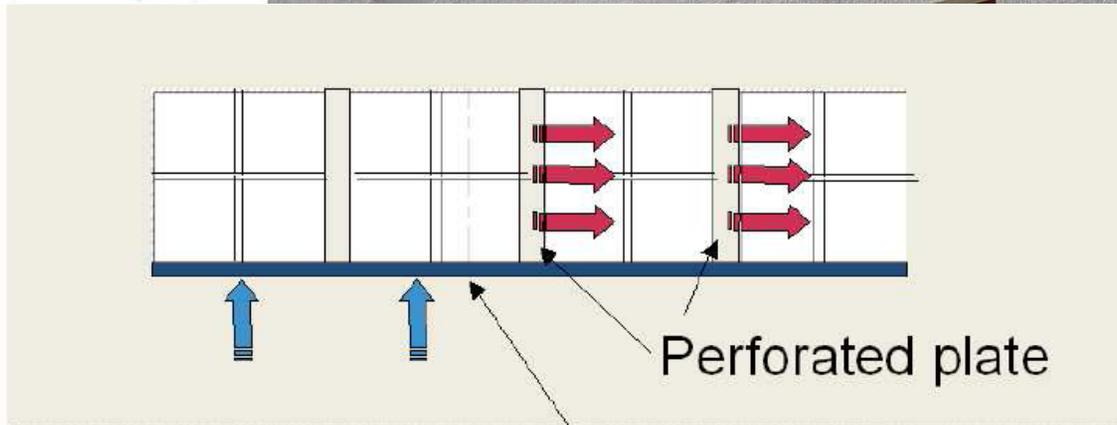
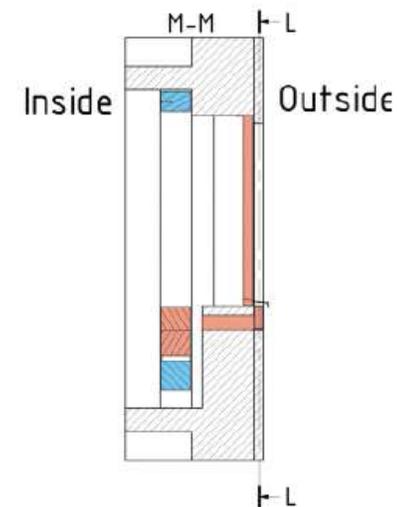
Dezentrale Lüftung

- Frischluft über Schlitz unter dem Fensterbrett
- Fortluft über perforierte Platte (o.ä.) im Fensterpfosten
