SUSTAINABLE NATURAL VENTILATION AND COOLING OF MUSEUMS

ABSTRACT

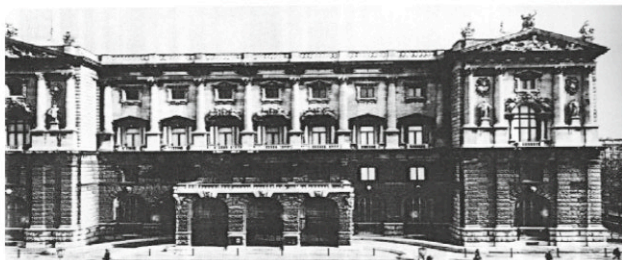
In the “Hofburg”, a historical building of the late 1890, a natural ventilations system was installed.

Figure 2 View to historic Hofburg.

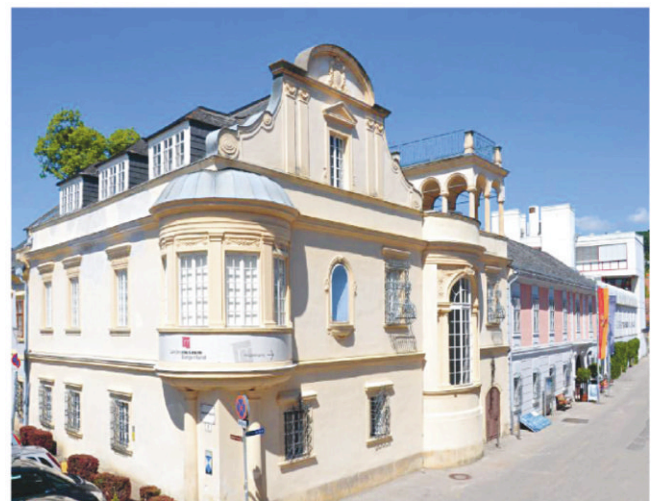
Insufficient shading systems, far too “hot” lighting in the exhibition rooms and strong southern sun, slowly increased room temperature to above 26°C due to heat accumulation in the outside walls.

Figure 8 View to the Landesmuseum, Eisenstadt

A simple system of natural ventilation through windows was installed after having improved shading and lighting. On the northern side of the museum, in the courtyard, a window ventilator with an efficient filter of about 2.000m³/h was mounted on a wooden board instead of the glass.

On the southern façade, a window ventilator was installed as an exhaust system in a box window. The ventilation system is controlled by temperature and absolute humidity and will be activated at night (and sometimes also at daytime) when all parameters are favorable to cooling. Also this system is driven by small overpressure of about 10 Pa.

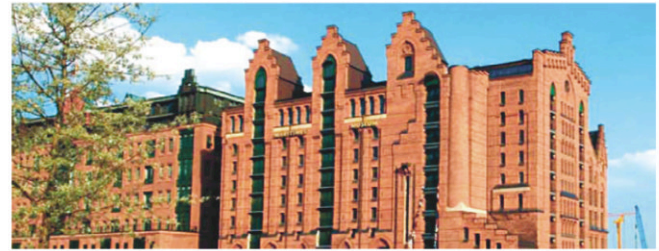
Always in summer, exhibition room temperatures exceeded 26°C, especially on upper floors.

Figure 11 Maritim Museum, Hamburg, D.

Moreover, there was another major problem: the ventilation of the museum was based on leaky windows with the negative result of dust pollution in the exhibition rooms and entrance of outside climate in winter (dry and cold outside air) and humid air in summer, due to a large uncontrolled air exchange rate.

The first step to improve climate stability and dust pollution in the exhibition rooms was to stop uncontrolled air exchange through the gaps of the windows by sealing them. Then the anti smoke ventilation system and the flaps on top of the museum were activated during hot summer periods when night temperature was significantly lower than day temperature, controlled by comparing not only temperature inside and outside the museums but also absolute humidity.

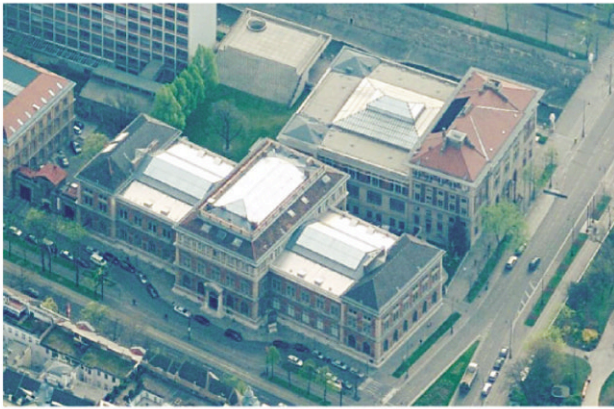
Figure 12 View to the glass roofs in MAK, Vienna.

The reason for the heat accumulation in this museum are glass roofs, which were refurbished with insulating glass and inside shading resulting in tremendously hot exhibition rooms in summer.
