Public Weigh House

Alexandra Troi, EURAC research

Diagnosis and pre-intervention status

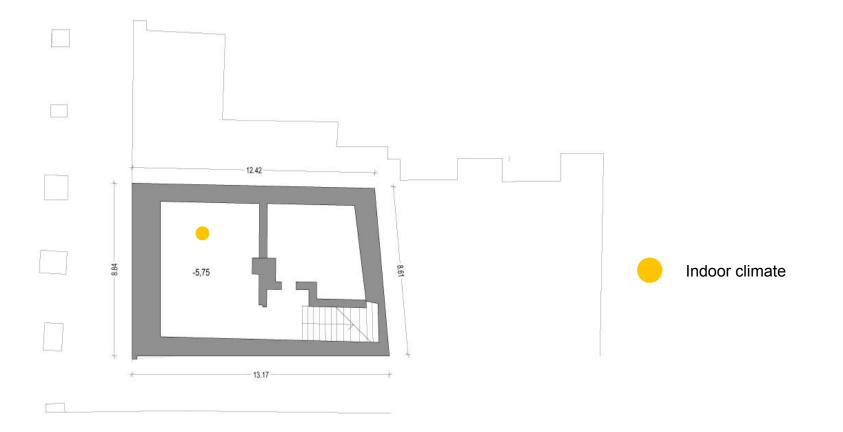
GROUNDPLAN_SECOND BASEMENT

Monitoring layout: Second basement

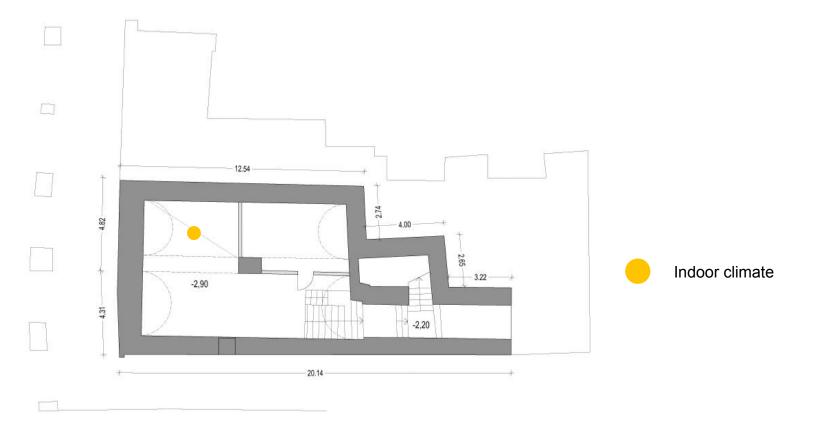
GROUNDPLAN_FIRST BASEMENT

Monitoring layout: First basement

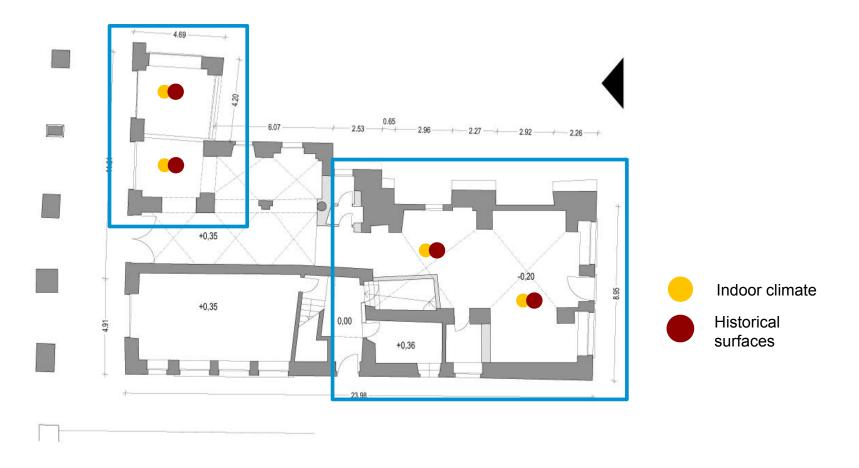
Monitoring Layout : Ground Floor

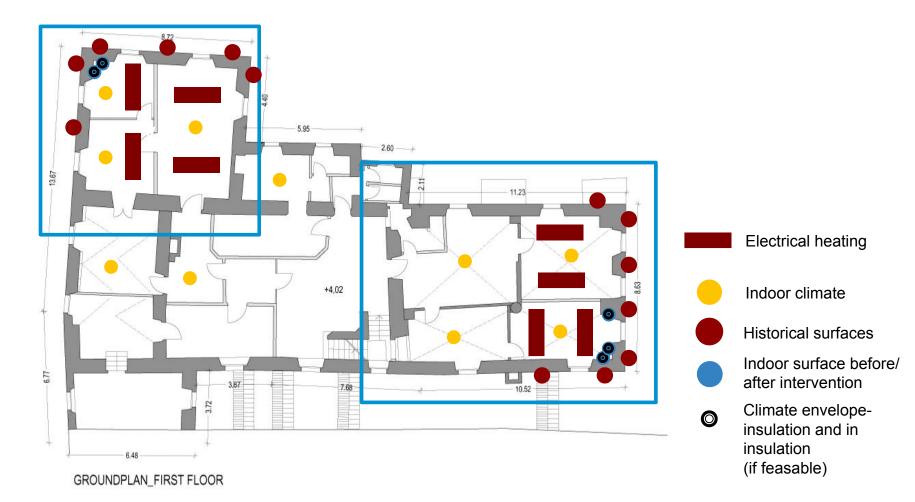
Monitoring layout: First floor

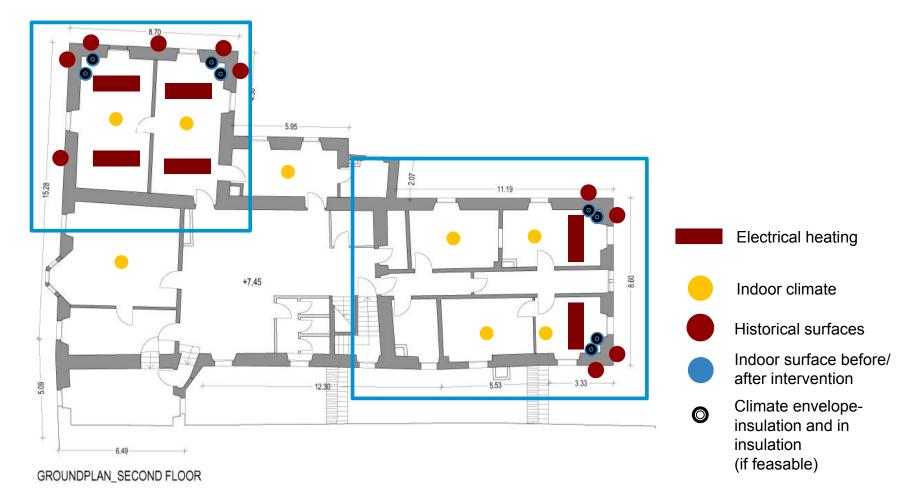
Monitoring layout: Second floor

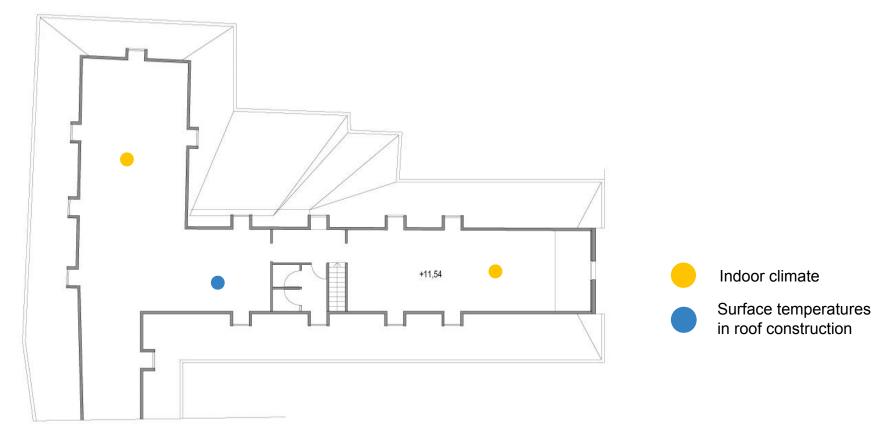
GROUNDPLAN_TOP FLOOR

Monitoring layout: Top floor

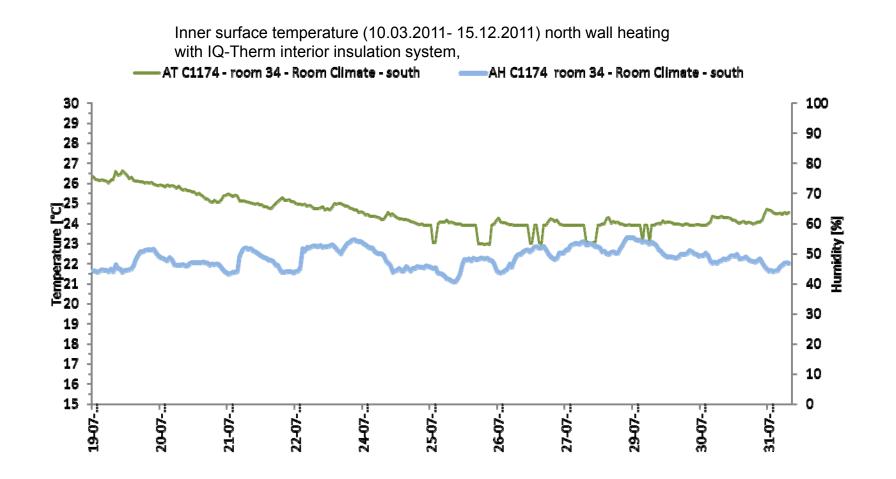
Example of environmental monitoring results

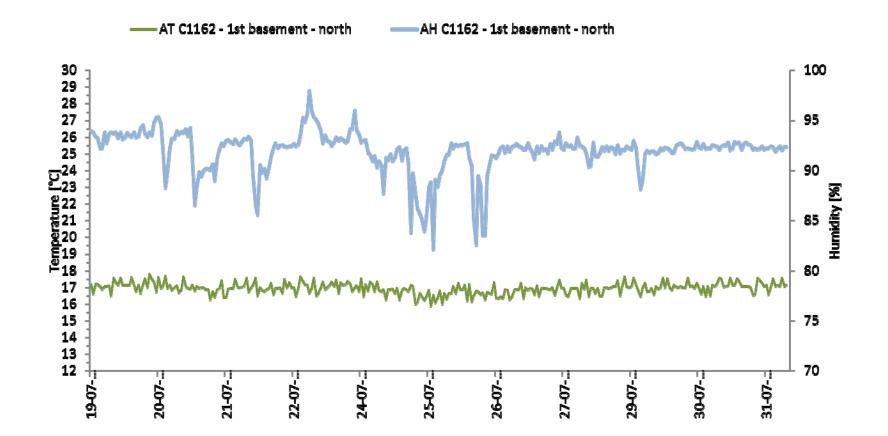
Example of monitoring results

Inner surface temperature (10.03.2011- 15.12.2011) north wall heating with IQ-Therm interior insulation system,

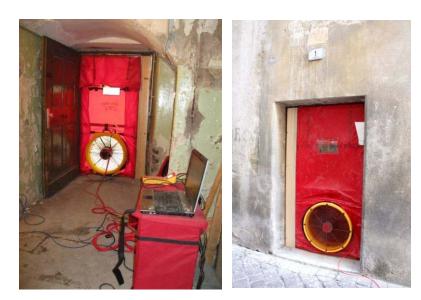
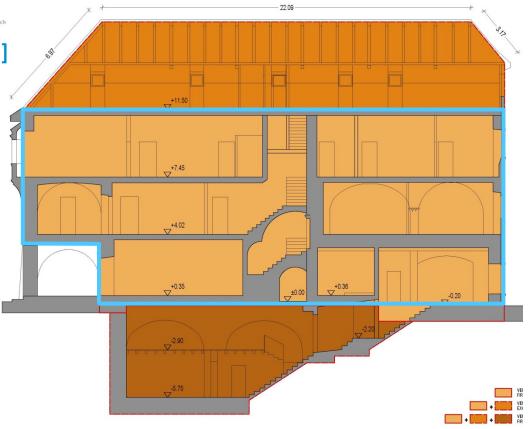
Evaluation of Blower Door Test:

Measurement without top floor (V_{Netto} = 1.780 m³)

Overpressure: $n_{50} = 9,98 \pm 0,04 \% [h^{-1}]^{+1}$ Underpressure: $n_{50} = 9,08 \pm 0,02 \% [h^{-1}]$

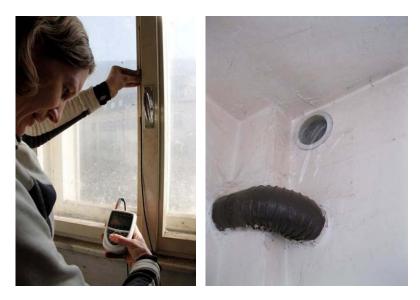
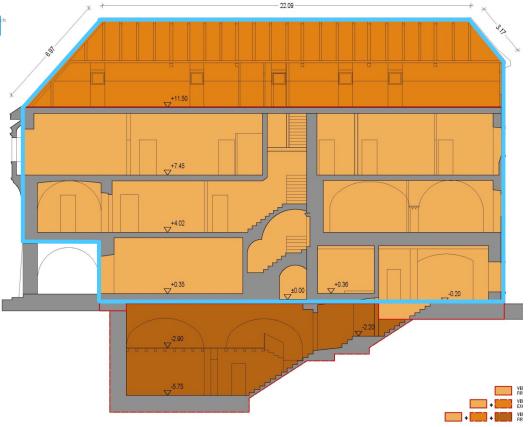
Evaluation of Blower Door Test:

Measurement with top floor (V_{Netto} = 2.042,5 m³)

Overpressure: $n_{50} = 10,05 \pm 0,13 \% [h^{-1}]^{*}$ Underpressure: $n_{50} = 9,1 \pm 0,02 \% [h^{-1}]$

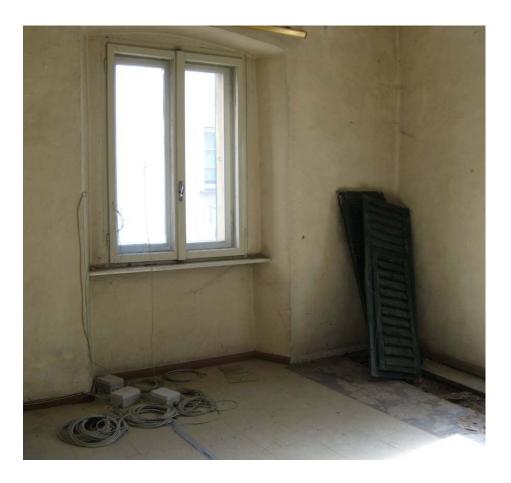
New window situation:

- **Outer window frame:** from baroque period 1750/1800, originally with impost
- Outer window sashes: around 1900
- Inner window sashes + box-type window frame: 1950th

- Need of a consistent window/façade concept
- Development of a 2nd window prototype
 -> energy efficient box-type window
- Bring existing window prototype (coupled window) forward to a applicable state

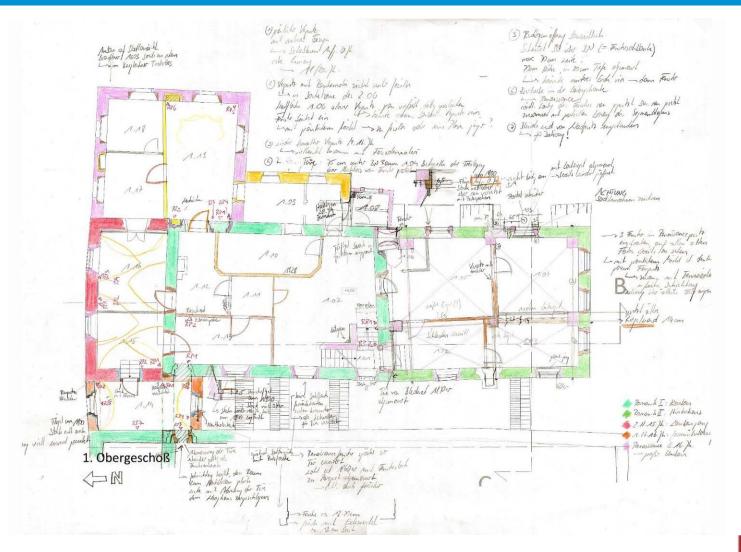
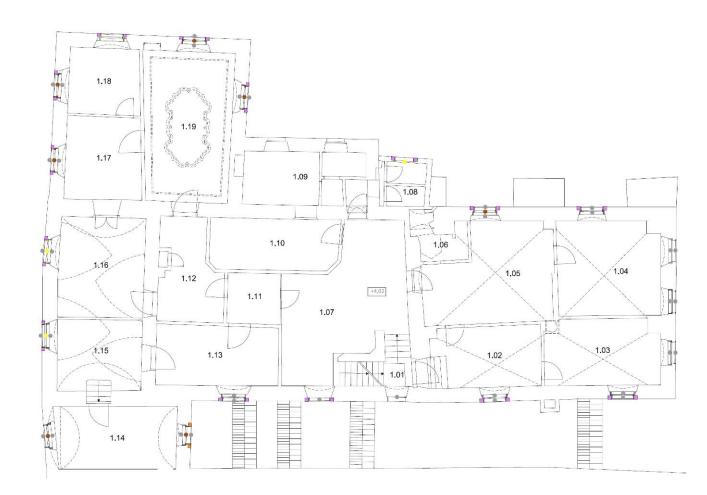
GRUNDRISS M 1:100 FENSTERKARTIERUNG

spätgotisches Sandsteingewände Anf. 16. Jh.

renaissancezeitliches Sandsteingewände um 1600

- spätbarocker Fensterstock 2. H. 18. Jh.
- historistischer Fensterstock um 1900
- Kastenfenster/Außenstock 1950/60er Jahre
- Isolierfenster 2012

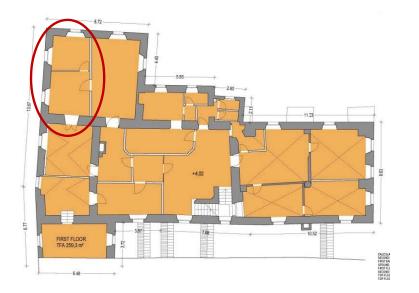
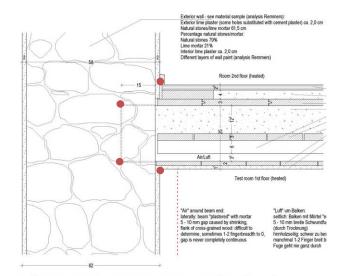
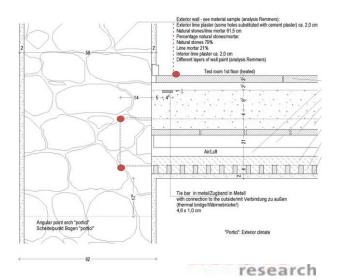
Simulation of beam ends floor (ceiling "portici")

Comparison: relative **humidity and temperature** within the structure on a cold winter day (Winter 2nd/3rd year: 12th January)

Simulations in DELPHIN of two significant points:

- Floor (beam ends)
- Ceiling (beam ends)
- Comparison of 2 thicknesses: 5 and 8 cm with as-isstate

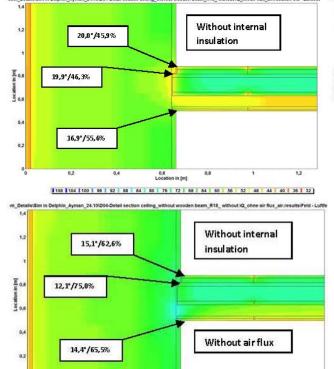
Simulation of beam ends ceiling -> with air flux and without

Comparison: relative **humidity and temperature** within the structure on a cold winter day (Winter 2nd/3rd year: 12th January)

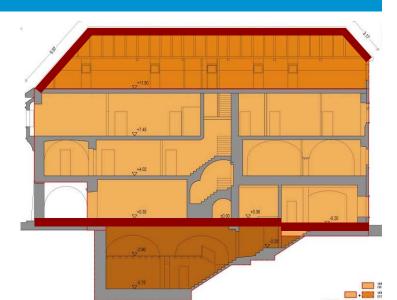
Annual heating demand 259 kWh/m²a -> 136 kWh/m²a

- Insulation of roof -> 244 kWh/m²a
- Insulation of baseplate/insulation of ceiling portici -> 188 kWh/m²a
- Higher airtightness/substitution of windows -> 150 kWh/m²a
- Constrolled ventilation with heat recovery (85%) -> 136 kWh/m²a

- Insulation of roof
- Insulation of baseplate
- Insulation of ceiling portici
- Higher airtightness (10,05 -> 1,5 h-1)
- Substitution of windows (2,5-2,9 ->1,2-1,4 double glazing)
- Controlled ventilation with heat recovery (85%)
- Solar collector under roof tiles (in comb. with heat pump)

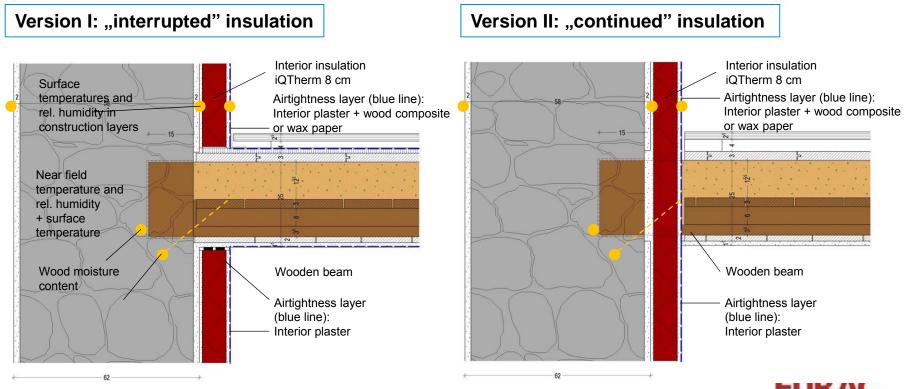
Installation of iQTherm 8 cm in test room (1st floor)

- Wooden beams in ceiling: implementation of two different connections
- Monitoring and comparison of both solutions: wood moisture content, temperature and rel. humidity

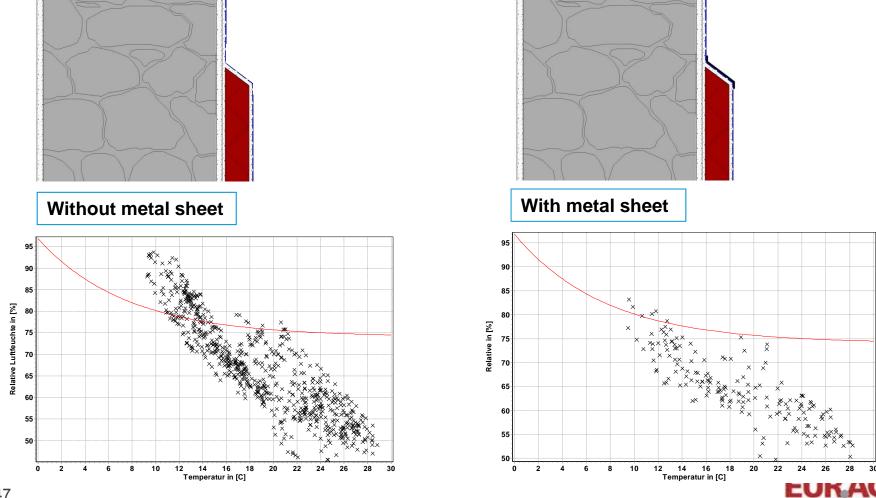
Detail: endpoint internal insulation at parapet height (room 2nd floor)
