# **3ENCULT Historic Building Information System: the “Raumbuch” concept integrated with energy issues - a tool for the multidisciplinary design approach**

Alexandra Troi, EURAC research

# ISSUE in 3ENCULT

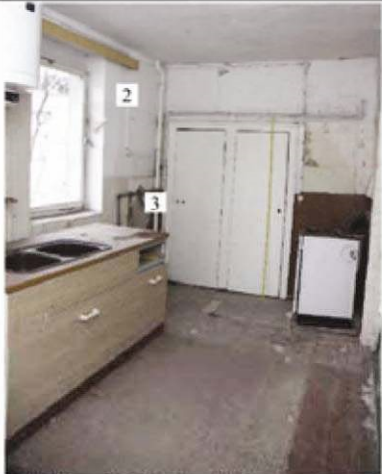
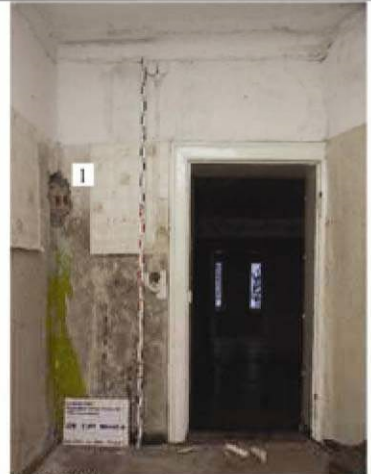
Abb. 1: Raum 2.09 - Blick nach Süden

Abb. 2: Wand a

<table><tr> <th>Bestand</th> <th>Pos.</th> <th>Zustand / Bemerkung</th> </tr><tr> <td> <b>Boden:</b>            Fußbodenniveau liegt ca. 30 cm höher als beim Raum 2.10. Holzdielen, rotbraun angestrichen, in Richtung Wand a - c verlegt. Der größere Teil der Fläche mit PVC belegt. Bei dem Schornstein (Ecke Wände c1/d) eine Betonplatte, in einem Niveau mit der Dielung. Dielen in den Kammern schmaler, ohne Anstrich, mit PVC belegt; profilierte Fußleiste aus Holz nur bei den Umfassungswänden a-d.         </td> <td></td> <td>           Fußbodenkonstruktion offenbar aus der Erbauungszeit, in den Kammern in jüngerer Zeit ausgetauscht.         </td> </tr><tr> <td> <b>Wand a:</b>            Innenwand aus rotem Backstein, verputzt und weiß gestrichen, bis Höhe 198 cm tapeziert. Wand a bindet nicht in die Wand d ein. Rechts in der Wand Türöffnung T 2.10/2.09 (82x182 cm). Profilierter Holzrahmen (schließt auf der rechten Seite direkt an die Wand b an).         </td> <td></td> <td>           Urspr. Außenwand des 1861 zum Hof erweiterten Hauses.             Tür T 2.10/2.09 wahrscheinlich befand sich an dieser Stelle ein Fenster; Hinweise dafür:         </td> </tr></table>

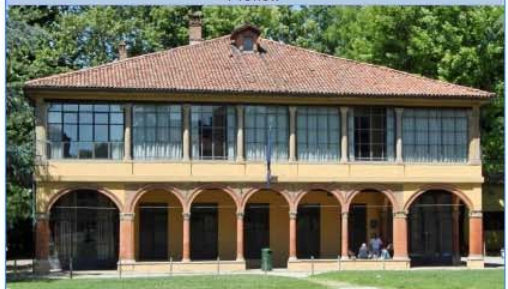
Name: CS3\_Viola\_MainFacade

Description: South-East facade

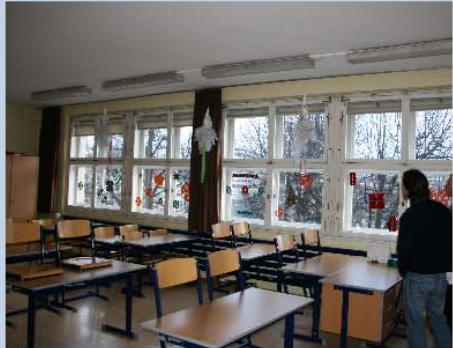
**Label:** CS5\_standard box-type window **Sublabel:** window hinge with 4 parts

**Typology:** **Number of sashes:** **Number of sash bars:**  
Box-type window 12 0

**General description:**  
The standard box-type window is a huge window hinge which is divided into 4 box-type windows with steel columns between. Each of these windows is separated into 4 sashes. The window is constructed with two layers with a gap of 16.5 cm between.
