**D 6.2 Documentation of each study case
CS1 Public Weigh House, Bolzano (Italy)
Delivered at M42**

**[Compatible solutions for improving the energy efficiency
of historic buildings in urban areas]**

Deliverable D6.2 Documentation of each study case

Project Acronym	3ENCULT
Project Title	Efficient ENergy for EU Cultural Heritage
Project Coordinator	Alexandra Troi EURAC research, Viale Druso 1, 39100 Bolzano/Italy Alexandra.troi@eurac.edu
Project Duration	1 October 2010 – 31 March 2014 (42 Months)

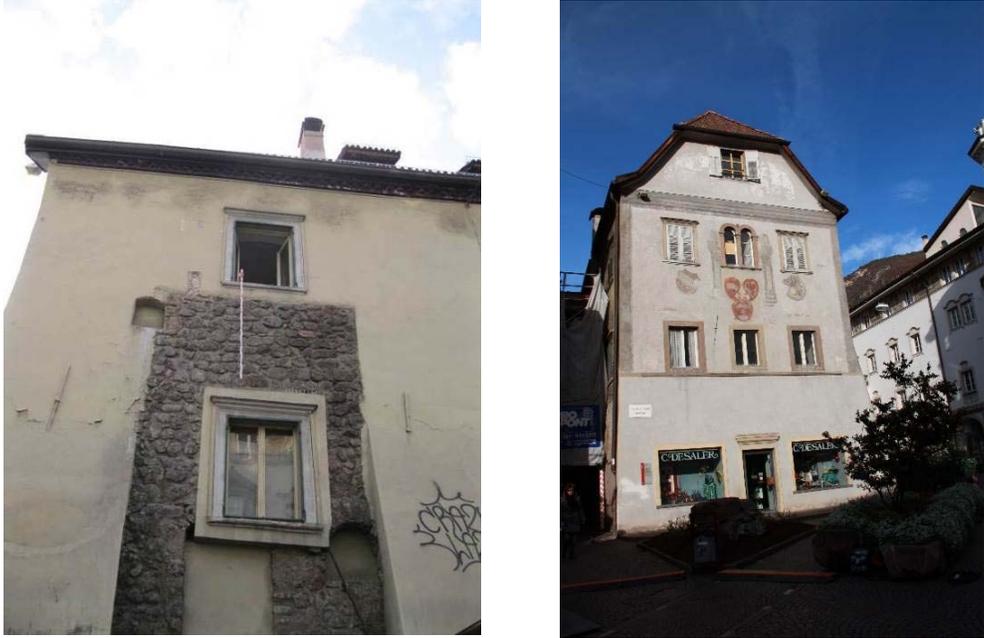
Constraint condition and protection: internal and external surfaces/walls

Actual state:	External walls and most internal partitions are of natural stones with lime mortar joints. The stonework is covered in most parts on both sides with historic lime plaster and painting, partially also wall paintings and frescoes. In some parts of the exterior surface, we have facing brickwork; the windows are framed with a profiled sandstone from baroque era. In various rooms, there are stuccoed or vaulted ceilings.
Assessment of the conservator:	The façade shows us the construction history of the building: on the south side, the façade has a baroque appearance. We have the frescos, which represent the armorial bearings of Austria, South Tyrol and the city of Bolzano. On the east side, we see the Romanesque masonry with the typical execution of the mortar joints for that time. All over the whole building, we have historic plaster, which are of historic value and therefore worth for preservation. The historic plaster, the frescos, the sandstone frames around the windows, the original proportions of the façade should remain perceivable and therefore not be covered.

Possible interventions:	To improve the thermal behavior of the external walls, the (temporary) installation of internal insulation is only possible in carefully selected parts of the building, from conservator's point of view. In general: the covering of surfaces has to be decided individually room by room. Internal insulation should be in any case removable and should not leave any trace on the existing walls. The original layers of paint (even if they are not historic), the appearance of the historic plaster, the uneven surfaces and edges should be preserved for historic

<p>and handicraft reason. The same counts for surfaces with wall paintings, even if the majority of mural painting is covered by paint layers and only partially visible, they are the most valuable surfaces and should be maintained as they are. The delicate original proportions of the rooms and above all the symmetry of stuccoed ceiling should not be changed by installation of internal insulation. Usual approach of renovation of inner side of the wall in similar cases: Uncover the last useful layer (that still has to be determined) and paint this layer with whitewash. Problems of internal insulation from conservation point of view: covering of historic surfaces in a way that they are no more visible and “perceivable”, changing symmetry of stuccoed ceiling.</p> <p>The Existing wooden pavement should be conserved.</p>
--	--

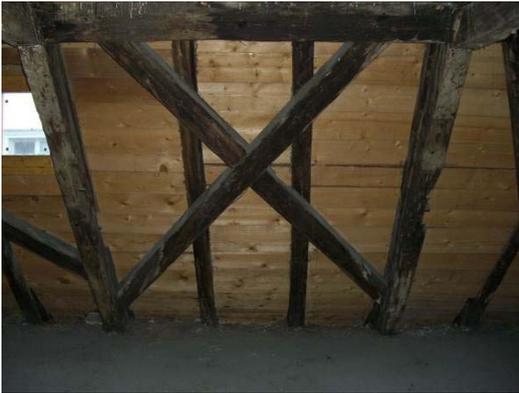
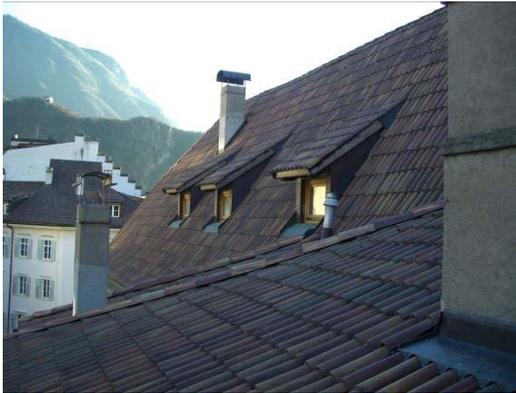
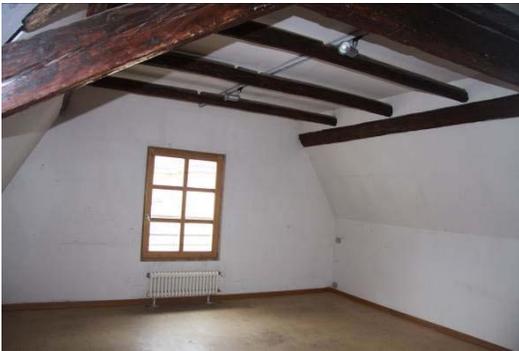
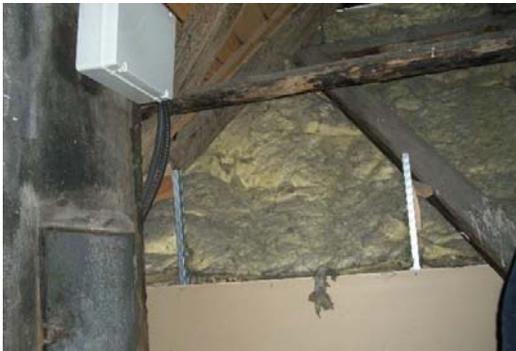
Constraint condition and protection: roof

Actual state:	<p>Saddle roof with wooden rafters and wooden casing, roofing cardboard (bitumen) on the wooden casing and above it roof cladding with tiles (Spanish tile roof). In the current state, the roof construction is partially insulated with a layer of mineral wool of 8 cm to the inside, in between the wooden rafters. The insulation is covered on the below side by a gypsum plasterboard.</p>
Assessment of the conservator:	<p>From conservator's point of view, the roof has to be preserved in his actual form for two main reasons: (i) The</p>

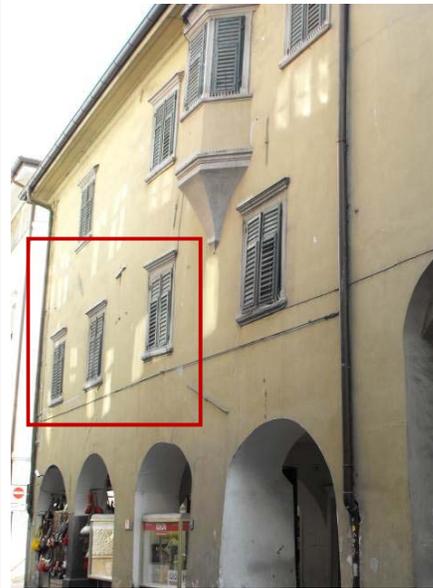
Heat flux measurement	M1			
Period of building up the study area	Renaissance 16 th century

Measure point	First floor, room 18, exterior wall north side		
	Exposure	North		
	Type	Solid exterior wall in natural stones		
	Using area	Residential zone (main room)		
	Measure period	Duration	Conductance not corrected	Conductance corrected with thermal mass factor
	29.12.2012-02.01.2013	96 h	1,355 W/m ² K	1,371 W/m ² K
	23.01.2012-28.01-2012	120 h	1,375 W/m ² K	1,399 W/m ² K

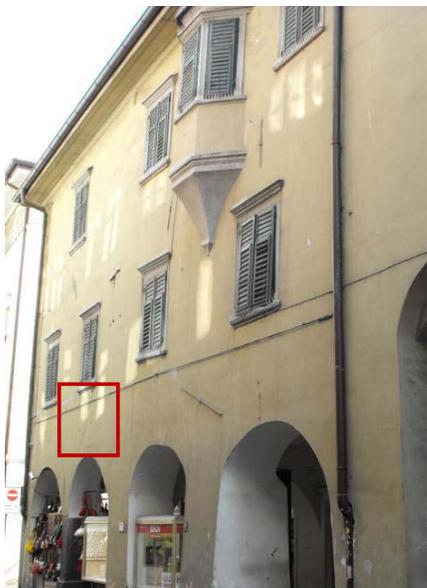
Heat flux measurement	M2_parapet			
Period of building up the study area	Renaissance 16th century

We measured the conductance of the parapet position under the window, considering it as a heavy element.

Measure point	First floor, room 18, exterior wall north side		
	Exposure	North		
	Type	Solid exterior wall in natural stones		
	Using area	Residential zone (main room)		
	Measure period	Duration	Conductance corrected	not
	16.01.2013-20.01.2013	96 h	2,864 W/m²K

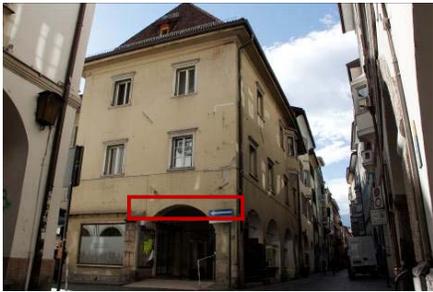
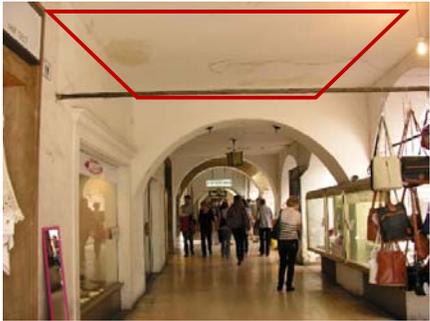
Heat flux measurement	M3		
Period of building up the study area	Renaissance 16th century

We measured the conductance of the ceiling above the portici, considering it as a heavy element.

Measure point	First floor, room 18, floor (ceiling over “Portici”)	
	Type	Ceiling over outdoor area in wooden beams with filling in earth, sand and little stones. Outer side covered with lime plaster. Floor in wooden boards.	
	Using area	Residential zone (main room)	
	Measure period	Duration	Conductance corrected not

23.01.2013- 28.01.2013	120 h	0,480 W/m ² K
---	---------------------------	-------	--------------------------

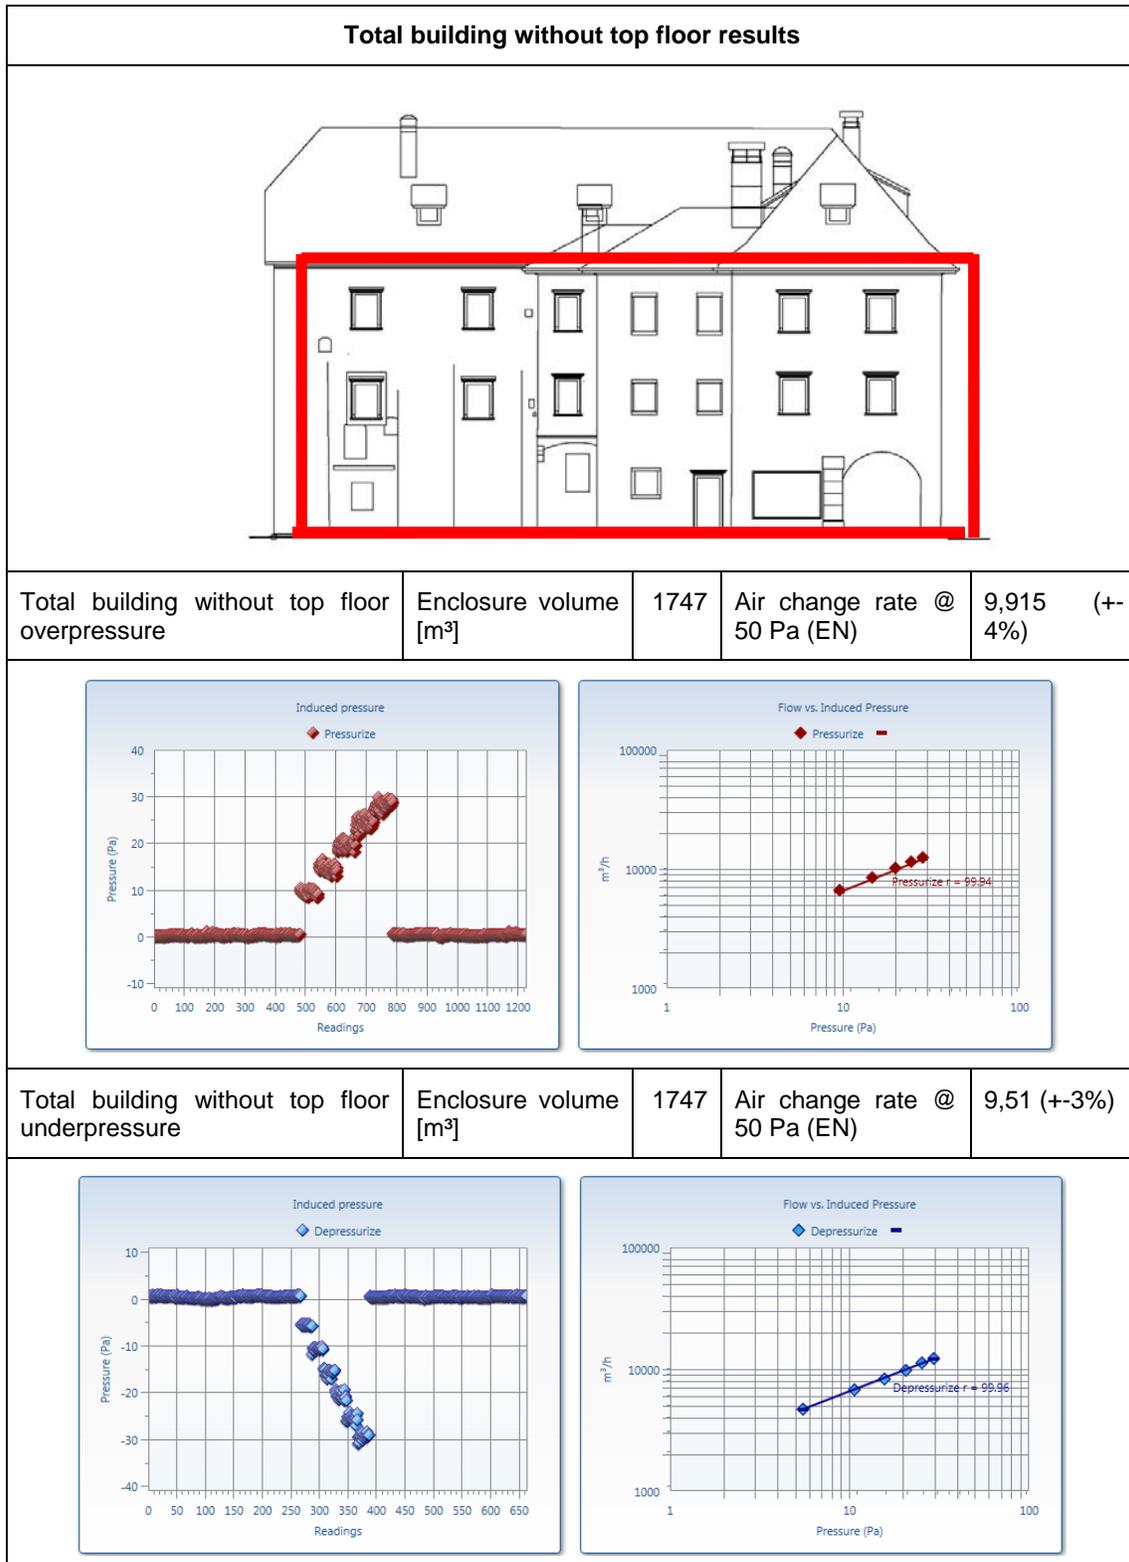
The blower door tests for the whole building were carried once considering the top floor and once excluding it. The fan was positioned on the outside door to create the pressure difference. The main difficult was to reach high levels of difference pressure, it was not possible to have more than 28 Pa. This caused an uncertainty in the measurements, especially carrying the test with overpressure in the building. For this reason after the test on the whole building we did the test also in some rooms, were we reached a difference pressure of 50 Pa (value established into the European and American legislation) without any problems. The results are similar for the measurements with and without the top floor: the air changes in an hour at a difference of pressure of 50 Pa are estimated to be in the range from 9,4 to 9,9 ac/h.

Total building with top floor results				
Total building with top floor overpressure	Enclosure volume [m ³]	2033	Air change rate @ 50 Pa (EN)	9,86 (+-12,8%)
Total building with top floor underpressure	Enclosure volume [m ³]	2033	Air change rate @ 50 Pa (EN)	9,38 (+-2,1%)

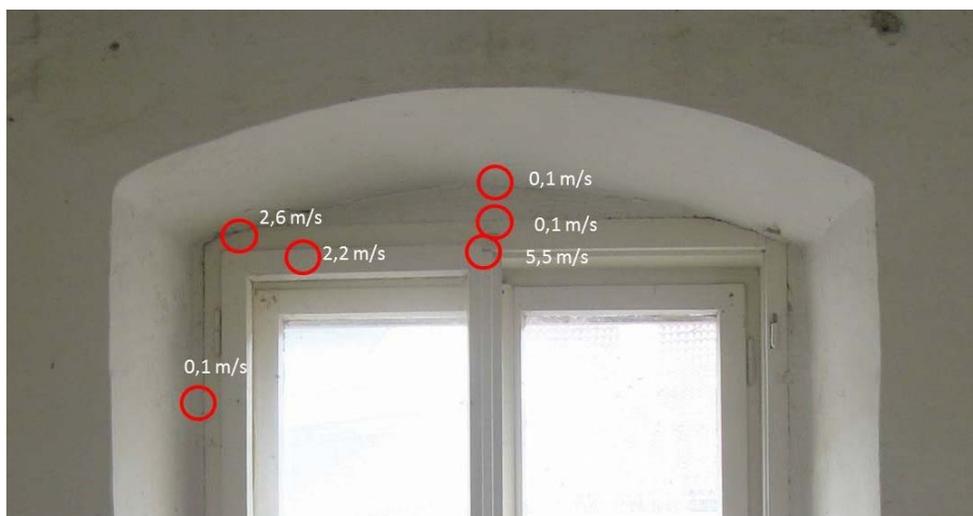
Figure 2: Air velocity near the window - details

We carried the test on some rooms on the second floor positioned on the south part. As a first step, we used the gas tracer to check where the air infiltrations were localized. We created a pressure difference of 50 Pa with the fan, and we blew the gas inside the room. We saw that the gas overflow mainly through the windows and through some cracks on the interior wall. Therefore, we measured the air velocity inside the room, near the windows and near the cracks to check the differences.

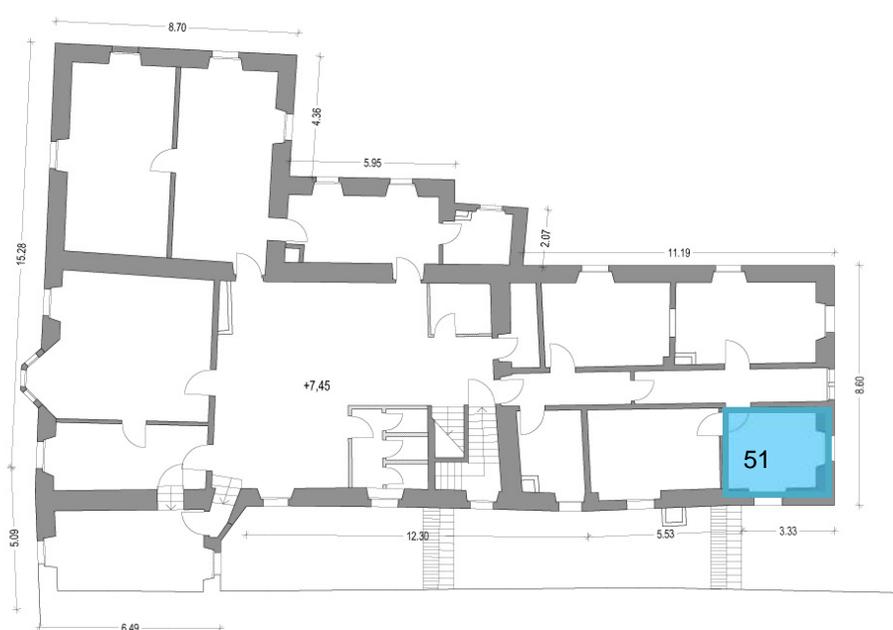
Room 51	
Enclosure volume [m ³]	38,65
Floor area [m ²]	9,99
Enclosure area [m ²]	67,57

<p>GROUNDPLAN_SECOND FLOOR</p>	
Equivalent Leakage Area [cm ² @ 10 Pa]	268,08 (+-2,1%)
Effective Leakage Area [cm ² @ 4 Pa]	159,68 (+-1,3%)
Intercept CI [m ³ / h Pa ⁿ]	62,028
Intercept Cenv [m ³ / h Pa ⁿ]	62,15
Slope, n	0,6394
Air change rate @ 50 Pa (ASTM)	18,15 (+-2,7%)
Air change rate @ 50 Pa (EN)	18,30 (+-4,4%)

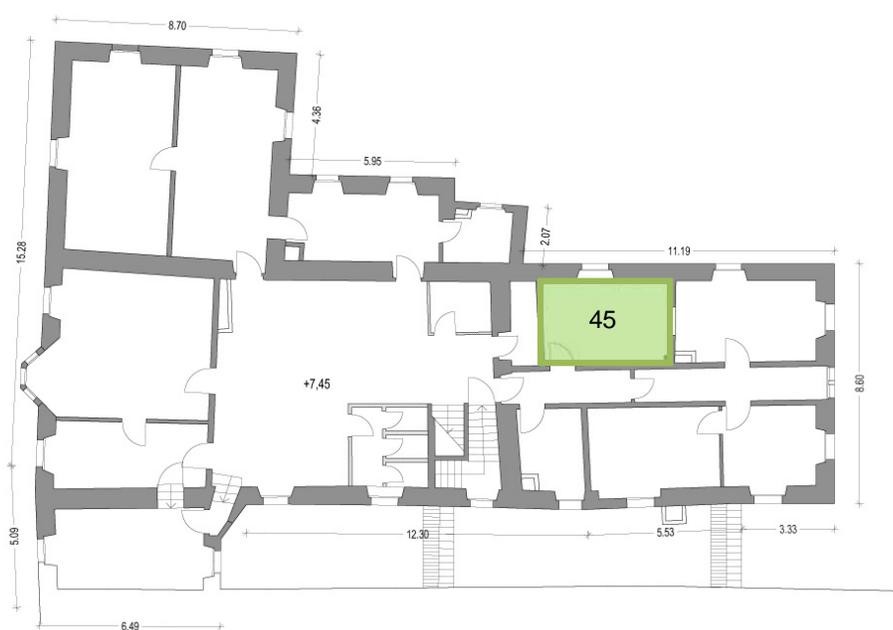
Room 45	
Enclosure volume [m ³]	52,61
Floor area [m ²]	13,81
Enclosure area [m ²]	84,64

<p>GROUNDPLAN_SECOND FLOOR</p>	
Equivalent Leakage Area [cm ² @ 10 Pa]	113,23 (+-2,2%)
Effective Leakage Area [cm ² @ 4 Pa]	59,032 (+-3,8%)
Intercept Cl [m ³ / h Pa ⁿ]	20,70
Intercept Cenv [m ³ / h Pa ⁿ]	20,713
Slope, n	0,6837
Air change rate @ 50 Pa (ASTM)	6,00 (+-1,5%)
Air change rate @ 50 Pa (EN)	6,01 (+-3,0%)

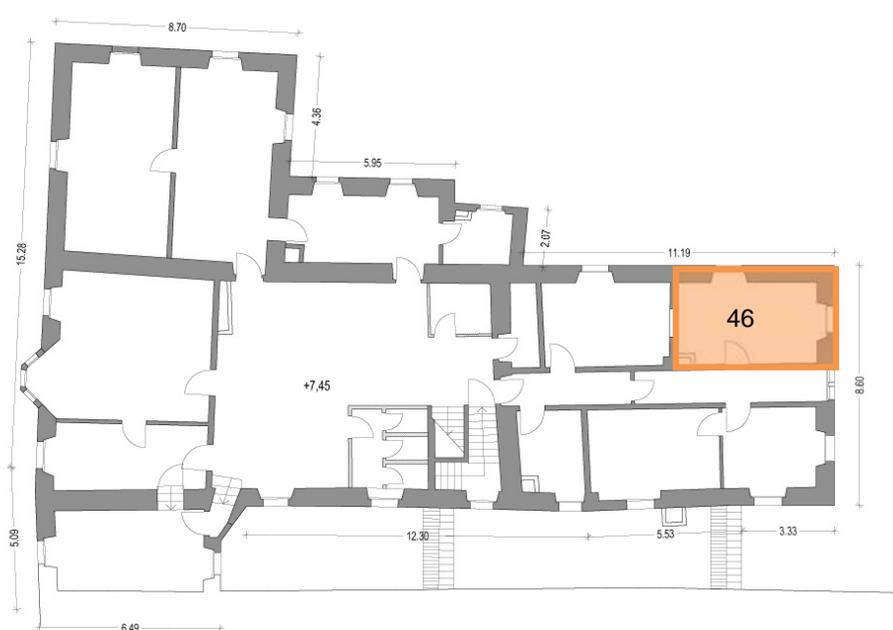
Room 46	
Enclosure volume [m ³]	46,05
Floor area [m ²]	14,89
Enclosure area [m ²]	77,37

<p>GROUNDPLAN_SECOND FLOOR</p>	
Equivalent Leakage Area [cm ² @ 10 Pa]	284,84 (+-0,5%)
Effective Leakage Area [cm ² @ 4 Pa]	155,16 (+-0,8%)
Intercept CI [m ³ / h Pa ⁿ]	67,25
Intercept Cenv [m ³ / h Pa ⁿ]	67,071
Slope, n	0,5987
Air change rate @ 50 Pa (ASTM)	15,10 (+-0,3%)
Air change rate @ 50 Pa (EN)	15,15 (+-6,3%)

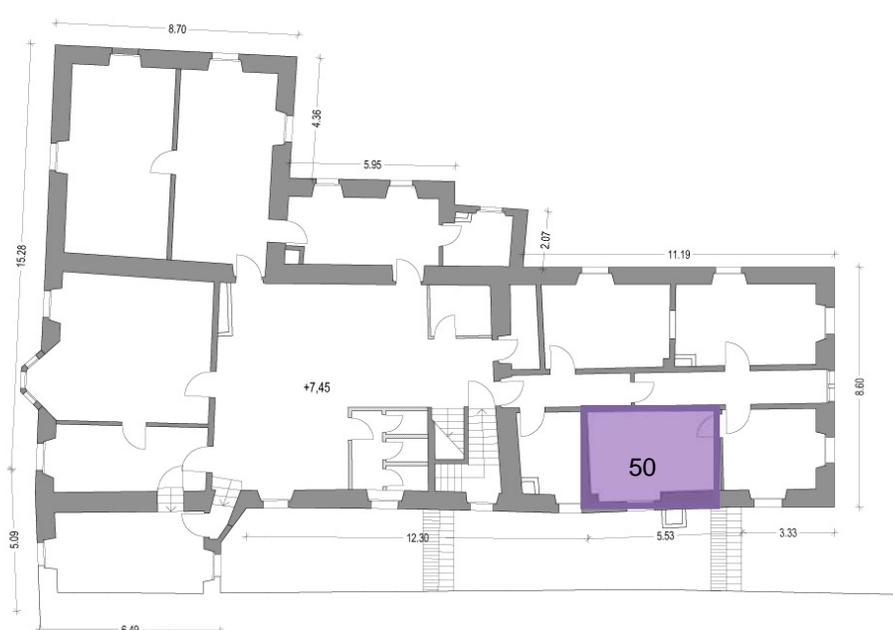
Room 50

<p>GROUNDPLAN_SECOND FLOOR</p>	
Equivalent Leakage Area [cm ² @ 10 Pa]	186,79 (+-1,3%)
Effective Leakage Area [cm ² @ 4 Pa]	100,97 (+-2,1%)
Intercept CI [m ³ / h Pa ⁿ]	36,25
Intercept Cenv [m ³ / h Pa ⁿ]	36,18
Slope, n	0,6545
Air change rate @ 50 Pa (ASTM)	8,43 (+-0,8%)
Air change rate @ 50 Pa (EN)	8,54 (+-1,8%)

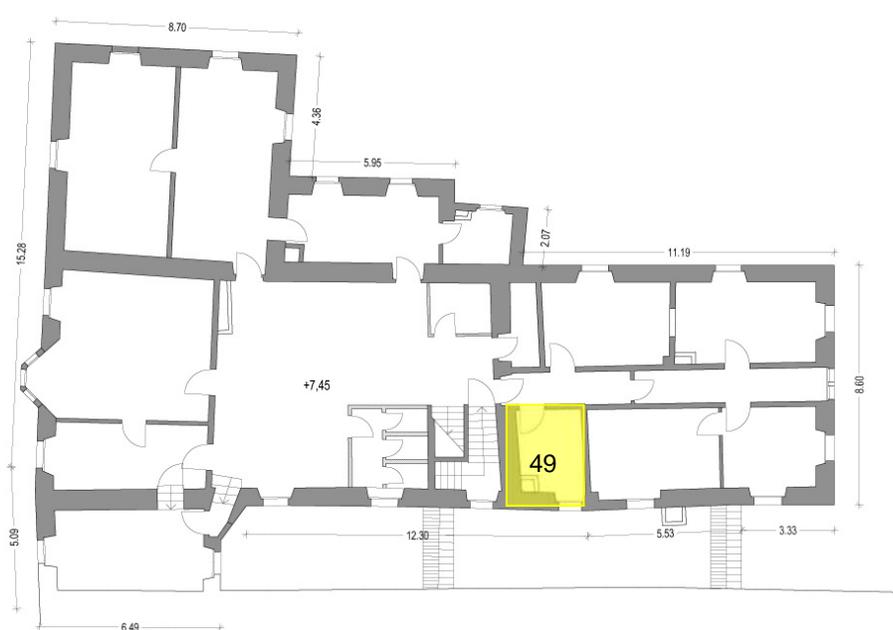
room 49

Equivalent Leakage Area [cm ² @ 10 Pa]	58,32 (+-0,8%)
Effective Leakage Area [cm ² @ 4 Pa]	29,29 (+-1,3%)
Intercept CI [m ³ / h Pa ⁿ]	10,85
Intercept Cenv [m ³ / h Pa ⁿ]	10,801
Slope, n	0,6839
Air change rate @ 50 Pa (ASTM)	6,47 (+-0,5%)
Air change rate @ 50 Pa (EN)	6,175 (+-3,0%)

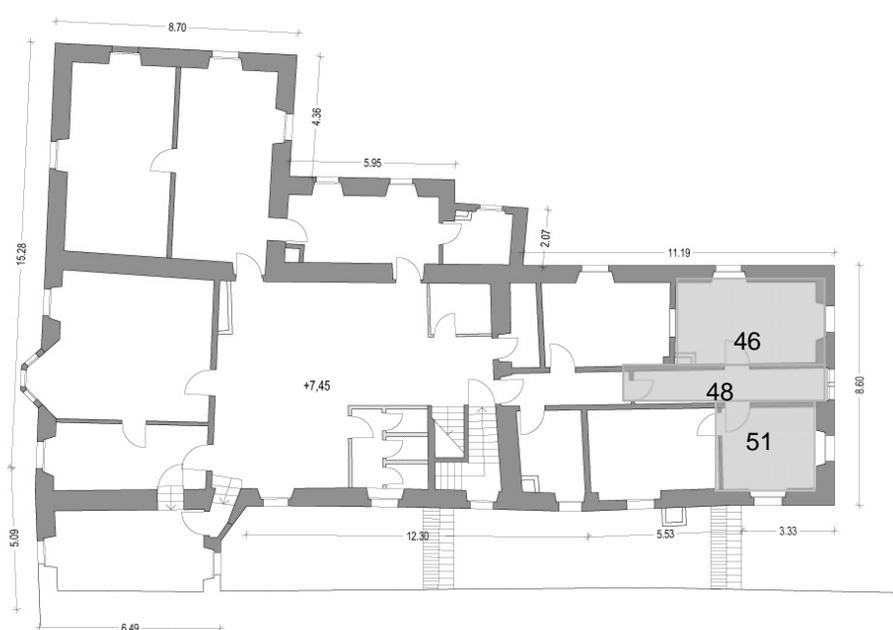
Room 46-48-51

<p>GROUNDPLAN_SECOND FLOOR</p>	
Equivalent Leakage Area [cm ² @ 10 Pa]	664,56 (+-6,1%)
Effective Leakage Area [cm ² @ 4 Pa]	371,24 (+-10,1%)
Intercept Cl [m ³ / h Pa ⁿ]	133,0
Intercept Cenv [m ³ / h Pa ⁿ]	132,10
Slope, n	0,6227
Air change rate @ 50 Pa (ASTM)	13,60 (+-3,9%)
Air change rate @ 50 Pa (EN)	13,15 (+-0,9%)

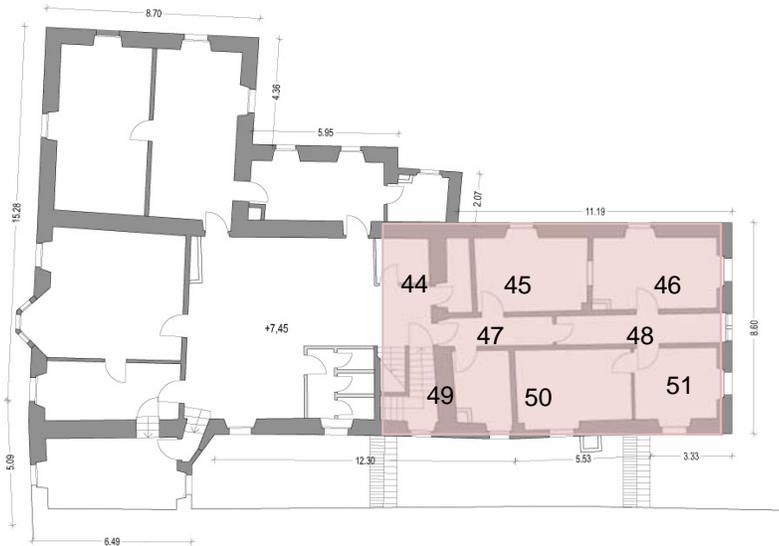
Room from 45 to 51

Equivalent Leakage Area [cm ² @ 10 Pa]	803,27 (+-1,6%)
Effective Leakage Area [cm ² @ 4 Pa]	432,6 (+-2,7%)
Intercept CI [m ³ / h Pa ⁿ]	158,0
Intercept Cenv [m ³ / h Pa ⁿ]	157,19
Slope, n	0,6535
Air change rate @ 50 Pa (ASTM)	7,5 (+-1%)
Air change rate @ 50 Pa (EN)	7,6 (+-2,9%)

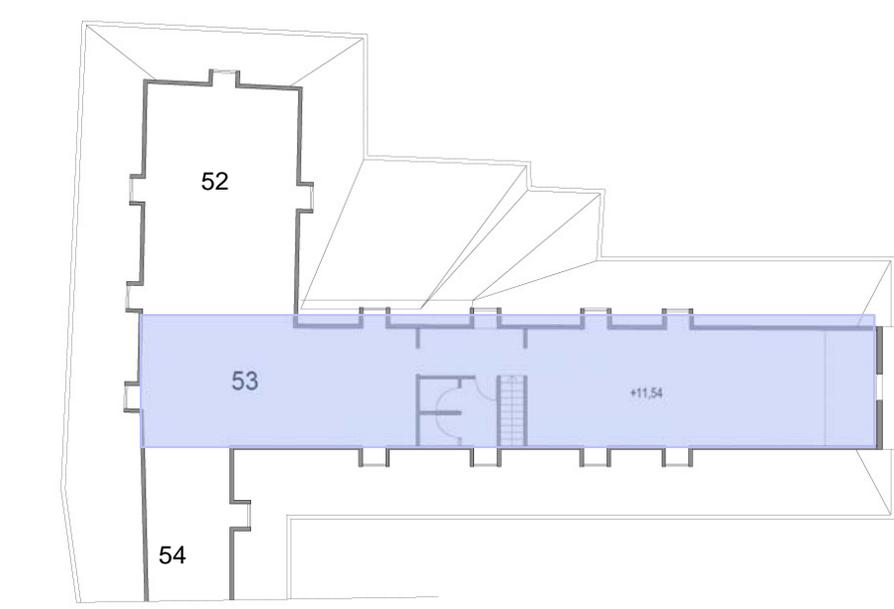
Room 53_Top floor

<p>GROUNDPLAN_TOP FLOOR</p>	
Equivalent Leakage Area [cm ² @ 10 Pa]	304,5 (+-1,8%)
Effective Leakage Area [cm ² @ 4 Pa]	168,0 (+-4,6%)
Intercept Cl [m ³ / h Pa ⁿ]	450,50
Intercept Cenv [m ³ / h Pa ⁿ]	444,45
Slope, n	0,5991
Air change rate @ 50 Pa (ASTM)	18,70 (+-0,9%)
Air change rate @ 50 Pa (EN)	18,55 (+-2,7%)

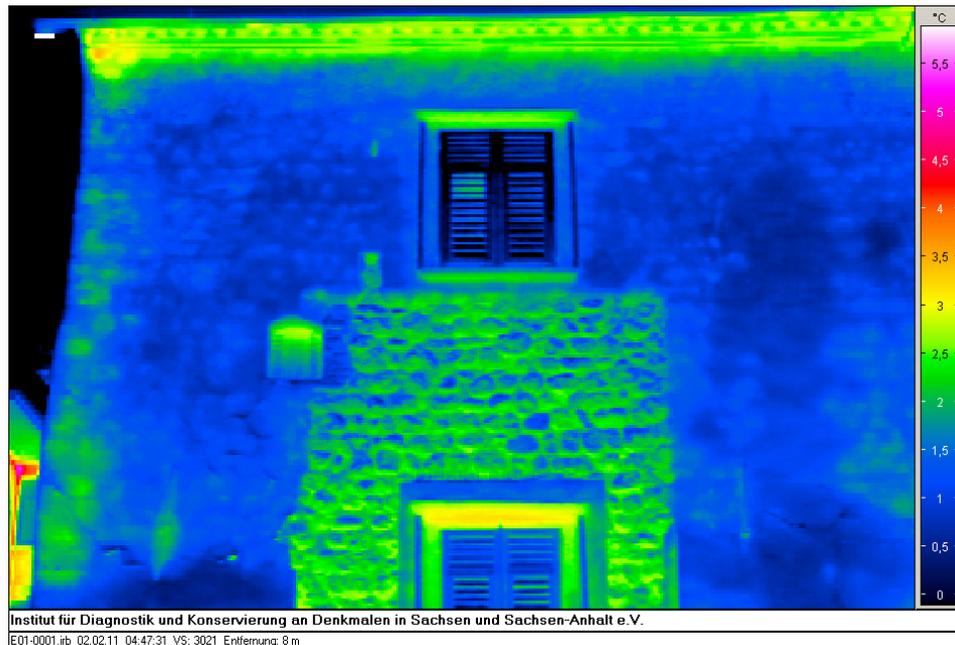
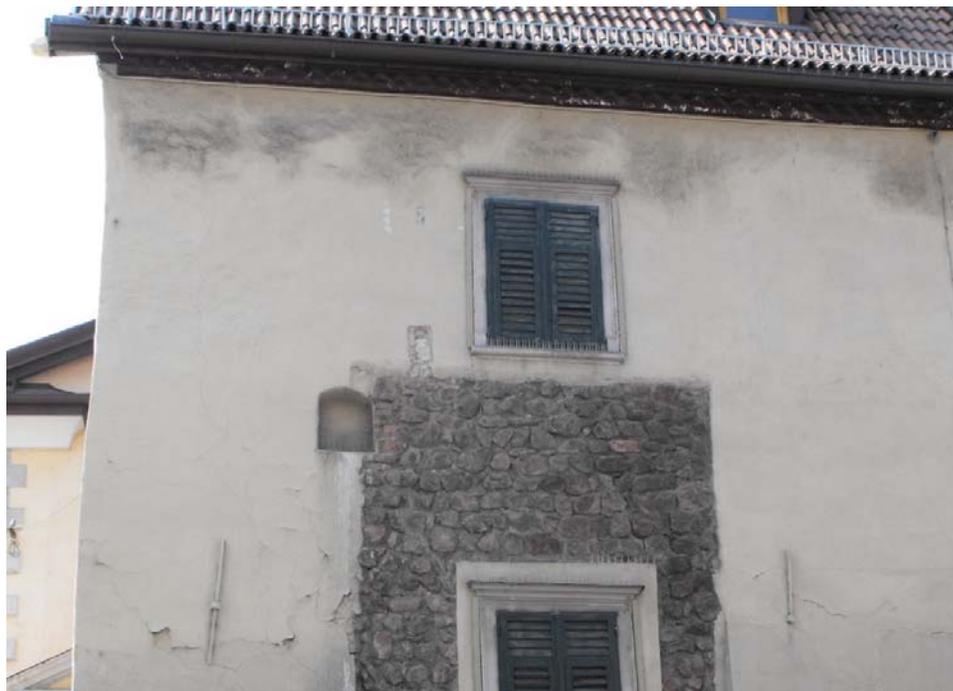
Figure 4: Eastern façade: additional information on masonry structure also behind plastered areas

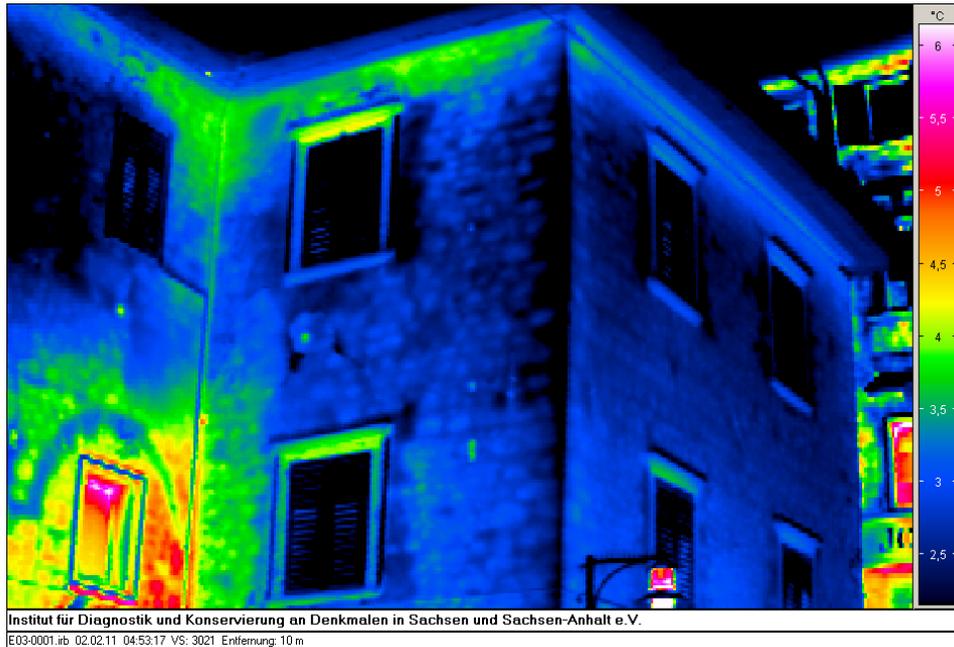
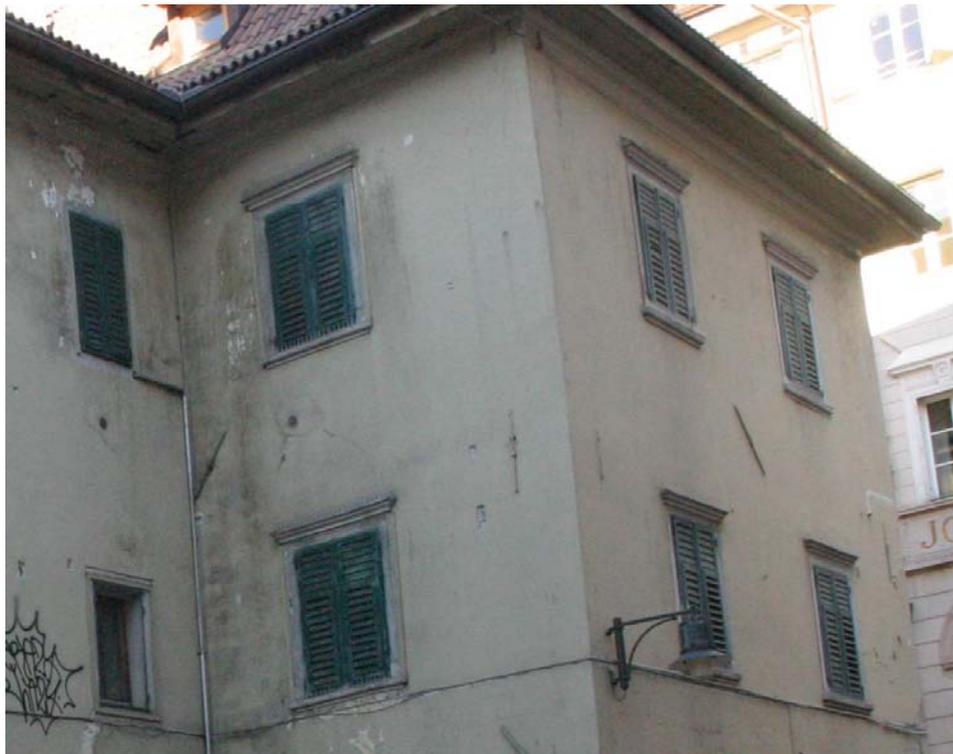
Figure 5: Eastern façade: information on masonry structure on completely plastered areas, arc construction

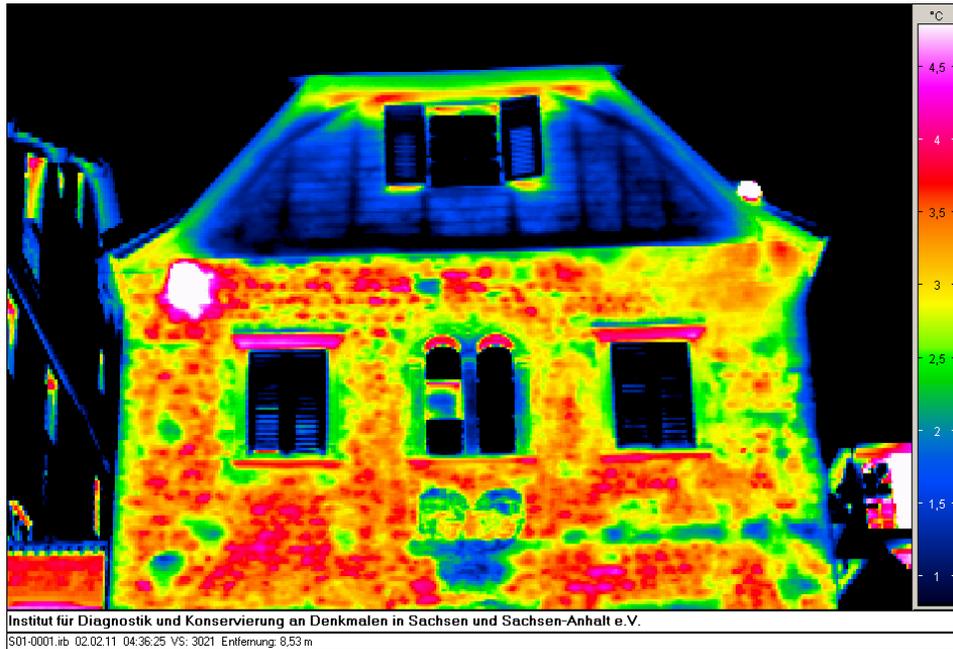
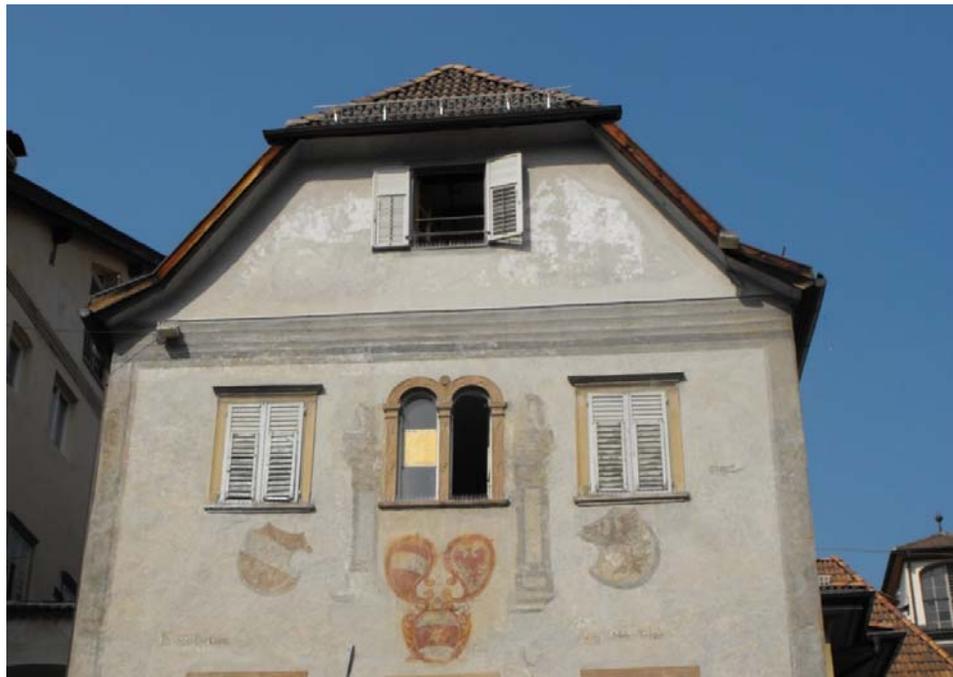
Figure 6: Southern façade: information on masonry structure in plastered areas, arc construction, attic

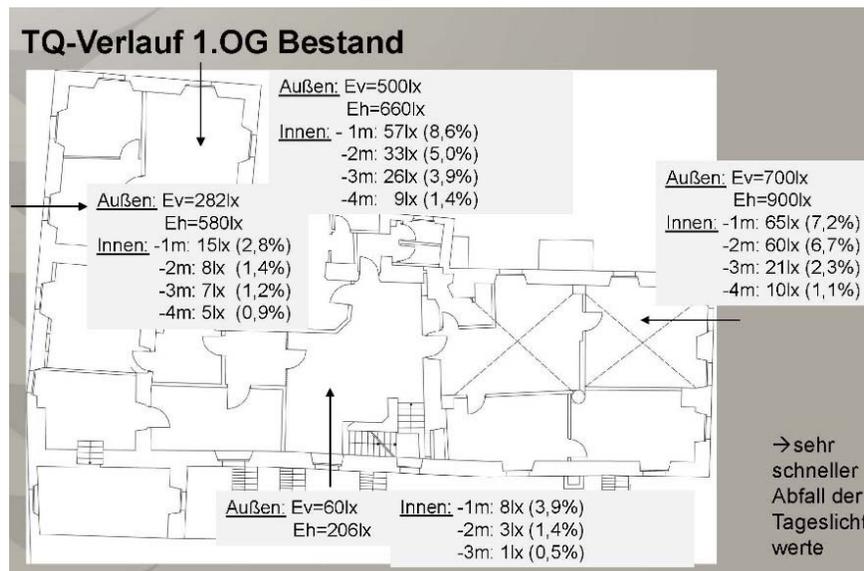
On-site lux measurements, obtained in a static way (at a single point in time), confirmed a punctual daylight factor in different rooms lower than 2.0%, which would be the minimum value to guarantee an acceptable supply of daylight. The daylight Factor is a ratio that represents the amount of illumination available indoors relative to the illumination present outdoors under an overcast sky. It determines the quantitative characteristics of daylight in a particular room, in order to verify if it has sufficient daylight. Especially in west, north and east oriented rooms there is a lack of daylight entering (see fig. 11), caused by the massive shading through the tight neighboring buildings. Notable is also the strong decrease of daylight towards the inside of the building. Throughout the building the type of window opening varies, the reveals are deep with few possibilities of changes/interventions.

Figure 11: Gradual reduction of the daylight coefficient in north, east, south and west oriented room on the first floor of the building

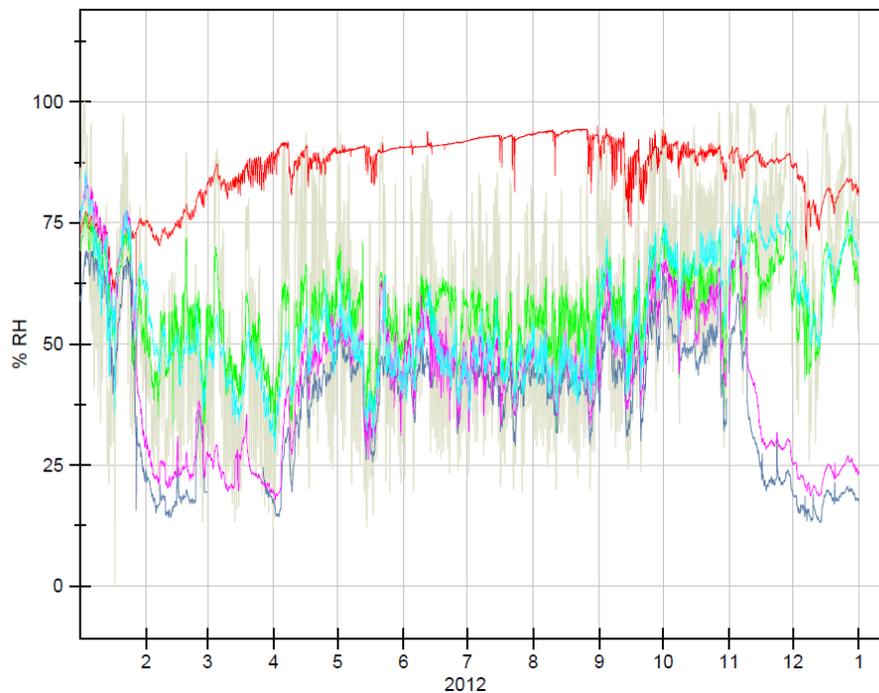
Figure 27 shows the internal air humidity on the monitored rooms on all the floors. The basement has the highest relative humidity both during summer and winter mainly because of the absence of ventilation or heating system. The rooms on the first and second floor have the lowest humidity during winter when the electric heaters are turned on.

Figure 27: Yearly humidity all floors

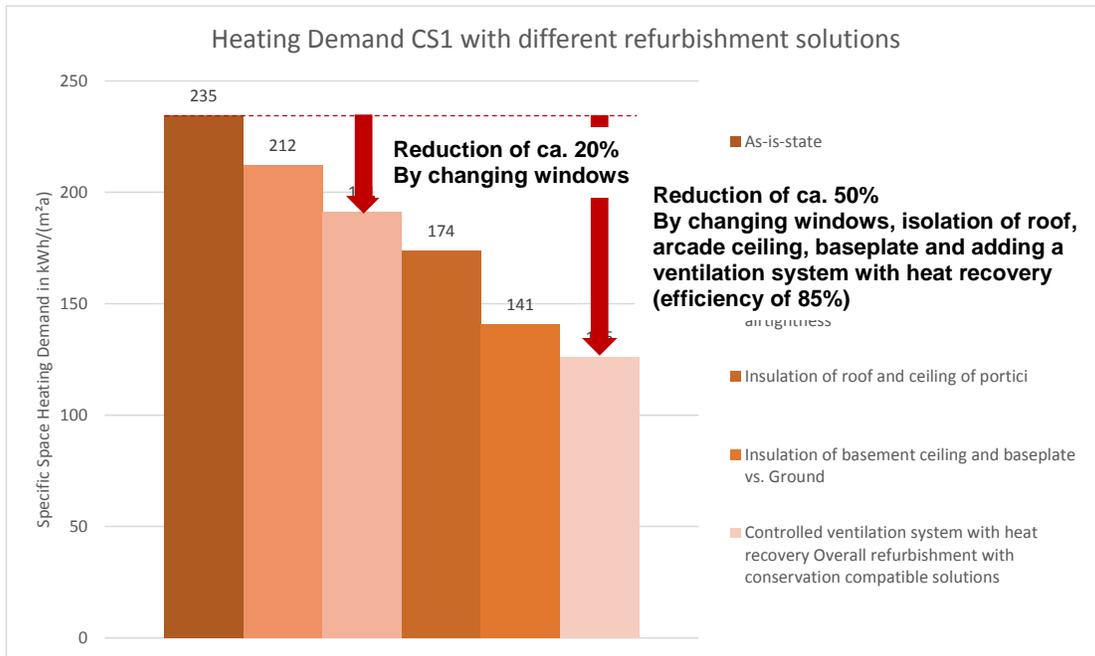
The calculation of the heating energy demand shows that it is possible to reduce the energy demand for heating to 50% considering the proposed refurbishment interventions.

Figure 29: Heating energy demand of Public Weigh House: Reduction of 20% by enhancing the windows, reduction of 50% implementing all heritage compatible interventions

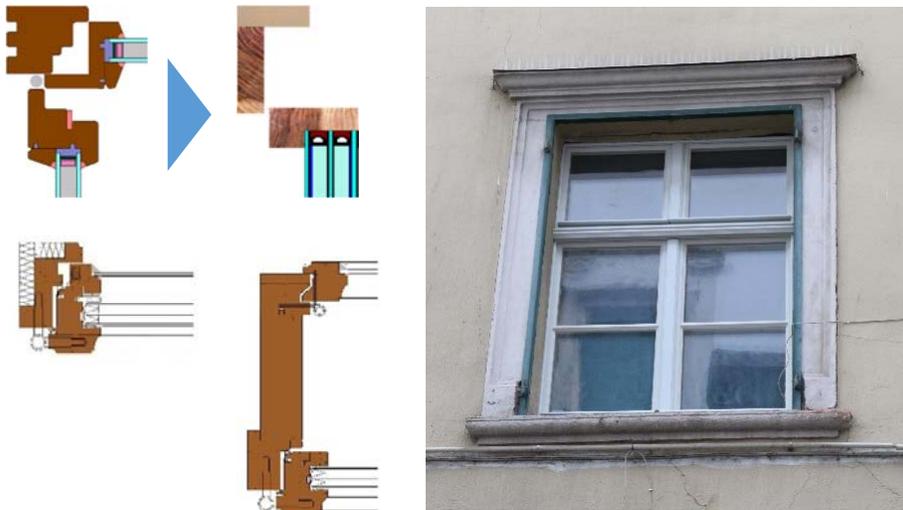
On the installed prototype of the coupled window version the conservator evaluated if heritage demands have been fulfilled: the appearance of the outer single glazing and the optic of the inner triple glazing, the proportions, subdivision and frame thickness and the evaluation of the concept of “division of functions” as well as colour and profiling. Based on this feedback the prototype was developed further. Since in the meanwhile a building historian had discovered traces of cut out impost (in some rare cases where the outer sashes the of box-type window from the 1950s/60s where installed in an original baroque frame), the new prototype was also built with a horizontal impost and four window sashes (2 above, 2 below). As model served the still existing window with impost in the jutting. The use of the very thin triple glazing (2/8/2/8/2), with the thickness of a double glazing, made it possible that the frame proportion became even more fragile and the optic from inside becomes very similar to a double glazing (see figure 37).

Figure 36-37: rotation of the frame cross section by 90 degrees (fig. 36 above) to achieve a smaller frame; separation of functions into two layers: “historic” window outside, integration of passive house window inside (fig. 36 below), last prototype installed in the Weigh House (fig. 37).

As there were no drawings from the original historic window available, the new window was based on a "classic" (coupled) window in terms of function, division and proportion, two sashes with two sash bars each. The developed concept separates the demands and functions into two layers: one outer layer for the reproduction of the original historic window and an inner layer for high energy efficiency. In this way, it is possible to obtain the same appearance like the original historic window from outside in terms of frame dimensions, sash bars and mirroring by taking a single glazing, without any negative effect on the energy efficiency. This outer layer takes over the weather tightness. The passive house window with triple glazing is integrated in a second additional inner layer, taking over the airtightness. By rotating the frame cross section 90 degrees and by moving the centre of rotation of the fitting, a smaller frame than the conventional solution was achieved (see figures 36 above). It is positioned in a way that its frame is

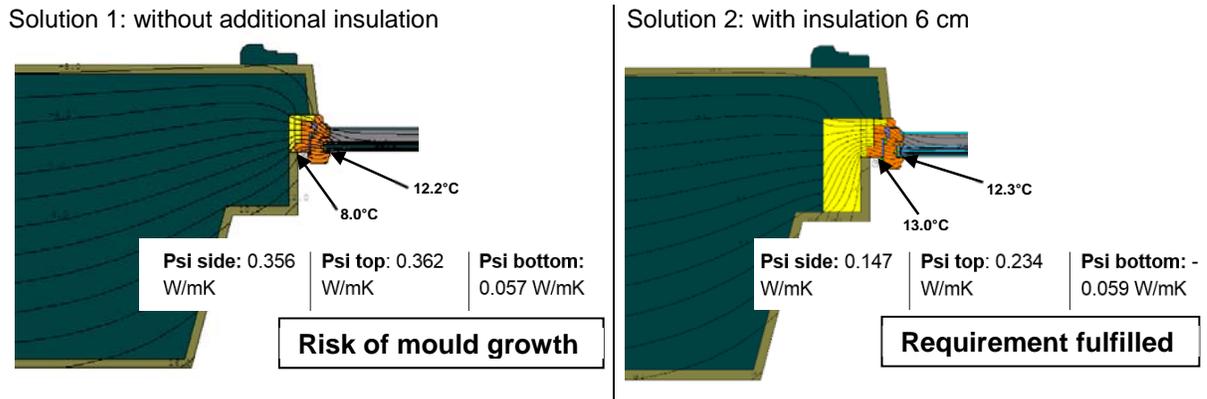
With regard to the window-wall connection, since in the major part of the case study, no application of internal insulation is possible, the junction was optimized by studying the existing reveal on-site and inserting all around the window an insulation layer of 4-6 cm. This helped to improve the psi-values and thereby to rise the surface temperatures in the critical points to required values (see figures 38-39).

Figure 38-39: comparison of two window connections – with and without additional insulation

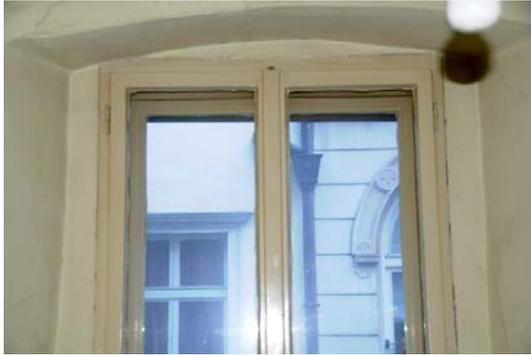
Fig. 1 Existing window

The pictures above show the air tightness of the existing box-type window from the fifties/sixties of the last century compared with the airtightness of the first window prototype implemented in the test room.

The IR-images were taken while the fan of the blower door instruments (see also chapter 7.5.1) generated under pressure in the room. Air leakages are made visible in this way through cold air that comes in from outside.

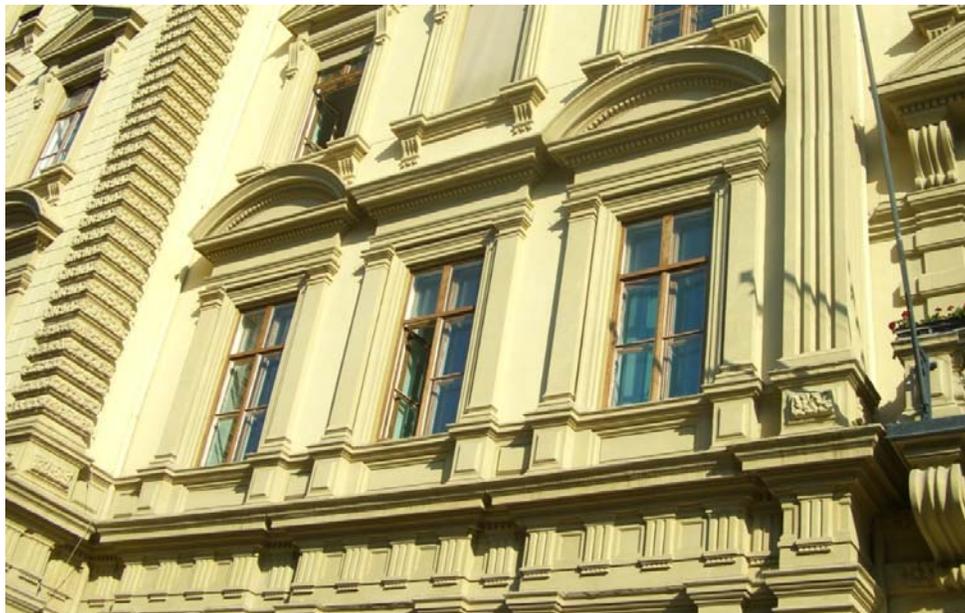
Landhaus Bozen

Window type: Box-type window in varnished spruce from the 19th century.

Actual state: Existing window was refurbished in 2008: The single glass of the inner window was replaced by double glazing. To maintain the historic appearance the glass of the outer window remained the existing one. The windows on the outer side were caulked with a profiled joint in the rabbet of the lower side. In the office rooms also the inner windows were tightened with profiled joint all around the rabbet.

1. Airtightness: Some windows are not airtight. The collaborators in the office are disturbed by cold air and draft in the winter season coming in through the closed windows.
2. Weather tightness: Although the profiled joint on the outer window, it is not rain proof.
3. Condition of weatherboard: coating is blistering from the weatherboard, humidity enters into the wood.
4. Varnish does not fit to putty: also here the coating is blistering from the putty, humidity and water enters the space behind the putty and comes into the window construction.

1. The reason for not airtight windows is that geometry of window frame is changing during the year according to climate. The adjustment of the old hinge is often not feasible as they are not flexible. To proof the airtightness in a fast way and to find non airtightness points on the window frame, Franz shows us the “paper-test”: A sheet of paper has to be put between the fixed and the movable window frame (in the rabbet – while the window is closed), if you can pull it away easily, the point is not airtight. A solution for airtightness in case of historic window frames could be a flexible geometric profiled joint. If it is possible to adjust the fittings, it is recommendable. In case that we replace a historic window and build a new one, the choice of the wood has to be done very carefully by an expert in order to obtain frames which keep the form as much as possible.

2. Also in case of missing weather tightness the reason is that geometry of window frame is changing during the year according to climate. Furthermore the profiled joint in some points is not fixed very well. The profiled joint on the lower part of the window is interrupted between the two window sashes. Also here a solution could be a flexible geometric profiled joint. To bridge the gap of the profiled joint between the two window sashes there are solutions already on the market, where a little extension of the profiled joint is added before closing the windows.

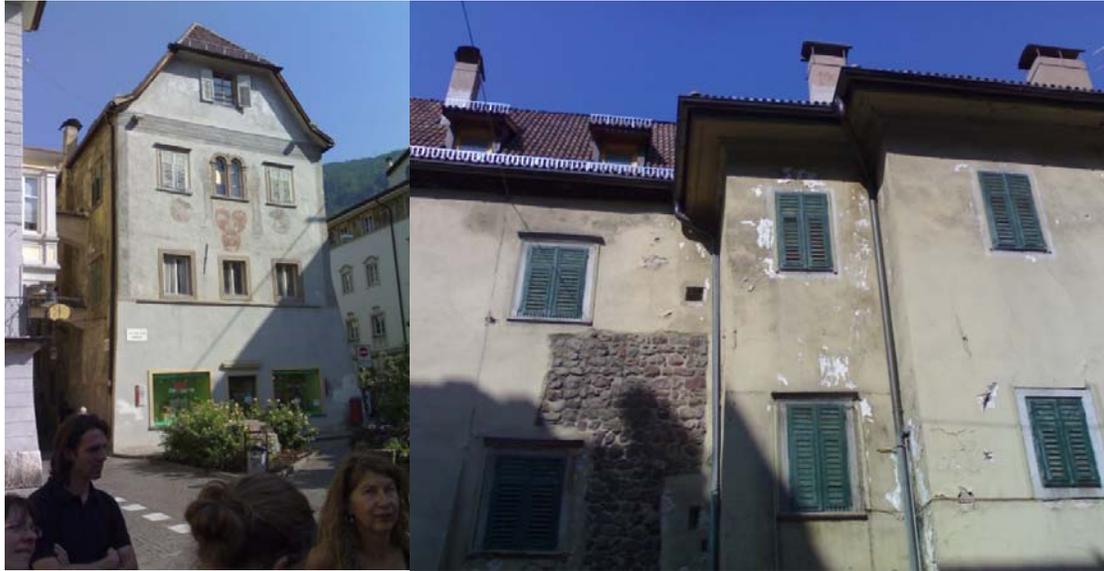
CS 1: Public Weigh House

Actual state: The main part of the existing structure is from the early middle age, several extensions and reconstruction were made in the last centuries. The window size is typical for baroque era. All original windows were replaced by different new window types during the last century. The main parts are box-type windows from the 50s/60s of the last century (see also pictures below: existing window from inside and outside). All of these windows are not of historic value from the conservator's point of view. This means that all windows should be replaced by a reproduction of a historic window. As there are no documents or information available on the type of the original historic window, the conservator proposes to base the new window on a "classic" window in terms of function, division and proportion. Mrs. Kofler-Engl recommends a window with two sashes with two sash bars each sash. It could be a box-type window, a coupled window or an insulating glass window. In case of a box-type window, the layer of the outer window layer should be placed behind the existing stone frame and the deepness of the box should be similar to the actual windows from the 50s/60s. It should be positioned and installed in the reveal in a similar way.

Possible interventions: Installation of a prototype, replacement of window during planned refurbishment
