# Engineering School Bejar

## Case Study 7 Engineering School of Béjar Salamanca - Spain

Béjar (Salamanca), 30/10/2012

3ENCULT CS7. Engineering School of Béjar

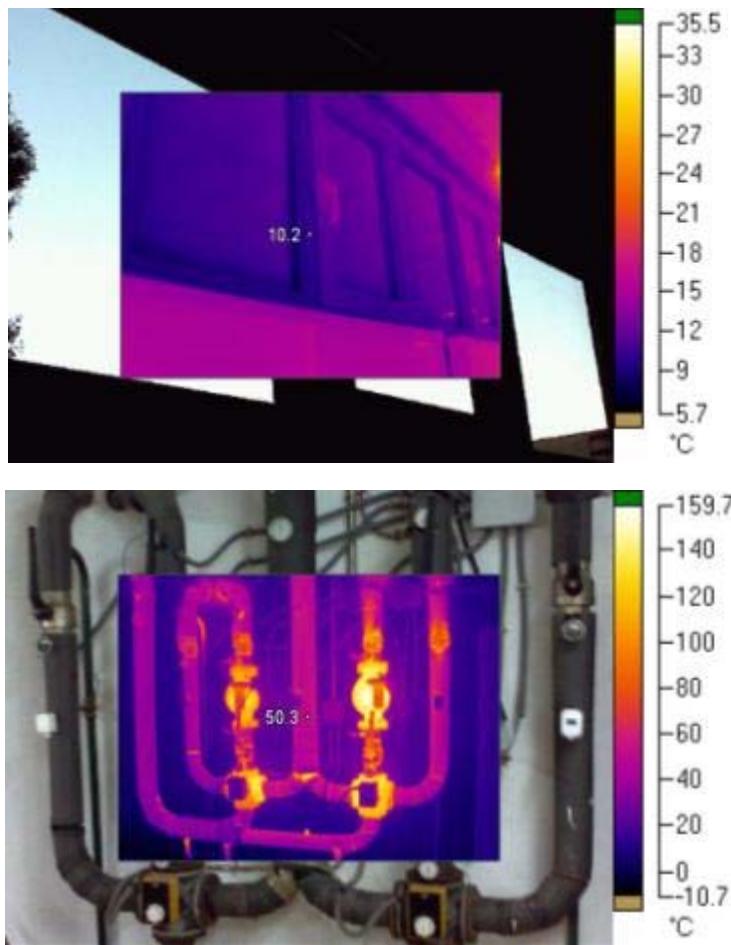
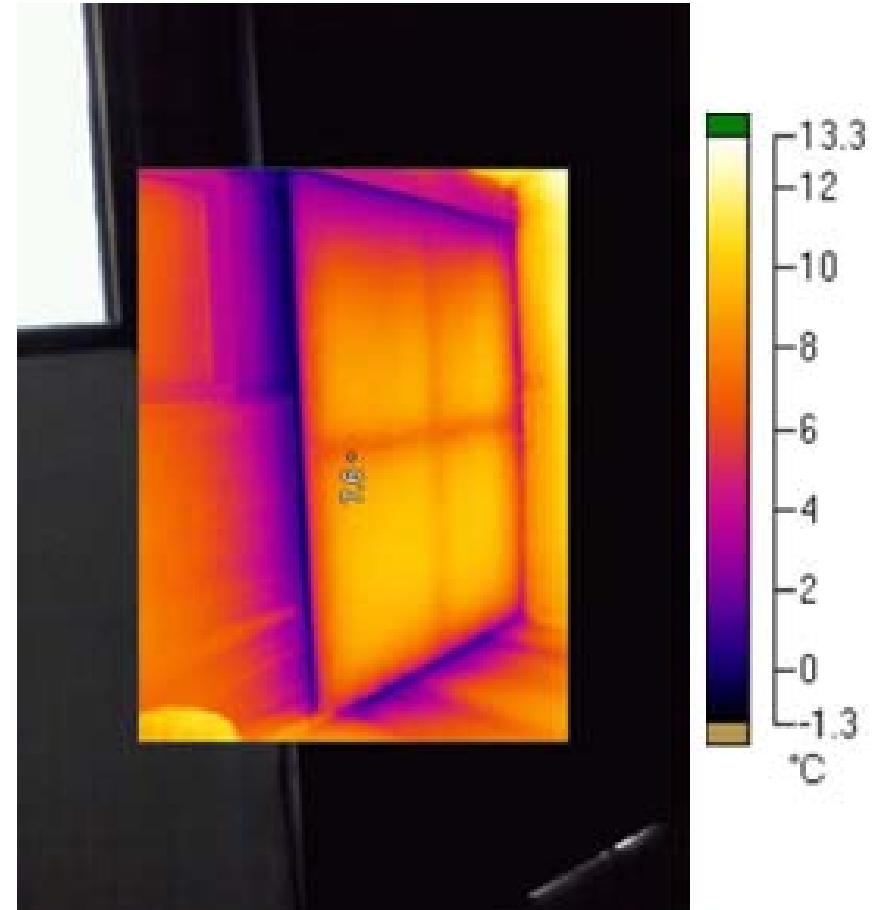
## 1. Infrared thermography

First IR report approach

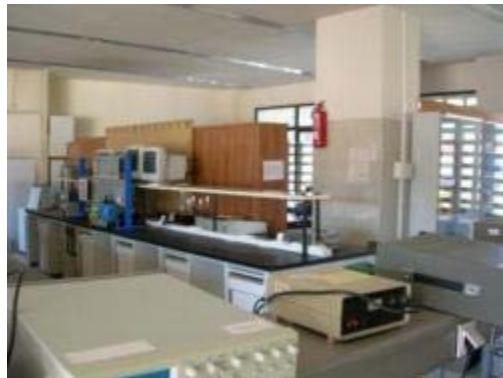
1. Physics laboratory
2. Library

- Physics Laboratory
  - Outdoor temperature = 3°C
  - Indoor temperature = 19,1°C
  - Indoor RH = 34,2%
- Library
  - Outdoor temperature = 5°C
  - Indoor temperature = 20,3°C
  - Indoor RH = 38,4%

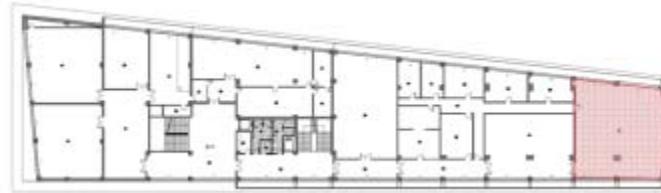
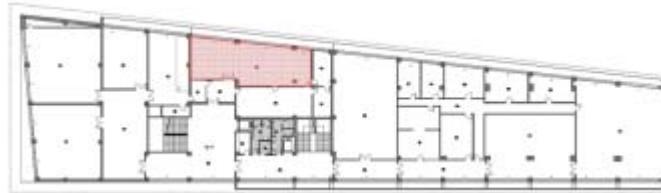
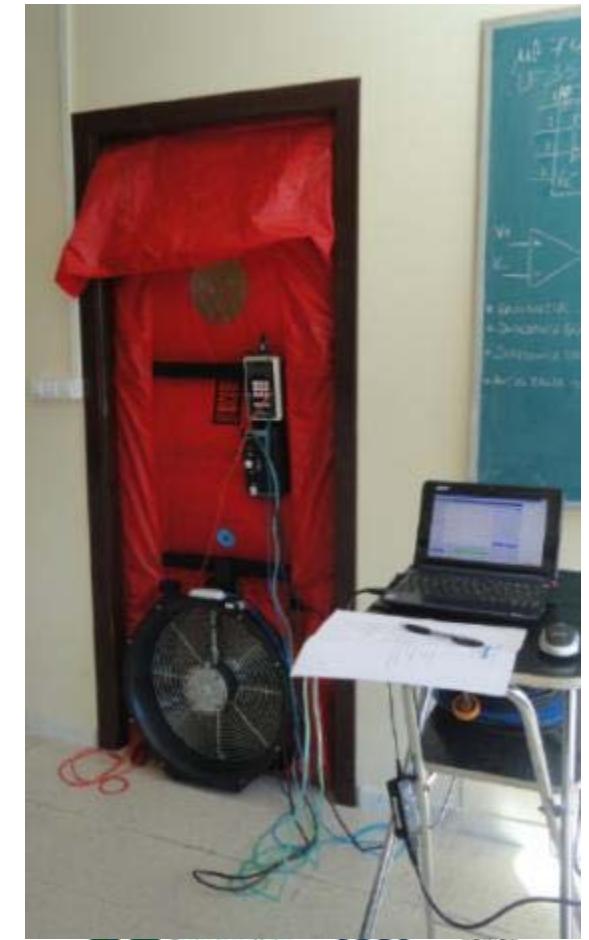
### TEST 1 - LABORATORY

$V =$	$967 \text{ m}^3$	$A_c =$	$172 \text{ m}^2$	$A_e =$	$821 \text{ m}^2$		
	$V_{50}$	Incertidumbre	$R_{50}$	Incertidumbre	$W_{50}$	Incertidumbre	$q_{50}$	Incertidumbre
	5191	± 12 %	0.3	± 15 %	30.2	± 13 %	10.0	± 13 %
Despresurización

- $V_{50}$  Average flow at 50 Pa (m³/h) = 5191 m³/h
- $n_{50}$  Airchange rate at 50 Pa (1/h) = 9,2 h⁻¹
- $w_{50}$  Air flow at 50 Pa / usable floor area = 30,2 m³/m²·h
- $q_{50}$  Air flow at 50 Pa / envelopment area = 10,0 m³/m²·h
- Annual average airchange rate = 9,2/20 = 0,46 h⁻¹

- $V_{50}$  Average flow at 50 Pa (m³/h) = 4778 m³/h
- $n_{50}$  Airchange rate at 50 Pa (1/h) = 8,4 h⁻¹
- $w_{50}$  Air flow at 50 Pa / usable floor area = 27,8 m³/m²·h
- $q_{50}$  Air flow at 50 Pa / envelopment area = 9,2 m³/m²·h
- Annual average airchange rate = 8,4/20 = 0,42 h⁻¹
